Subject: 10CFR21 Reporting of Defects and Non-Compliance -
Engine Systems, Inc. Report No. 10CFR21-0128, Rev. 0

Selenium Surge Suppressor, EMD P/N 8403049

Report No. **10CFR21-0128**

COMPONENT: Selenium Surge Suppressor
P/N 8403049

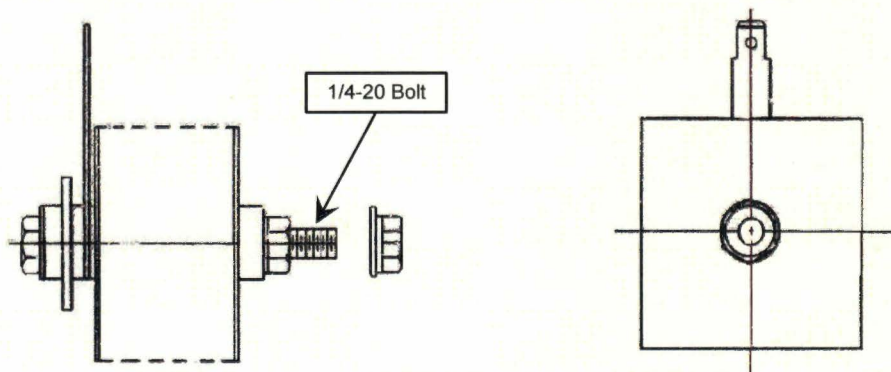
Figure 1: Outline Drawing of Selenium Surge Suppressor P/N 8403049

Three batches of selenium surge suppressors supplied by ESI between 2011 and 2013 utilize a thread modification that is inadequate for the application. The design specifies the use of a single 1/4-20 x 2-3/4" long bolt to compress the stack of selenium cells as well as mount the suppressor (see Figure 1). Contrary to this requirement, the manufacturer used a #8-32 screw through the body of the stack and added a modified bolt to obtain the required 1/4-20 mounting threads. The modified bolt consisted of a 1/4-20 x 5/8" long bolt that was drilled and tapped in the head to accept #8-32 threads. An attempt to install the selenium surge suppressor by tightening the corresponding mounting nut may result in failure of the modified bolt threads. See photos 1, 2, & 3.

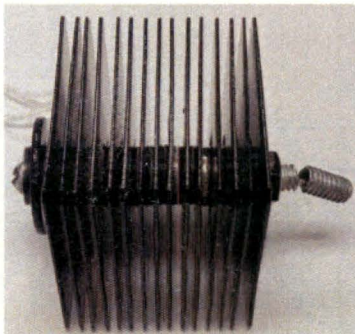
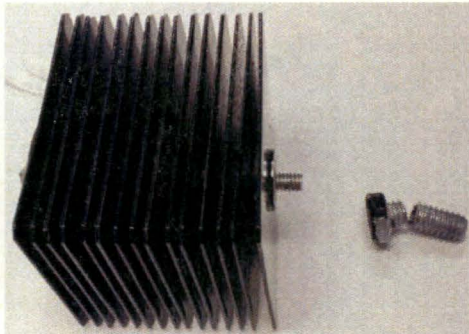
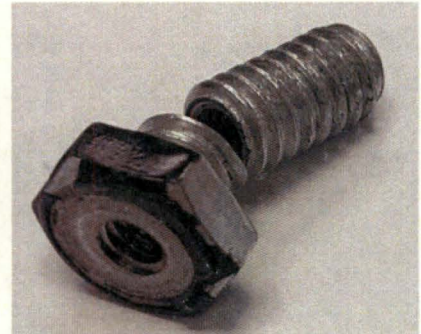
Photos 1, 2, & 3: Views of Suppressor with Modified Screw

Use of this thread modifier significantly reduces the strength of the mounting threads. Failure of the mounting threads creates the possibility of the suppressor dislodging with the potential to electrically short between the positive and negative plates of the rectifier assembly. An electrical short would affect output of the voltage regulator system which may prevent the emergency diesel generator set from performing its safety-related function. This issue is therefore considered to be a reportable defect as defined by 10CFR-part 21.

- For surge suppressors installed, these are functionally acceptable but may be structurally compromised. The concern is the mounting nut may have unknowingly been tightened beyond the allowable strength of the bolt which could eventually cause the mounting system to fail. ESI recommends inspection and/or replacement at the next opportunity.*
- For surge suppressors not installed, ESI recommends they be returned for replacement.*
