July 5, 1972

MONTICELLO NUCLEAR GENERATING PLANT  
Docket No. 50-263 License No. DPR-22

Inspection of Support Hangers for Emergency Core  
Cooling System Suction Header

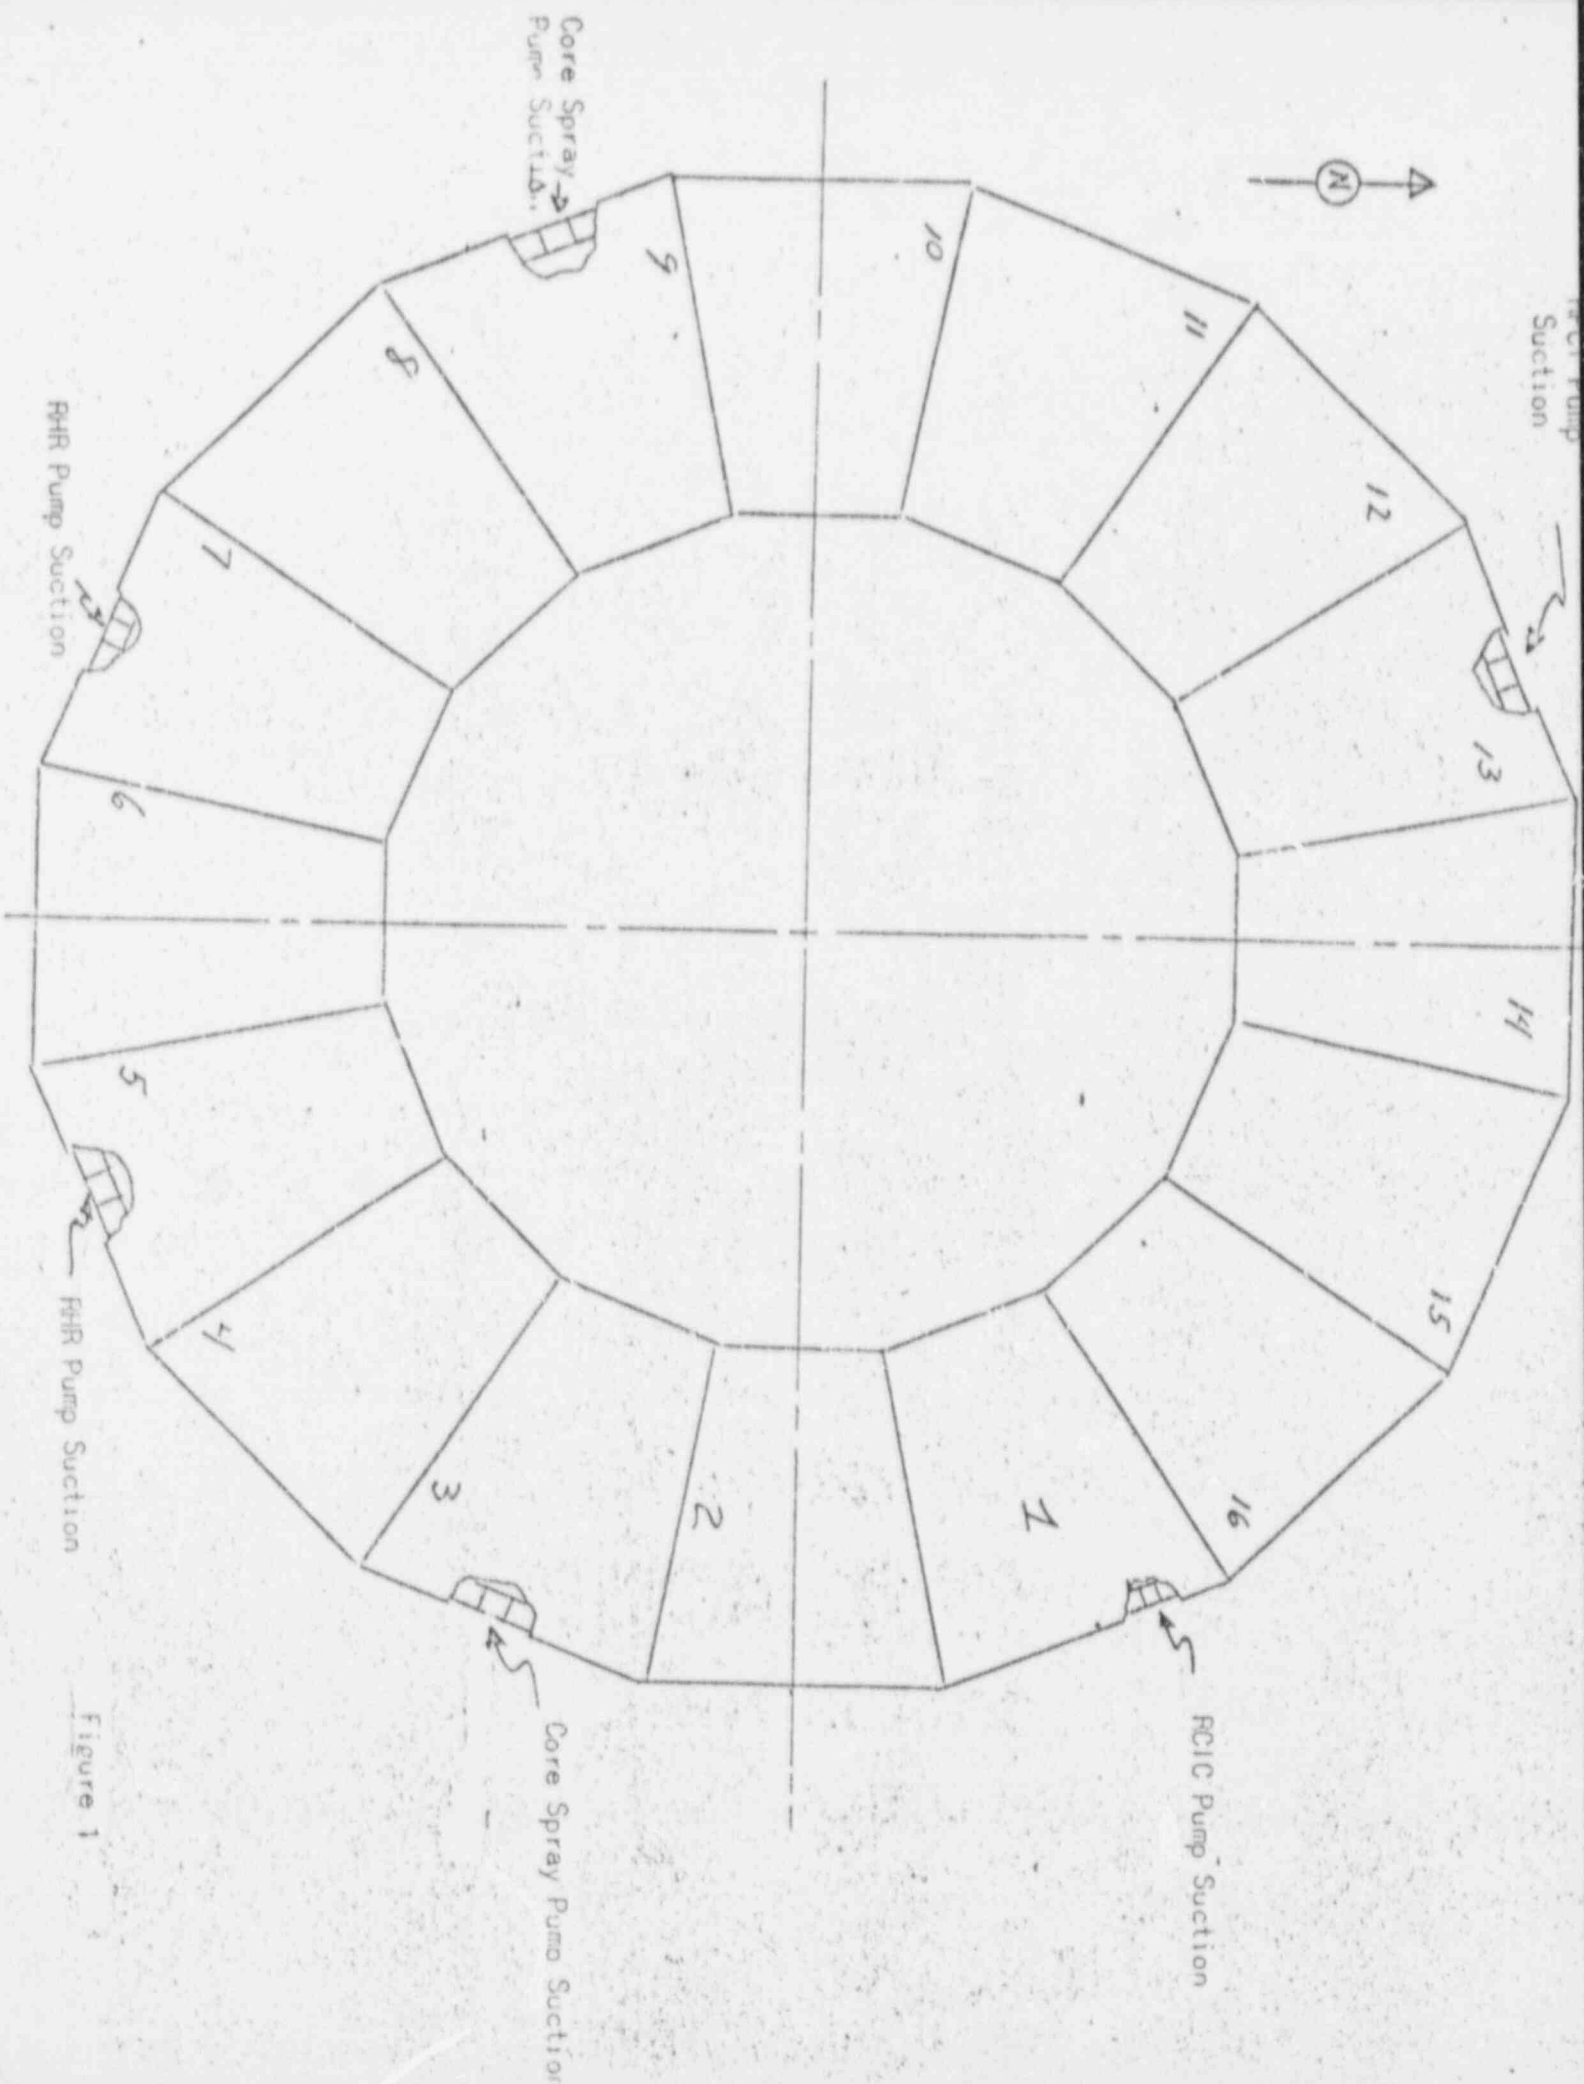
Figure 1

The support structure and bolting arrangement are exhibited in Figures 1 and 2. For clarity, the bolting arrangement has been identified as "upper vertical, lower vertical, outboard horizontal and inboard horizontal". The sixteen mitered sections of the torus have been numbered arbitrarily for ease of inspection location as indicated on Figure 1. Of these sections only twelve are support assembly locations. As specified by the Chicago Bridge and Iron Company the bolting should consist of 3/4" HEX HD BOLTS, 2 3/4" in length and 3/4" REG HEXLOCK NUTS both meeting ASME specification A307.

The "as found" bolting consisted of 3/4" HEX HD BOLTS, 2 3/4" in length, full threaded and without lock nuts. No identification markings were stamped on the bolts to specify grade. The bolts exhibited thread damage on the bearing surface varying from crushed threads to moderate thread damage. In several instances localized thread damage was apparent due to the irregularity of a torch cut hole. Of the 48 bolts, only one other exhibited bowing and that to a slight extent.

As indicated in Table 1, nine sections had torch cut holes in the bracket gusset plate, pipe web or support straps. The torch cut holes were in addition to the drilled hole. A hydraulic jack was required for removal of the outboard horizontal bolts in section nine and section three, indicating horizontal compressive loading on the torus at these points. A qualitative judgment based on the jack size and discussion with the personnel who performed this work indicates the horizontal loading force at these points was in the range of one to two thousand pounds.

As of June 8, 1972, all the support bolts for the 20" torus suction ring header were replaced with SAE grade 8 or 9; 3/4" HEX HD partially threaded bolts having no threads in the shear load area. The bolts were locked with double nuts.

General Electric and Chicago Bridge and Iron are providing services to return the support assembly system to the original design. A static load analysis of vertical loading has been completed to provide a basis for adjusting the system to balanced loading on the support assemblies. Welding and inspection procedures for repair of bolt holes are currently being reviewed. It is intended that all bolting will be replaced with ASME A325 HEX HD 3/4" BOLTS with no threads in the load-bearing area, and lock nuts will be provided. Any replacement of support straps will be made using original specification material. We currently anticipate completion of all work by the end of July 1972.
