James A. FitzPatrick
Nuclear Power Plant
P.O. Box 41
Lycoming, New York 13093
315 342-3840

April 17, 1991
JAFF-91-0233

SUBJECT: DOCKET NO. 50-333
LICENSEE EVENT REPORT: 91-004-00
Unmonitored Radiation Release

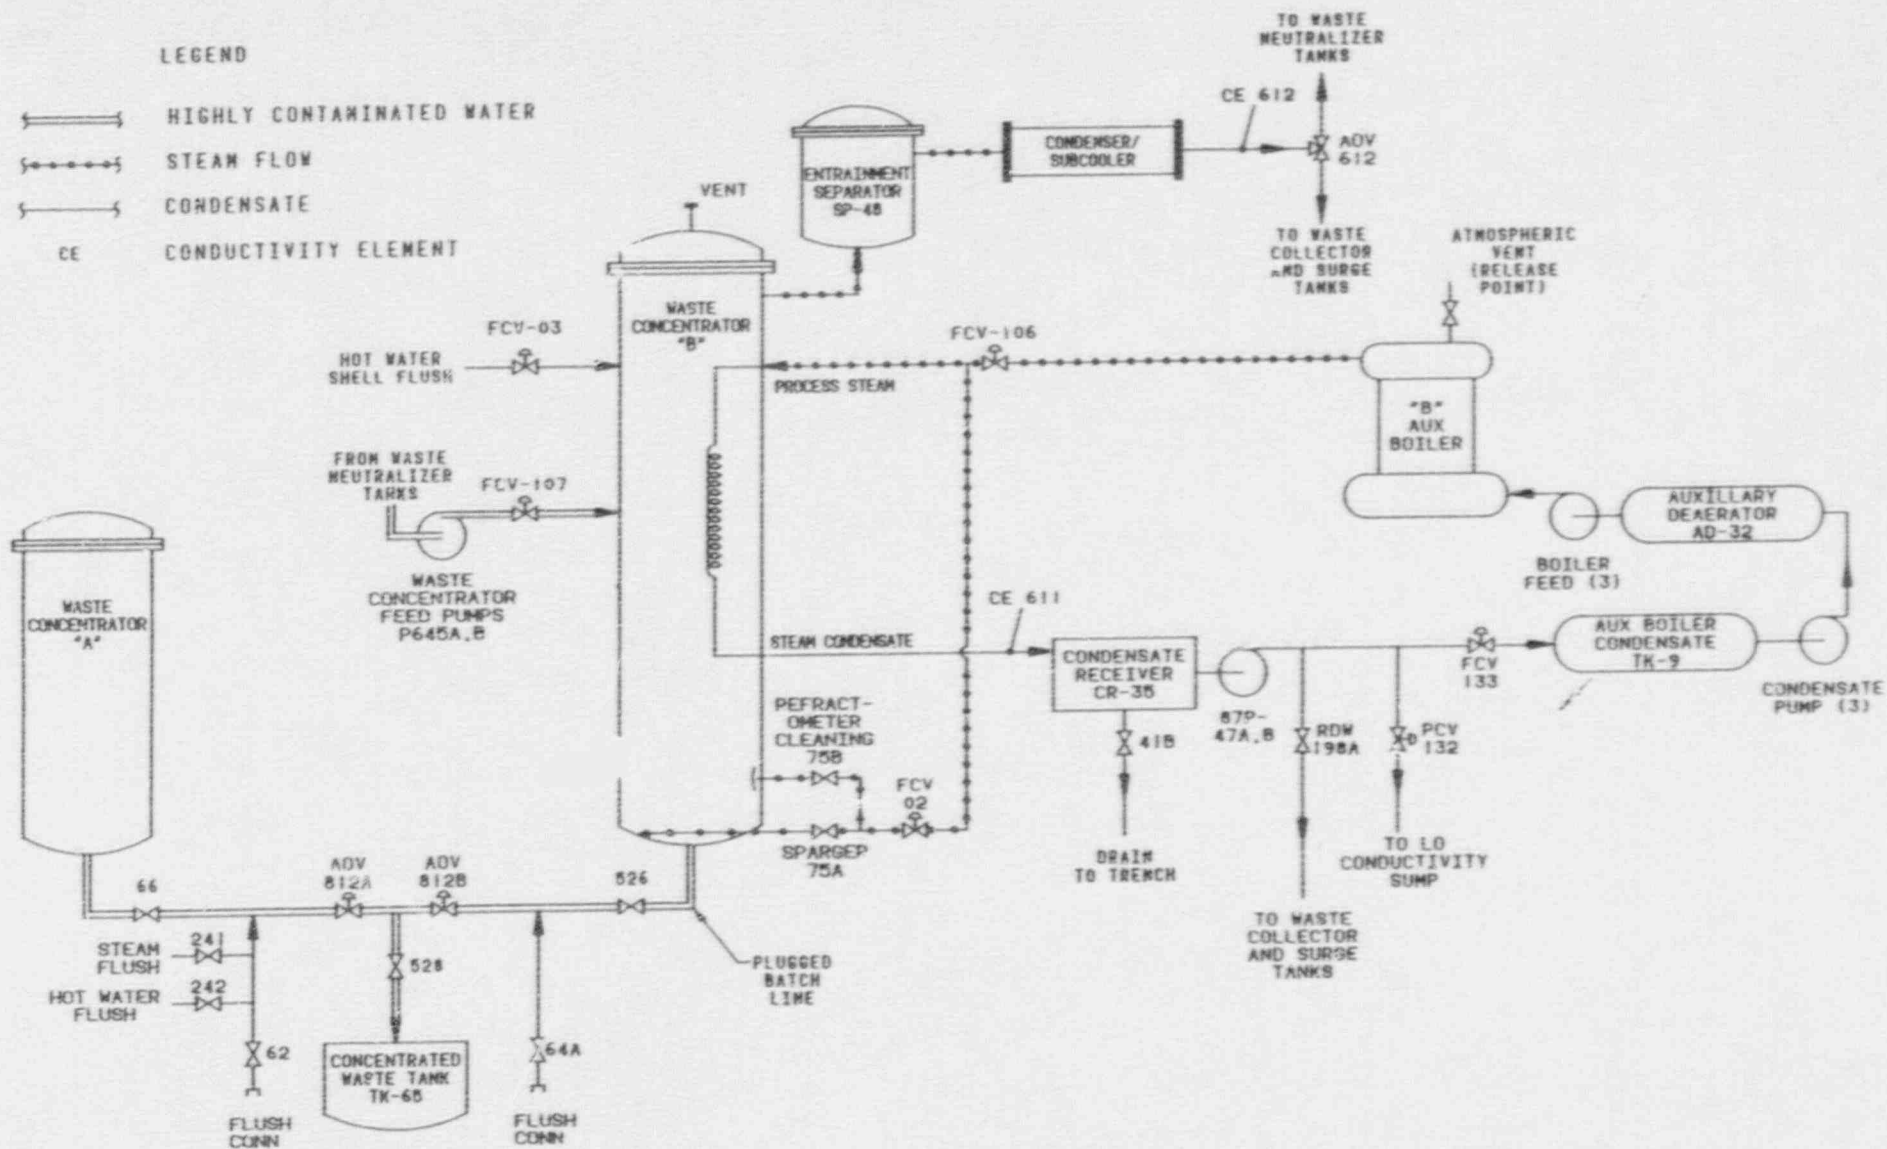
DOCKET # 50-333
 LER-91-004-00
 WASTE CONCENTRATOR TO AUXILIARY BOILER
 SIMPLIFIED FLOW DIAGRAM

The design of the steam supply to the waste concentrator contains an error in piping arrangement. Manufacturer's drawings of the waste concentrator show the flush line to the refractometer connected upstream of the steam flow control valve, 20FCV-106. The original design from the architect engineer has the flush line installed downstream of the flow control valve. This error was not discovered until this event. This incorrect piping arrangement establishes the flow path for the siphoning situation discussed earlier. Refer to Attachment 1 and 2 for a basic sketch of the waste concentrator.

An engineering study is in progress on the radioactive waste concentrator and the auxiliary boiler.

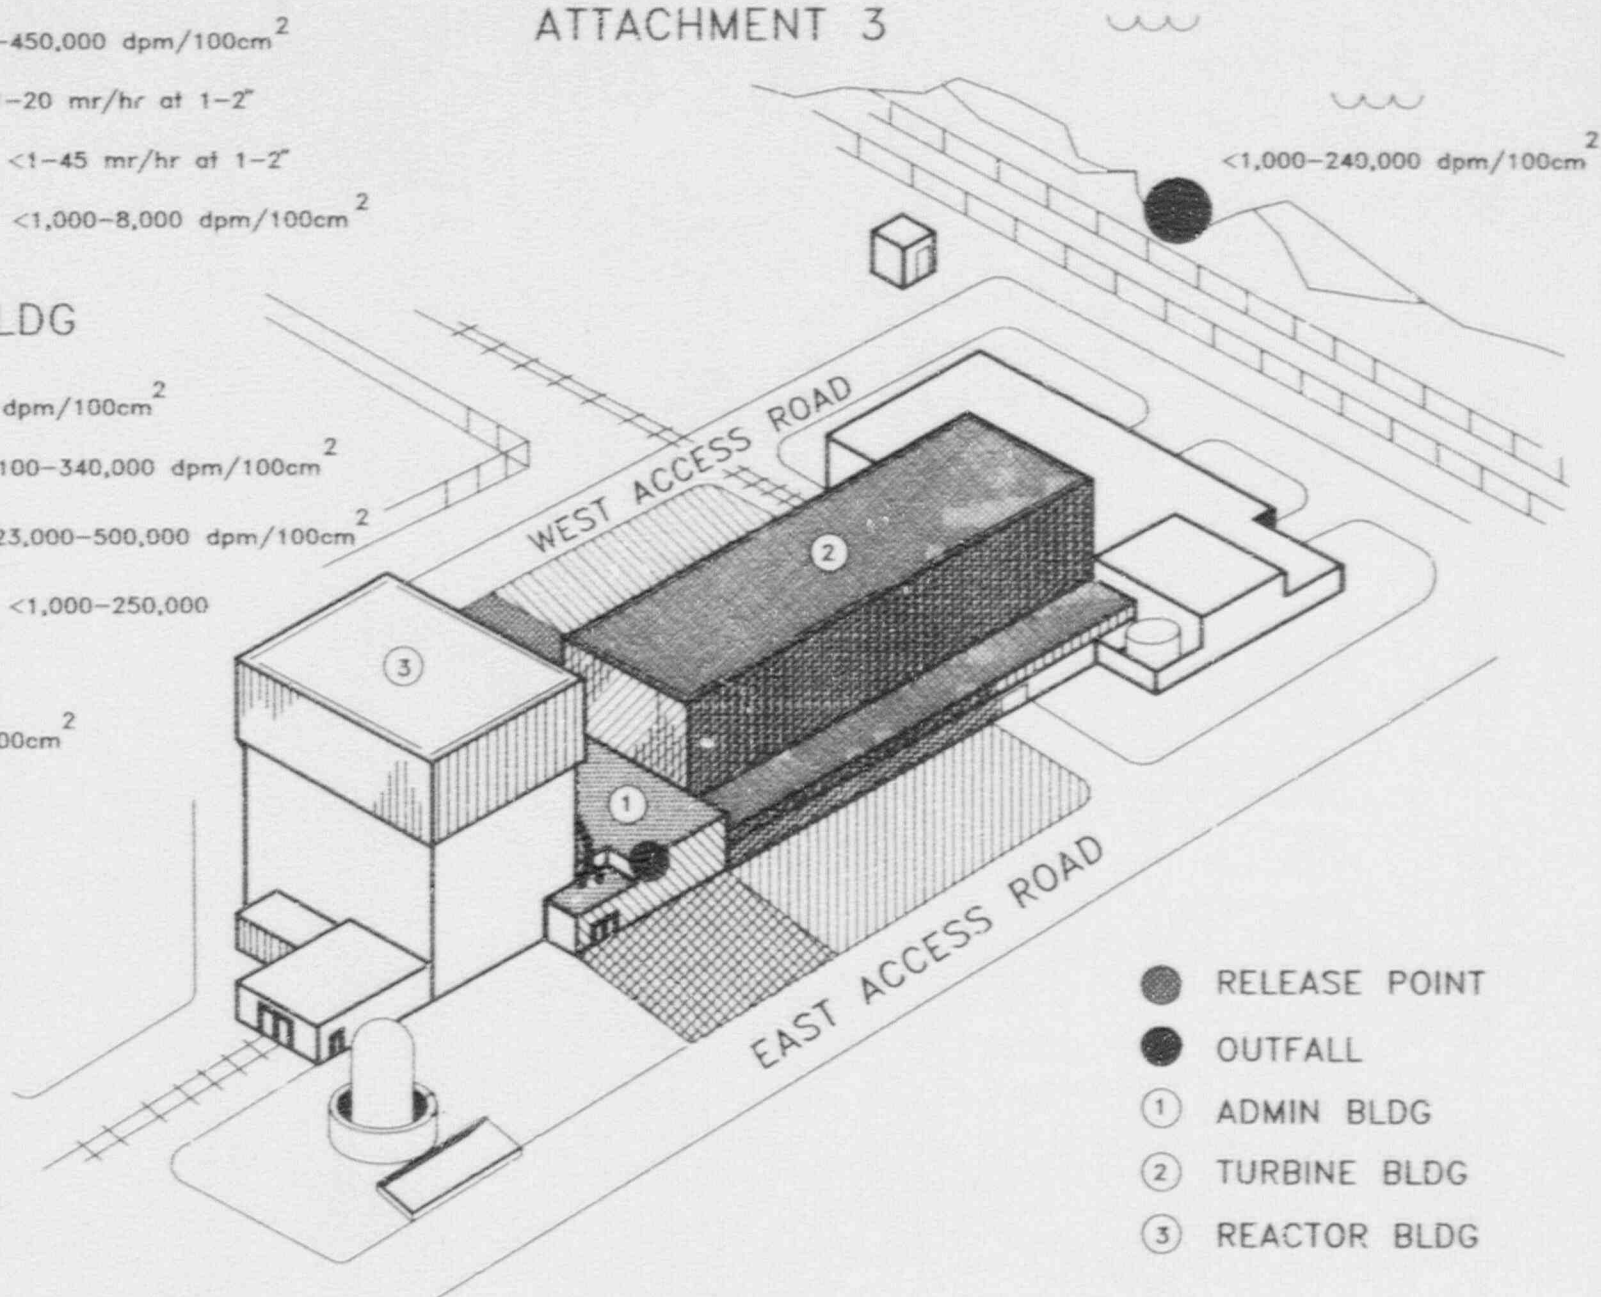
DOCKET NO. 50-333
LER 91-004-00
ATTACHMENT 3

- ROOF <1,000-450,000 dpm/100cm²
- ▨ EAST WALL <1-20 mr/hr at 1-2"
- ▩ GROUND EAST <1-45 mr/hr at 1-2"
- GROUND WEST <1,000-8,000 dpm/100cm²

- ROOF <1,000 dpm/100cm²
- ▨ EAST WALL 1,100-340,000 dpm/100cm²
- ▩ SOUTH WALL 23,000-500,000 dpm/100cm²
- ▨ GROUND EAST <1,000-250,000 dpm/100cm²
- ▨ GROUND WEST <1,000dpm/100cm²
