## Nebraska Public Power District

## LICENSEE EVENT REPORT (LER)

FACILITY NAME (1) Cooper Nuclear Station										DOCKET NUMBER (2) 0 5 0 0 0 2 9 8										PAGE (3) 1 OF 0 5																													
TITLE (4) Reactor Water Cleanup Isolation Due to High System Temperature During Plant Cooldown Caused by Failed Temperature Indication and Potential Equipment Failure																																																	
EVENT DATE (5) MONTH DAY YEAR 0 3 2 4 9 1										LER NUMBER (6) YEAR SEQUENTIAL NUMBER REVISION NUMBER 9 1 0 0 2 0 0 0 4 2 3 9 1										REPORT DATE (7) MONTH DAY YEAR 0 3 2 4 9 1										OTHER FACILITIES INVOLVED (8) FACILITY NAMES DOCKET NUMBER(S) 0 5 0 0 0 0																			
OPERATING MODE (9) N										THIS REPORT IS SUBMITTED PURSUANT TO THE REQUIREMENTS OF 10 CFR § (Check one or more of the following) (11)																																							
POWER LEVEL (10) 0 0 0										20.402(b)										20.406(a)										X 50.73(a)(2)(iv)										73.71(b)

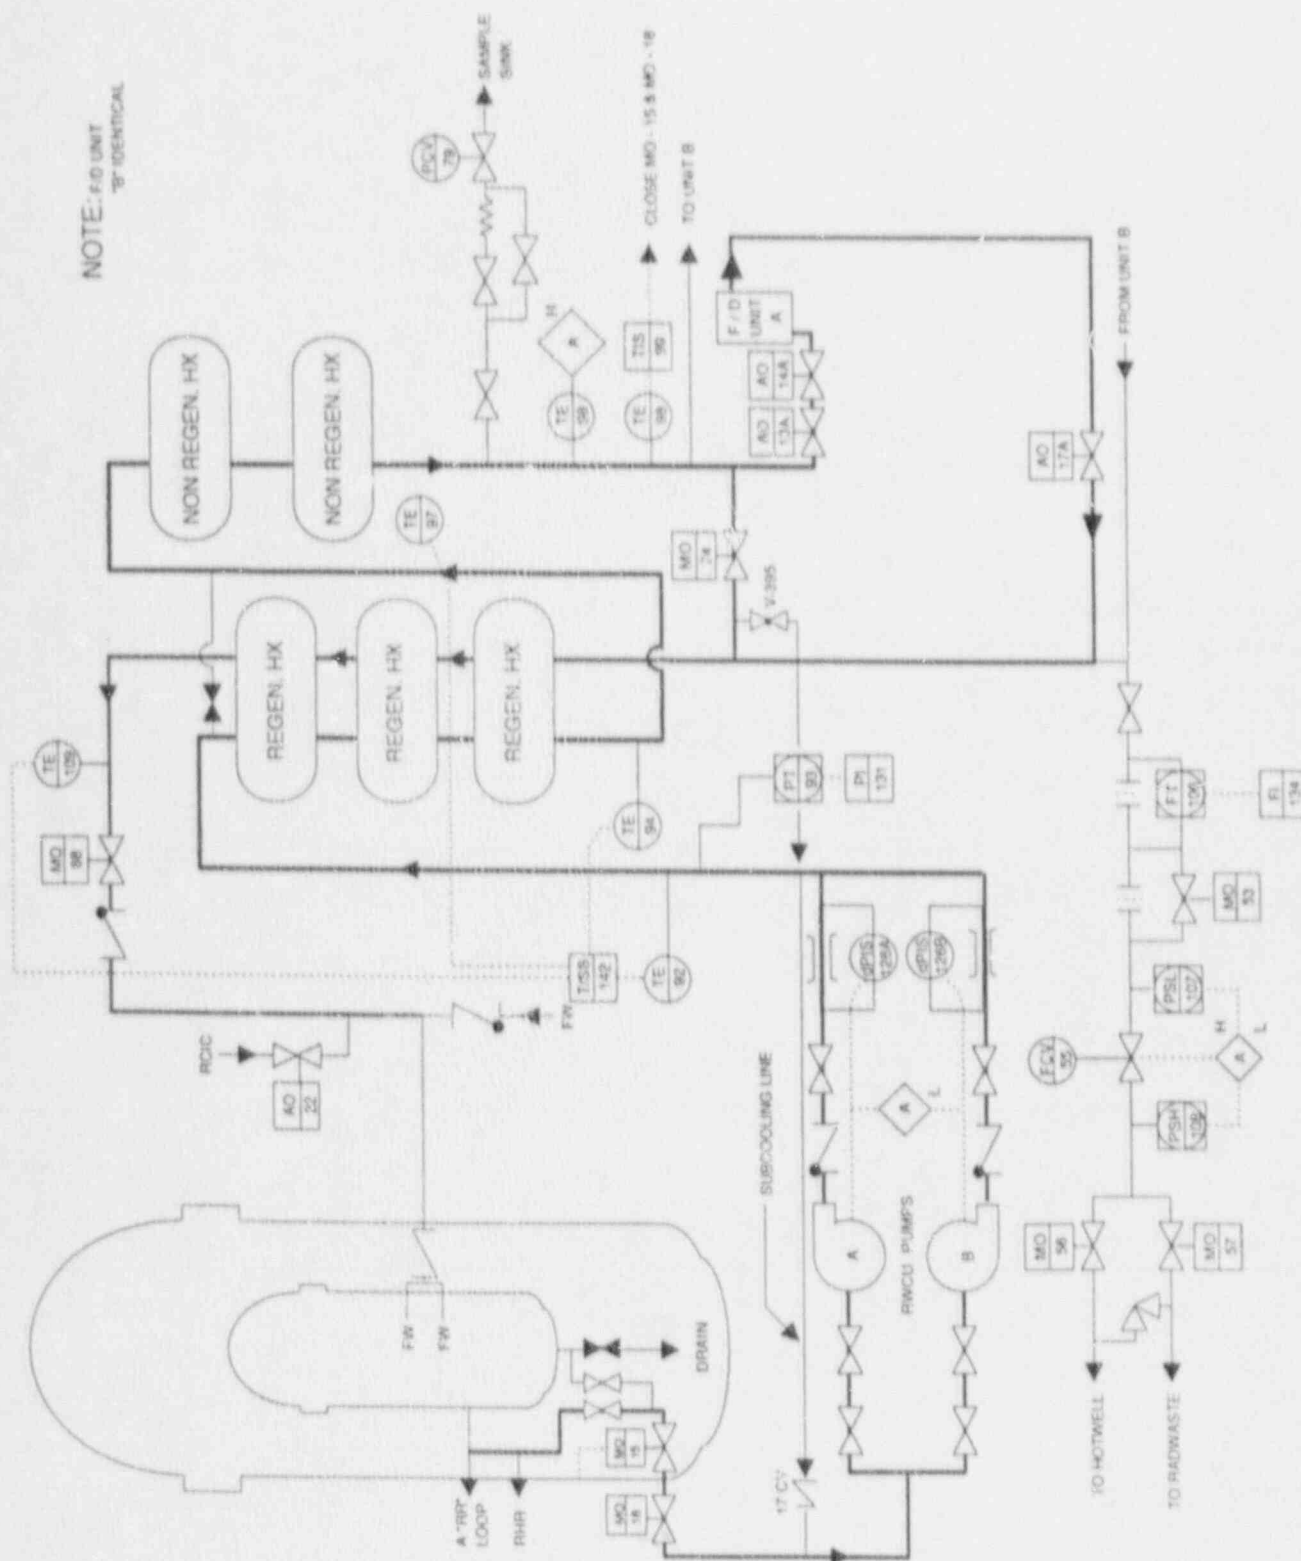
## REACTOR WATER CLEAN-UP

The isolations were caused by a high temperature condition in the piping downstream of the RWCU NRHX.

The RWCU System was aligned with a flow path open to the condenser hotwell to provide for reactor vessel level control. However, to facilitate Feedwater System maintenance, the pumps were not in operation. Since reactor vessel level control was well established, minimal flow existed in the RWCU System. It is probable that the high temperature condition occurred due to the input of residual heat from RWCU piping and components. This condition may have been compounded had there been any backflow through the check valve in the 3/4 inch subcooling line installed between the NRHX outlet and the RWCU System inlet piping. With virtually no system differential pressure, this backflow could have existed, allowing direct input of hot (185 degree F) water into this section of piping. (See attached sketch). The subcooling line is designed to prevent flashing at the RWCU pump suction by providing cooled water from the outlet of the NRHX. Contributing to this condition was the lack of correct indication (TE-97) and annunciation (TS-115) of a high temperature condition.

Testing of the thermocouple indicated a lead was grounded, causing the indication in the Control Room to read a constant 80 degrees F. It is not known how long the ground had existed. The root cause of this failure is considered to be an isolated, random failure of the component.

The internal mechanisms of the temperature switch were found to be worn, preventing actuation of the microswitch. This switch, installed in 1985, is calibrated on a four year frequency, and had satisfactorily passed its last calibration in 1988. The root cause of the switch failure is an inadequate Preventive Maintenance Program, as the switch should have been replaced prior to reaching the end of its life.

The failed thermocouple and temperature switch were replaced and calibrated prior to startup from the maintenance outage. The isolation switch was confirmed to be operating correctly.

A Preventive Maintenance activity will be initiated to periodically replace the temperature switch. The frequency of the switch calibration will also be increased. Based upon recent documented calibration and response checks of installed thermocouples, the failure of TE-97 is considered to be an isolated incident. Therefore, no further corrective action is warranted.
