**BOSTON EDISON**

The enclosed Licensee Event Report (LER) 91-005-00, "Loss of AC Power to 'B' Trains of Safety Systems Due to Diesel Generator 'B' Voltage Regulator Failure During Surveillance", is submitted in accordance with 10 CFR Part 50.73.

## LICENSEE EVENT REPORT (LER)

FACILITY NAME (1) Pilgrim Nuclear Power Station										DOCKET NUMBER (2) 0 5 0 0 0 2 0 3 1 OF 1 1				PAGE (3) 1		
TITLE (4) Loss of AC Power to 'B' Trains of Safety Systems Due to Diesel Generator 'B' Voltage Regulator Failure During Surveillance																
EVENT DATE (5)			LER NUMBER (6)				REPORT DATE (7)			OTHER FACILITIES INVOLVED (8)						
MONTH	DAY	YEAR	YEAR	SEQUENTIAL NUMBER	REVISION NUMBER	MONTH	DAY	YEAR	FACILITY NAMES				DOCKET NUMBER(S)			
									N/A				0 5 0 0 0			
0 3	2 5	9 1	9 1	0 0 5	0 0	0 4	2 4	9 1	N/A				0 5 0 0 0			
OPERATING MODE (9)		THIS REPORT IS SUBMITTED PURSUANT TO THE REQUIREMENTS OF 10 CFR 5. (Check one or more of the following) (11)														
N		20.402(b)				20.405(a)				X		50.73(a)(2)(iv)		73.71(b)		
POWER LEVEL (10)		1 0 0				20.405(a)(1)(i)				X		50.73(a)(2)(v) (D)		73.71(c)

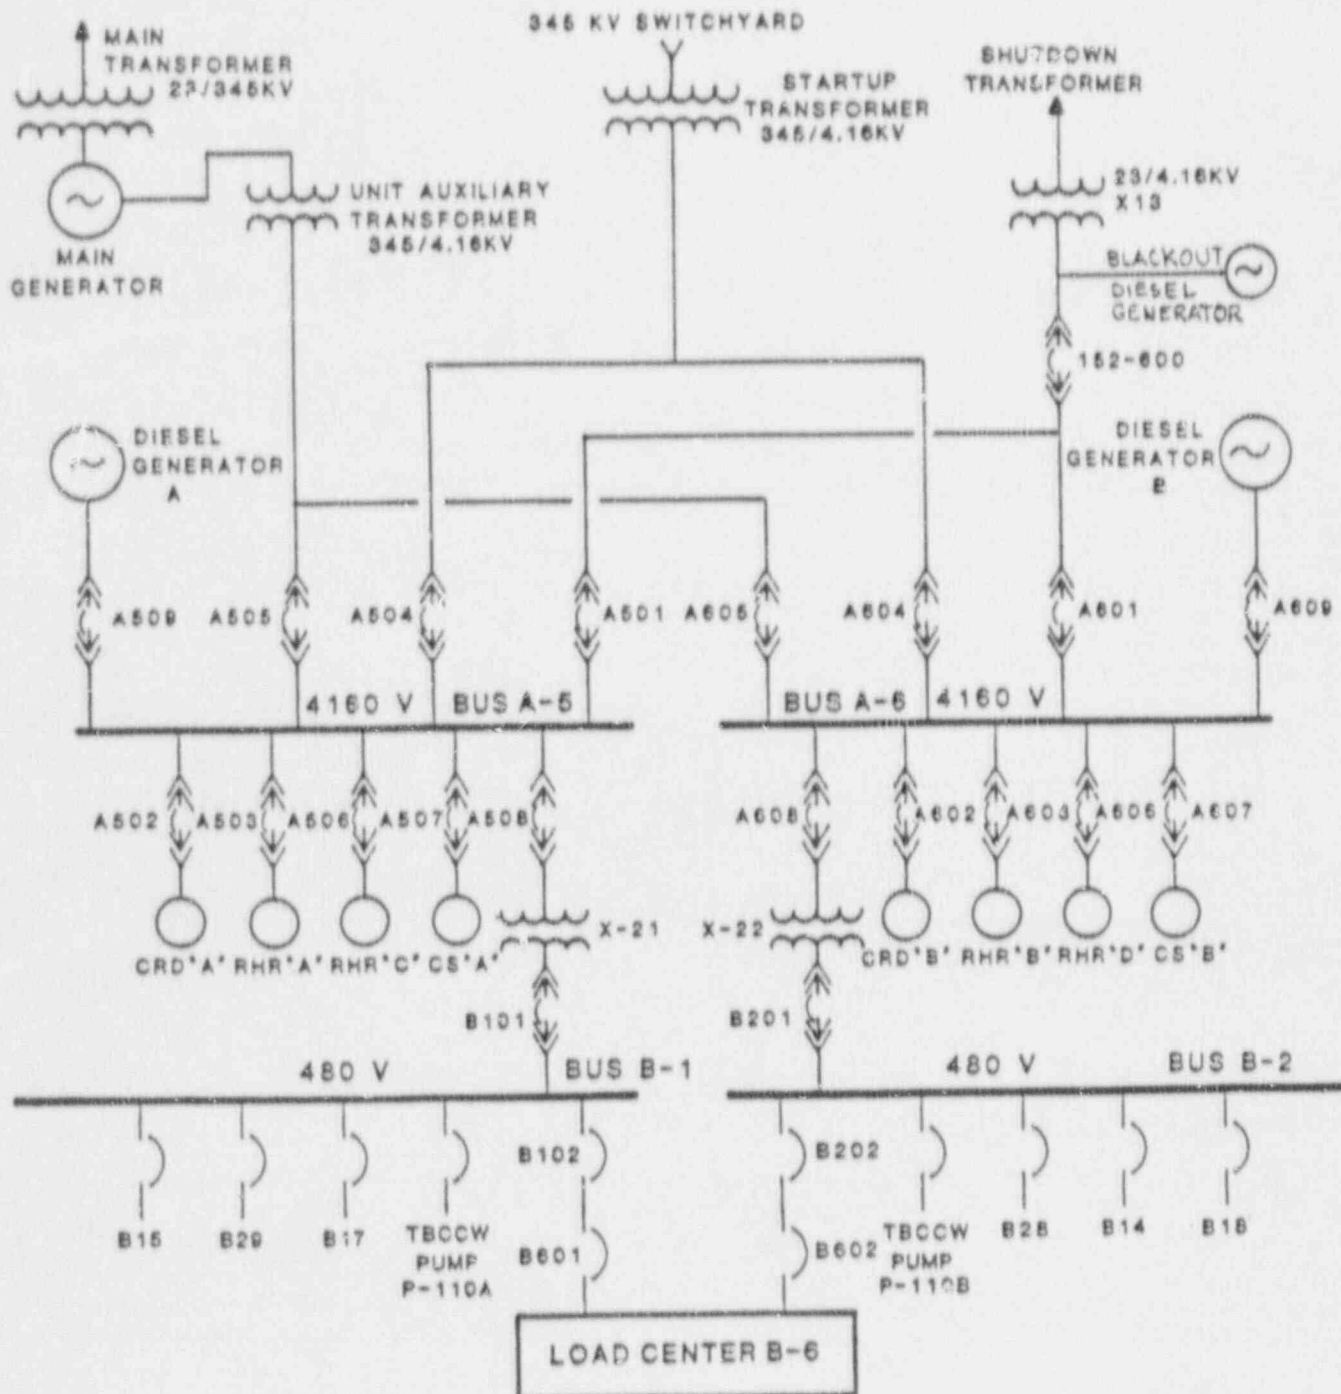
EMERGENCY AC DISTRIBUTION

Located at the end of this report is a Figure that depicts a simplified single line diagram of a portion of the APDS including Buses A5 and A6. The diagram does not depict feeder breakers A801 (152-801) and A802 (152-802) that are located on the Blackout Diesel Generator and Shutdown Transformer side of breaker 152-600.

The cause for the actuation of lockout relay 186-A6 was an overcurrent condition sensed by protective devices for phase 'B' of feeder breaker A605. The overcurrent condition was the result of a failure of the EDG 'B' automatic voltage regulator that occurred during the surveillance test (8.9.1) while EDG 'B' was loaded on Bus A6. The voltage regulator was manufactured by the Basler Electric Company, model number SVR01A05B2B1B, serial number 9047500105. The cause for the failure of the automatic voltage regulator had not been identified when this report was submitted. The manufacturer's root cause analysis is currently expected to be completed by May 31, 1991. Therefore, this report is expected to be updated by July 30, 1991.
