LIMERICK GENERATING STATION

SUBJECT: Licensee Event Report
Limerick Generating Station - Unit 2

This LER reports a condition of the refueling platform monorail mounted auxiliary hoist where operation of the uptravel mechanical stop permitted the handling of a control rod outside the limits of Technical Specifications due to procedure deficiencies.

Reference:	Docket No. 50-353
Report Number:	2-91-007
Revision Number:	00
Event Date:	April 10, 1991
Report Date:	May 10, 1991
Facility:	Limerick Generating Station P.O. Box A, Sanatoga, PA 19464

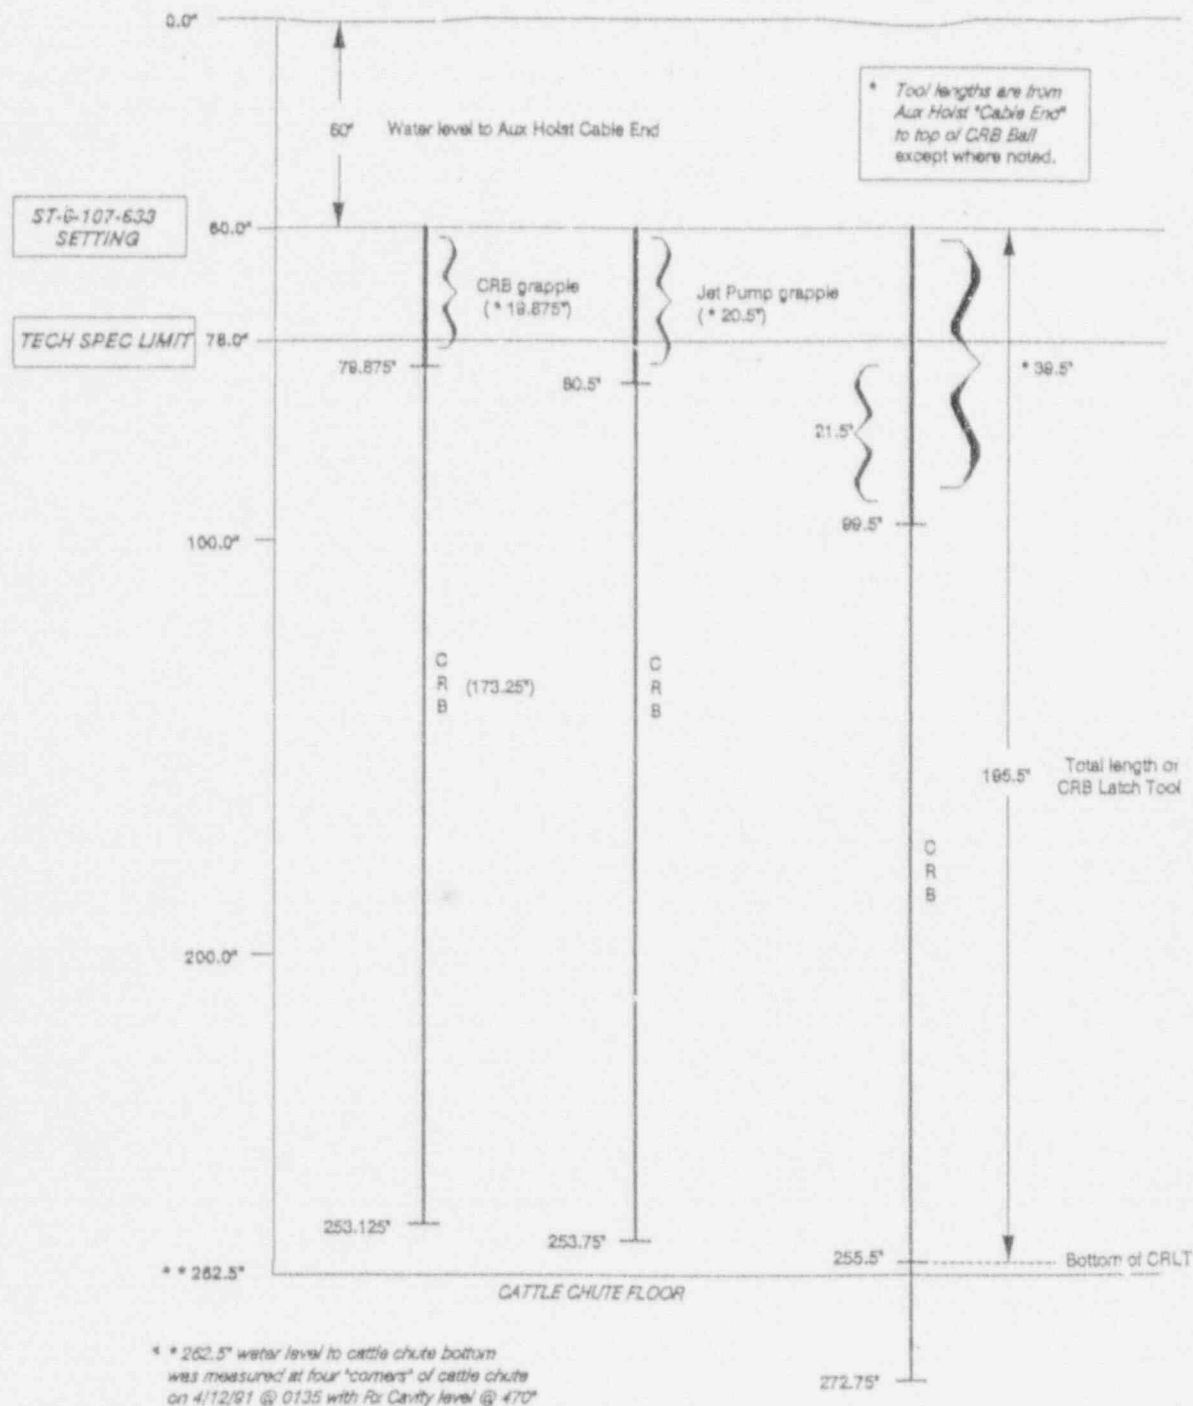
FIGURE 1

On April 9, 1991, procedure ST-6-107-633-2 was performed to ensure compliance with TS SR 4.9.6.3b prior to control rod blade (CRB) movement. Procedure ST-6-107-633-2 sets the mechanical stop to ensure the loose end of the hoist cables, with no tools attached, will remain at least 5 feet below the surface of the water. With an invessel tool attached, the distance from the hoist cable loose end to the top of the CRB bail handle provides the other 18 inches necessary to meet the 6 feet 6 inch TS SR. The actual distances provided are 19.875 inches by the CRB grapple, 20.5 inches by the jet pump grapple, and 39.5 inches by the control rod blade latch tool (Figure 1). A CRB can be transferred between the reactor vessel and the spent fuel pool following performance of procedure ST-6-107-633-2 using the CRB grapple or jet pump grapple but not by using the CRB latch tool. While the CRB grapple and jet pump grapple provide 9.125 inches of clearance from the bottom of the CRB to the transfer canal (cattle chute) floor, the CRB latch tool extends the bottom of the CRB 10.25 inches below the transfer canal floor.

On April 10, 1991 at 1240 hours, the mechanical stop was moved 24 inches to transfer a CRB from the spent fuel pool to the reactor vessel using the CRB latch tool. This resulted in the top of the CRB being 6 feet 3.5 inches below the surface of the water in violation of TS SR 4.9.6.3b. At shift turnover on April 10, 1991, at 1630 hours the oncoming, a licensed Fuel Handling Supervisor observed the uptravel mechanical stop to be mispositioned. The mechanical stop was reset and procedure ST-6-107-633-2 was performed to verify compliance with TS SR 4.9.6.3b.

AXIAL MEASUREMENTS FOR VARIOUS SFP TOOLS
