SUBJECT: COMANCHE PEAK STEAM ELECTRIC STATION (CPSES)  
DOCKET NO. 50-445  
REPORT OF EVENT WITH GENERIC INTEREST  
LICENSEE EVENT REPORT 91-016-00

Enclosed is Licensee Event Report 91-016-00 for Comanche Peak Steam Electric Station Unit 1, "Manufacturing Error Leading to the Failure of a Check Valve to Prevent Backflow."

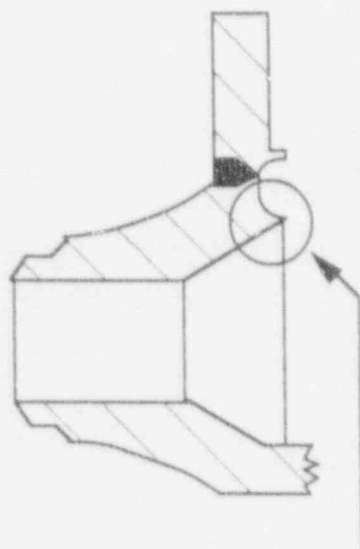
The affected check valve stuck open due to interference between the disk counterweight and a lip of excess casting material on the valve body, allowing reverse flow in one branch of the AFW system.

A manufacturing error in the machining process of the valve body casting allowed excess casting material to remain on the inside surface of the valve body.

**Root cause :** The component was not manufactured in accordance with design. During the manufacture of the valve body, finish machining of the rough casting was not adequately performed. The incomplete machining resulted in excess casting material inside the valve body (Refer to Figure 1) which interfered with full stroke motion of the swing arm counterweight. Information related to valve port dimensions is BW/IP proprietary information and not an inspectable attribute during receipt inspection.

EXCESS CASTING MATERIAL

The affected valve was machined to remove excess casting material from the valve body and restore the design contour of the valve port. The remaining seven check valves in the AFW branch lines were disassembled, photographed, and inspected to ensure that finish machining had been adequately performed. Measurements inside the valve body were taken for each of the valves and revealed that finish machining had been performed correctly. The valves were reassembled and are scheduled to receive forward and reverse flow testing prior to plant restart.

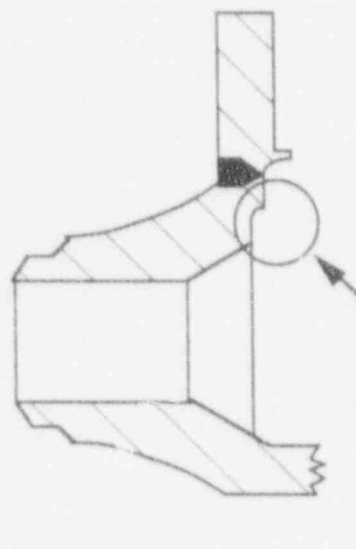
Figure 1

AS-DESIGNED CONTOUR
