# New Hampshire Yankee

Subject: Licensee Event Report (LER) No. 91-004-00: Feedwater Check Valve Bolting Failures

FACILITY NAME (1) Seabrook Station										DOCKET NUMBER (2) 0 5 0 0 0 4 4 3				PAGE (3) 1 OF 0 6									
TITLE (4) Feedwater Check Valve Bolting Failures																							
EVENT DATE (5)			LER NUMBER (6)				REPORT DATE (7)			OTHER FACILITIES INVOLVED (8)													
MONTH	DAY	YEAR	YEAR	SEQUENTIAL NUMBER	REVISION NUMBER	MONTH	DAY	YEAR	FACILITY NAMES				DOCKET NUMBER(S)										
0	4	0	1	9	1	9	1	0	0	4	0	0	0	5	2	3	9	1	0	5	0	0	0
OPERATING MODE (9)		THIS REPORT IS SUBMITTED PURSUANT TO THE REQUIREMENTS OF 10 CFR 5. (Check one or more of the following) (11)																					
2		20.402(b)				20.405(a)				50.73(a)(2)(iv)				73.71(b)									
POWER LEVEL (10)		20.405(a)(1)(i)				50.36(c)(1)				50.73(a)(2)(v)				73.71(c)									
2		20.405(a)(1)(ii)				50.36(c)(2)				50.73(a)(2)(vi)				OTHER (Specify in Abstract below and in Text, NRC Form 36.4A)

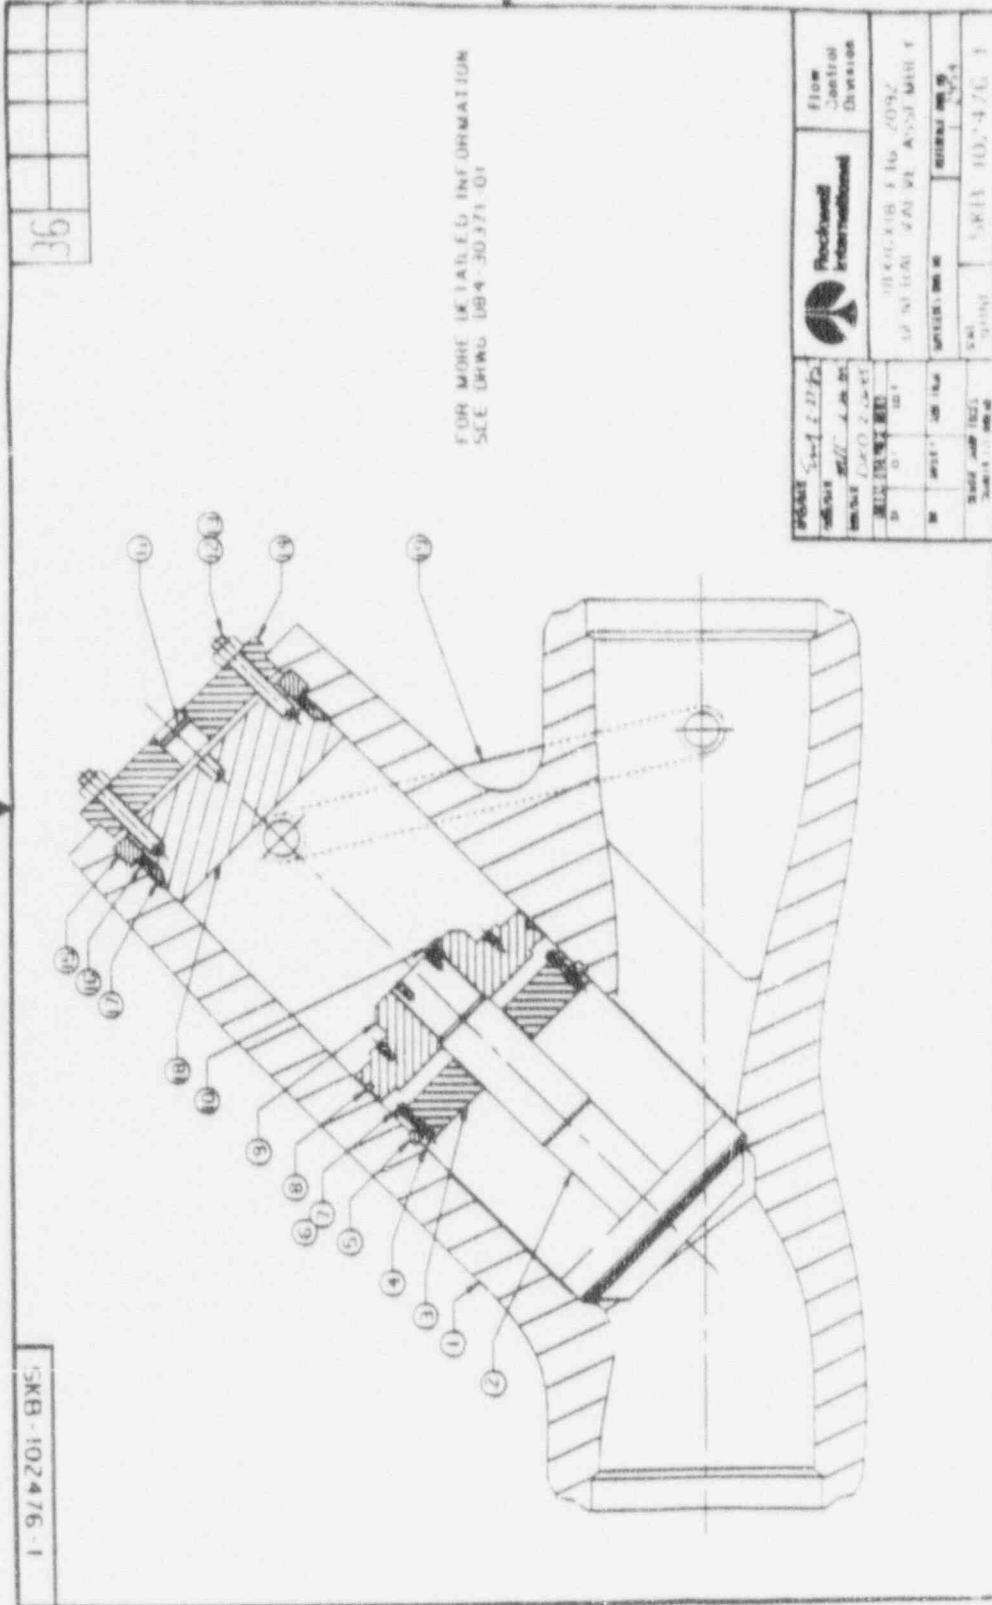
The feedwater header check valves are an angled body, controlled closure design, manufactured by Rockwell Corporation (currently Edward Valves Inc.). The valve disk (globe valve design) is attached to an upper body piston that controls the valve closure rate to prevent feedwater system water hammer on loss of feedwater flow. The valve disk and piston are connected by a stem, which passes through a dash plate. This dash plate provides a barrier between the disk and the piston and provides a dash pot effect during valve closure. The dash plate is fixed to a retaining ring which is recessed into the valve body. Eight capscrews and a locking ring clamp the dash plate to the retaining ring. (See the figure on pages 5 and 6).

Subsequent disassembly of 1-FW-V330 revealed that seven of the eight dash plate capscrews were broken and the eighth capscrew was stretched. This configuration allowed the disk piston to become jammed in a near closed position. Further disassembly of the other three feedwater header check valves, 1-FW-V331, 1-FW-V332 and 1-FW-V333, revealed additional broken and stretched capscrews. Valve 1-FW-V331 exhibited no damage, 1-FW-V332 had five broken and three stretched capscrews and 1-FW-V333 had four stretched capscrews. The feedwater header check valves are ANSI Safety Class 2, ASME III Class 2 check valves located in each feedwater line to the steam generators.

The dash plate capscrews (3/8" x 2", ASTM A-193, Gr. B7) failed due to a differential pressure across the dash plate. The resultant dash plate differential forces created higher than expected tensile loads on the capscrews. The capscrews ultimately failed due to this loading.

Valve design modifications were implemented to modify the dash plate and locking ring. These modifications increased the number of hold down capscrews from 8 to 16 and machined the dash plate surface that faces the valve disk on valves 1-FW-V330 and 1-FW-V331. By increasing the number of capscrews the individual capscrow loading will be reduced, preventing future capscrow failures. Additionally, dash plate machining was performed to prevent the valve disk from coming in contact with the dash plate when the valve fully opens. The remaining two valves, 1-FW-V332 and 1-FW-V333, did not require machining because the tolerances were such that no contact would occur between the disk and the dash plate.
