Crystal River Unit 3
Docket No. 50-302

Subject: Licensee Event Report (LER) 91-003

TITLE (4) Water Intrusion Into Pump Motor Leads to Loss of Circulating Water Pump.
Emergency Feedwater Actuation, and a Manual Reactor Trip

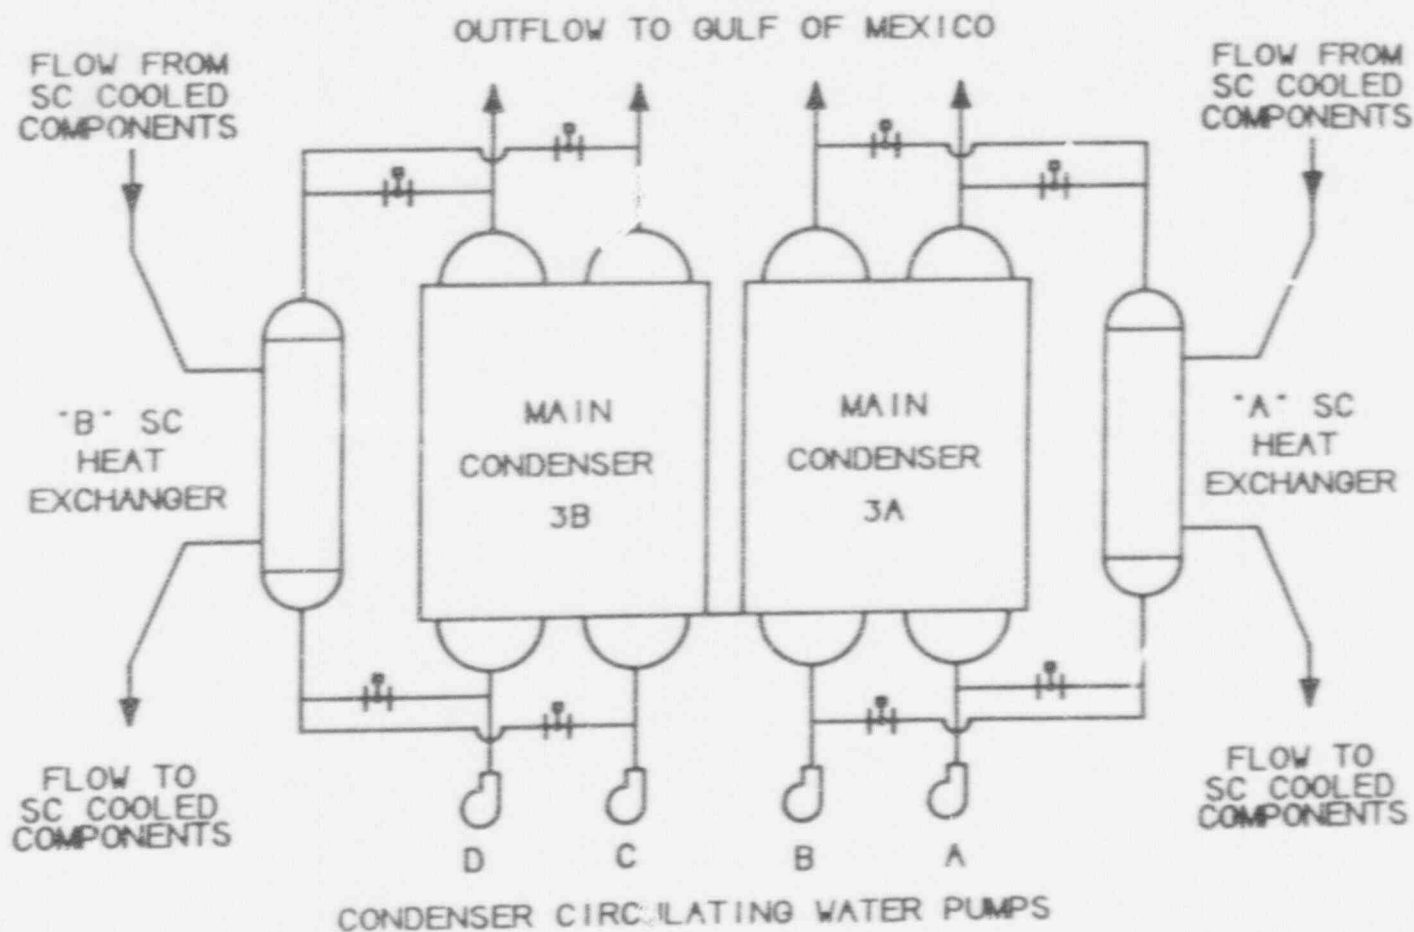
CW AND SC SYSTEM SCHEMATIC DIAGRAM

At 0650, CWP-1A tripped. This left one water box functional in condenser "B" and none in condenser "A". It also left the secondary plant equipment such as the main turbine oil coolers, generator hydrogen cooler, etc. without cooling because the "A" Secondary Services heat exchanger [KB,HX] was no longer receiving cooling water flow from the circulating water system. (See the attached drawing.)
