SUBJECT: Arkansas Nuclear One - Unit 1  
Docket No. 50-313  
License No. DPR-51  
Licensee Event Report 50-313/91-003-00

LICENSEE EVENT REPORT (LER)

FACILITY NAME (1) Arkansas Nuclear One, Unit One  
Automatic  
DOCKET NUMBER (2) 050003131 OF 05  
PAGE (3) 5  
TITLE (4) Actuation of the Emergency Feedwater System During Plant Heatup due to Low Once through Steam Generator Level Which Resulted From a Leaking Feedwater Recirculation Valve.

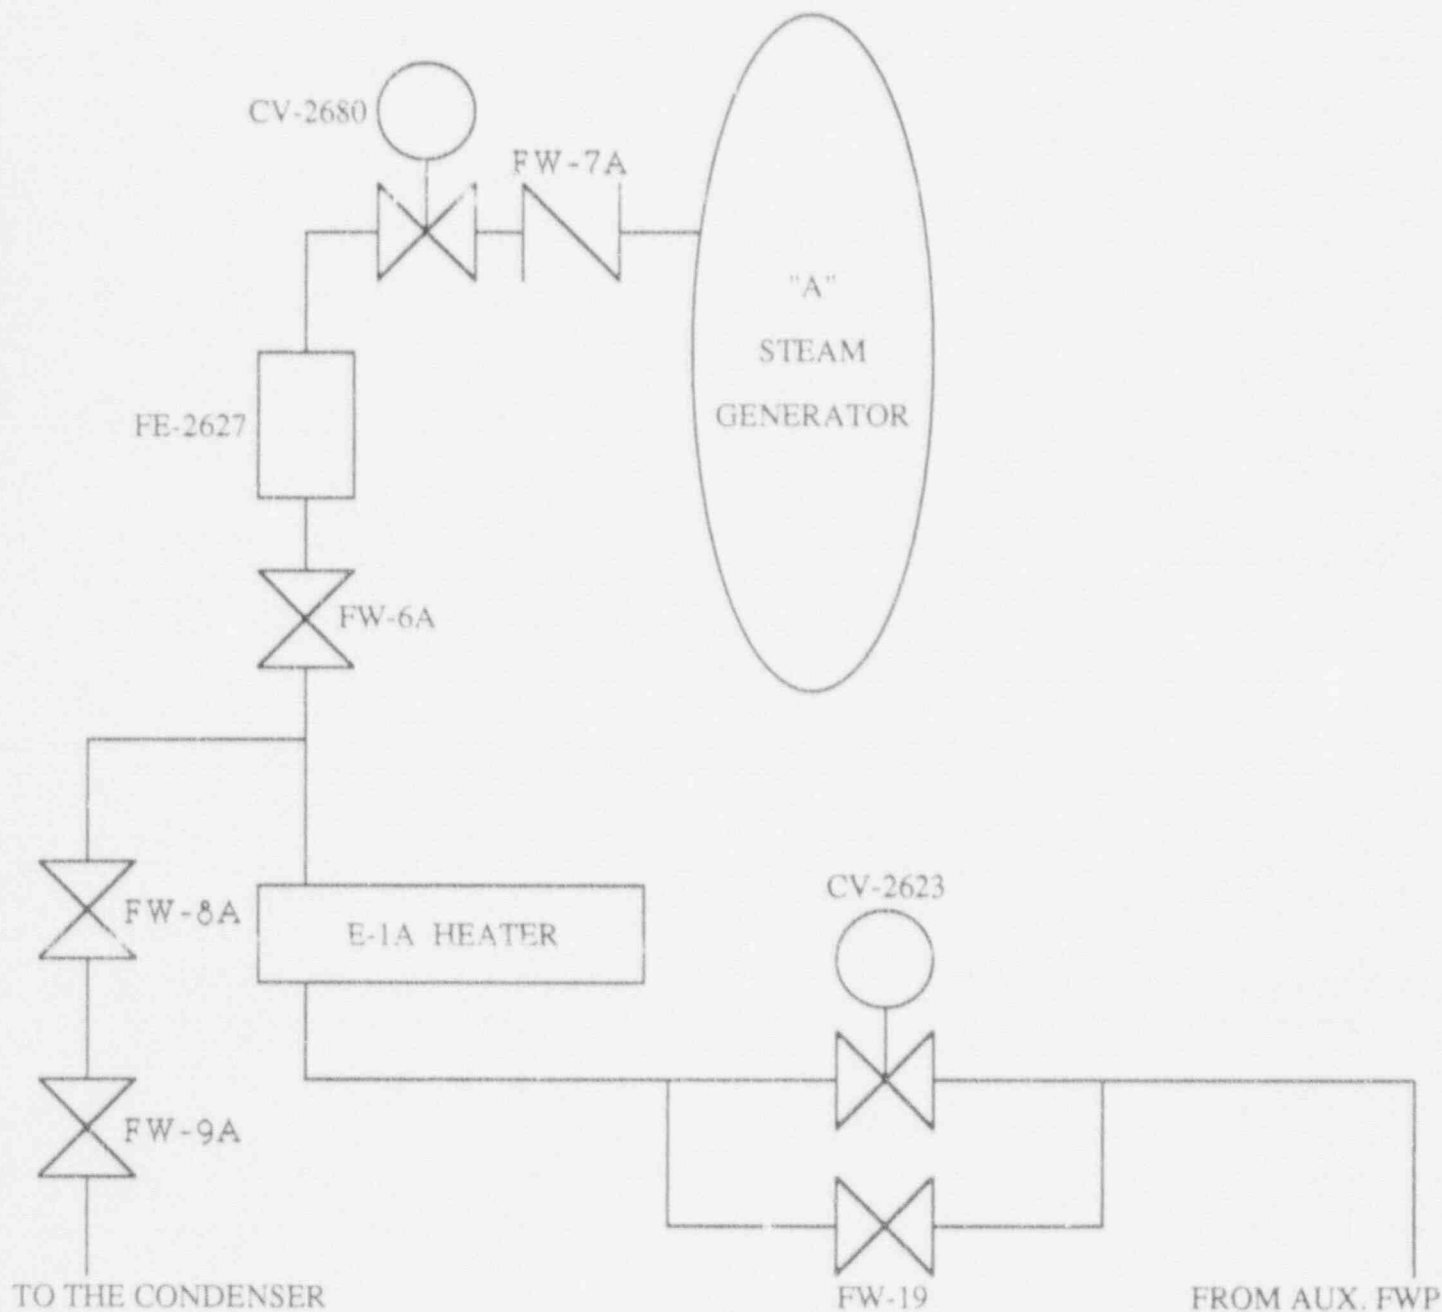
ATTACHMENT

The cause of this event was determined to be leakage past the seat of FW-8A (feedwater recirculation line) which was closed at the time of this event, and through FW-9A, which was open, to the condenser (see attachment). This leakage, over a period of time when OTSG feedwater was not required, resulted in the feedwater line between CV-2623 and FW-7A becoming voided. When the 'A' OTSG reached its lower limit, CV-2623 began to open as designed. However, since flow was entering a partially voided line, the OTSG level continued to drop and CV-2623 continued to ramp open in response to the decreasing level. As CV-2623 continued to open, P-75 discharge pressure dropped below OTSG pressure, and the 'B' OTSG level began to decrease, resulting in the 'B' startup valve (CV-2673) beginning to open farther. It is believed that P-75 pumping into the voided feedwater line resulted in the pump reaching a 'runout' condition which rendered it incapable of supplying feedwater to the OTSGs.

FW-8A will be repaired prior to plant heatup from refueling outage 1R10, which is scheduled to begin in April, 1992. FW-9A is presently closed, effectively isolating the feedwater recirculation line. This line is not expected to be used prior to restart from 1R10.

- The 'Plant Startup' procedure (OP 1102.02) will be revised by July 31, 1991 to require that FW-9A and B be closed whenever FW-8A and B are required to be closed.
- The 'Plant Startup' procedure will also be revised to include a requirement to verify the ability to feed the OTSGs with the auxiliary feedwater pump prior to reaching the low level limits when lowering OTSG levels during startup. This revision will also be completed by July 31, 1991.
- A repetitive maintenance task has been developed for FW-8A, FW-8B, FW-9A and FW-9B.
