Millstone Nuclear Power Station, Unit No. 3  
Modification to Pipe 3SWP-030-334-3  
Relief Request From ASME Code Section XI Requirements

Modification to Pipe 3SWP-030-334-3  
Request for Relief From ASME Code Section XI

Relief Request Control Number NCR 391-243

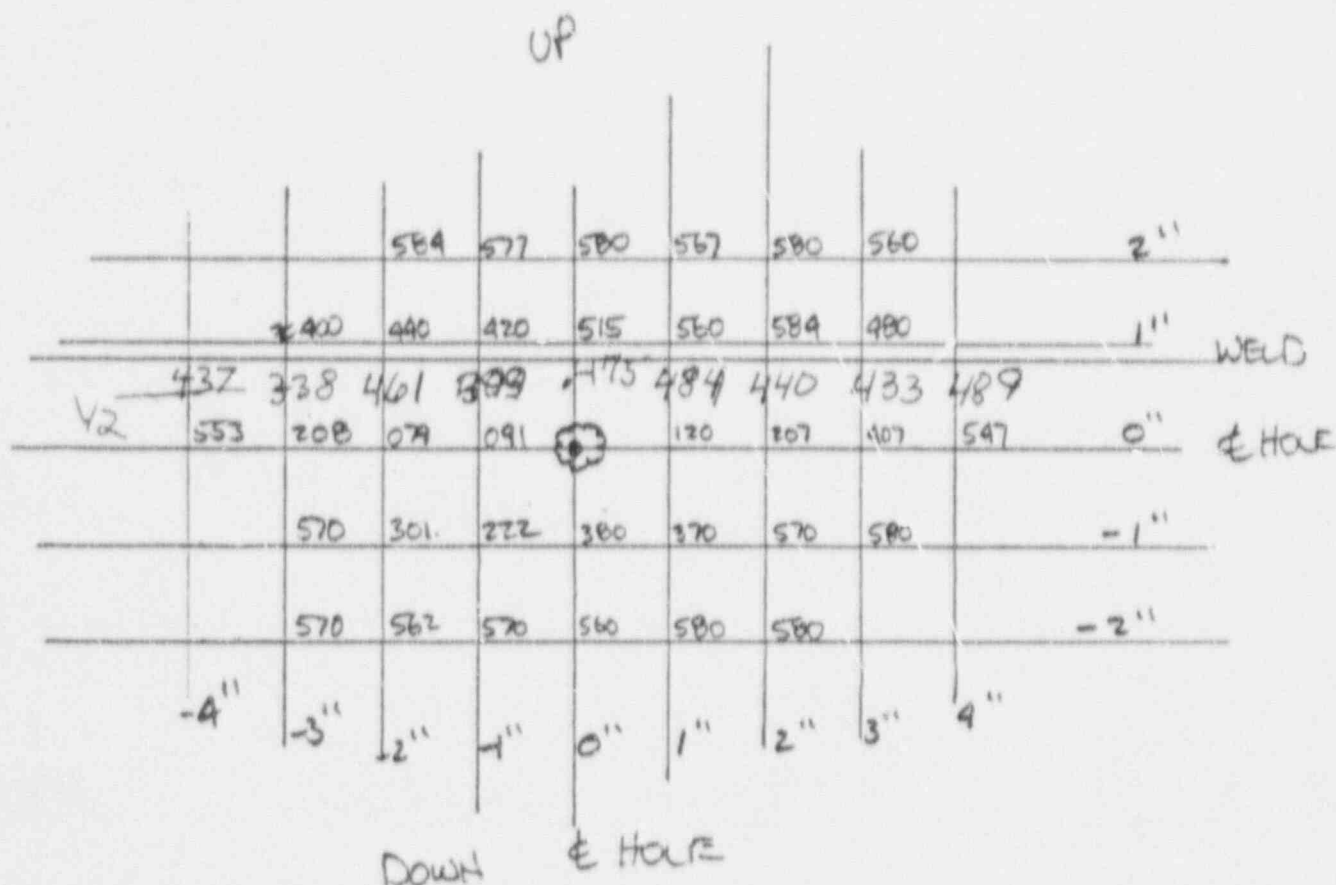
UT MAP - HOLE ON  
3 SWP 030 334 03

See the attached drawing. The leak was discovered on May 2, 1991. An 8 by 5 inch area was examined by UT. The grid size was 1 inch square.

The hole is located on the extrados of a 90° elbow downstream of a restricting orifice used to maintain backpressure on the system. The hole is 1" below a longitudinal fabrication weld and is approximately 1/4"

in diameter. The area where piping has degraded below nominal wall is  
approximately 6 inches by 3 inches. The minimum wall thickness outside  
the hole is 0.079 inches.

Root Cause Description: Erosion/corrosion due to turbulence created  
by the restricting orifice upstream of the elbow.

- ① READINGS AT WELD BOUNCED AROUND. WELD TO LEFT SIDE OF HOLE APPEARS TO HAVE SOME MATERIAL LOSS BUT AVERAGED AROUND 0.400"
- ② ALL OTHER READINGS WERE REPEATABLE
- ③ HOLE  $\approx \frac{1}{4}$ " DIA.

The hole has been covered by a soft patch held in place by metal bands.  
The temporary repair is completely reversible.
