**Commonwealth Edison**

September 9, 1982

Subject: Byron Station Units 1 and 2  
Braidwood Station Units 1 and 2  
Waterhammer Prevention  
NRC Docket Nos. 50-454, 50-455,  
50-456 and 50-457

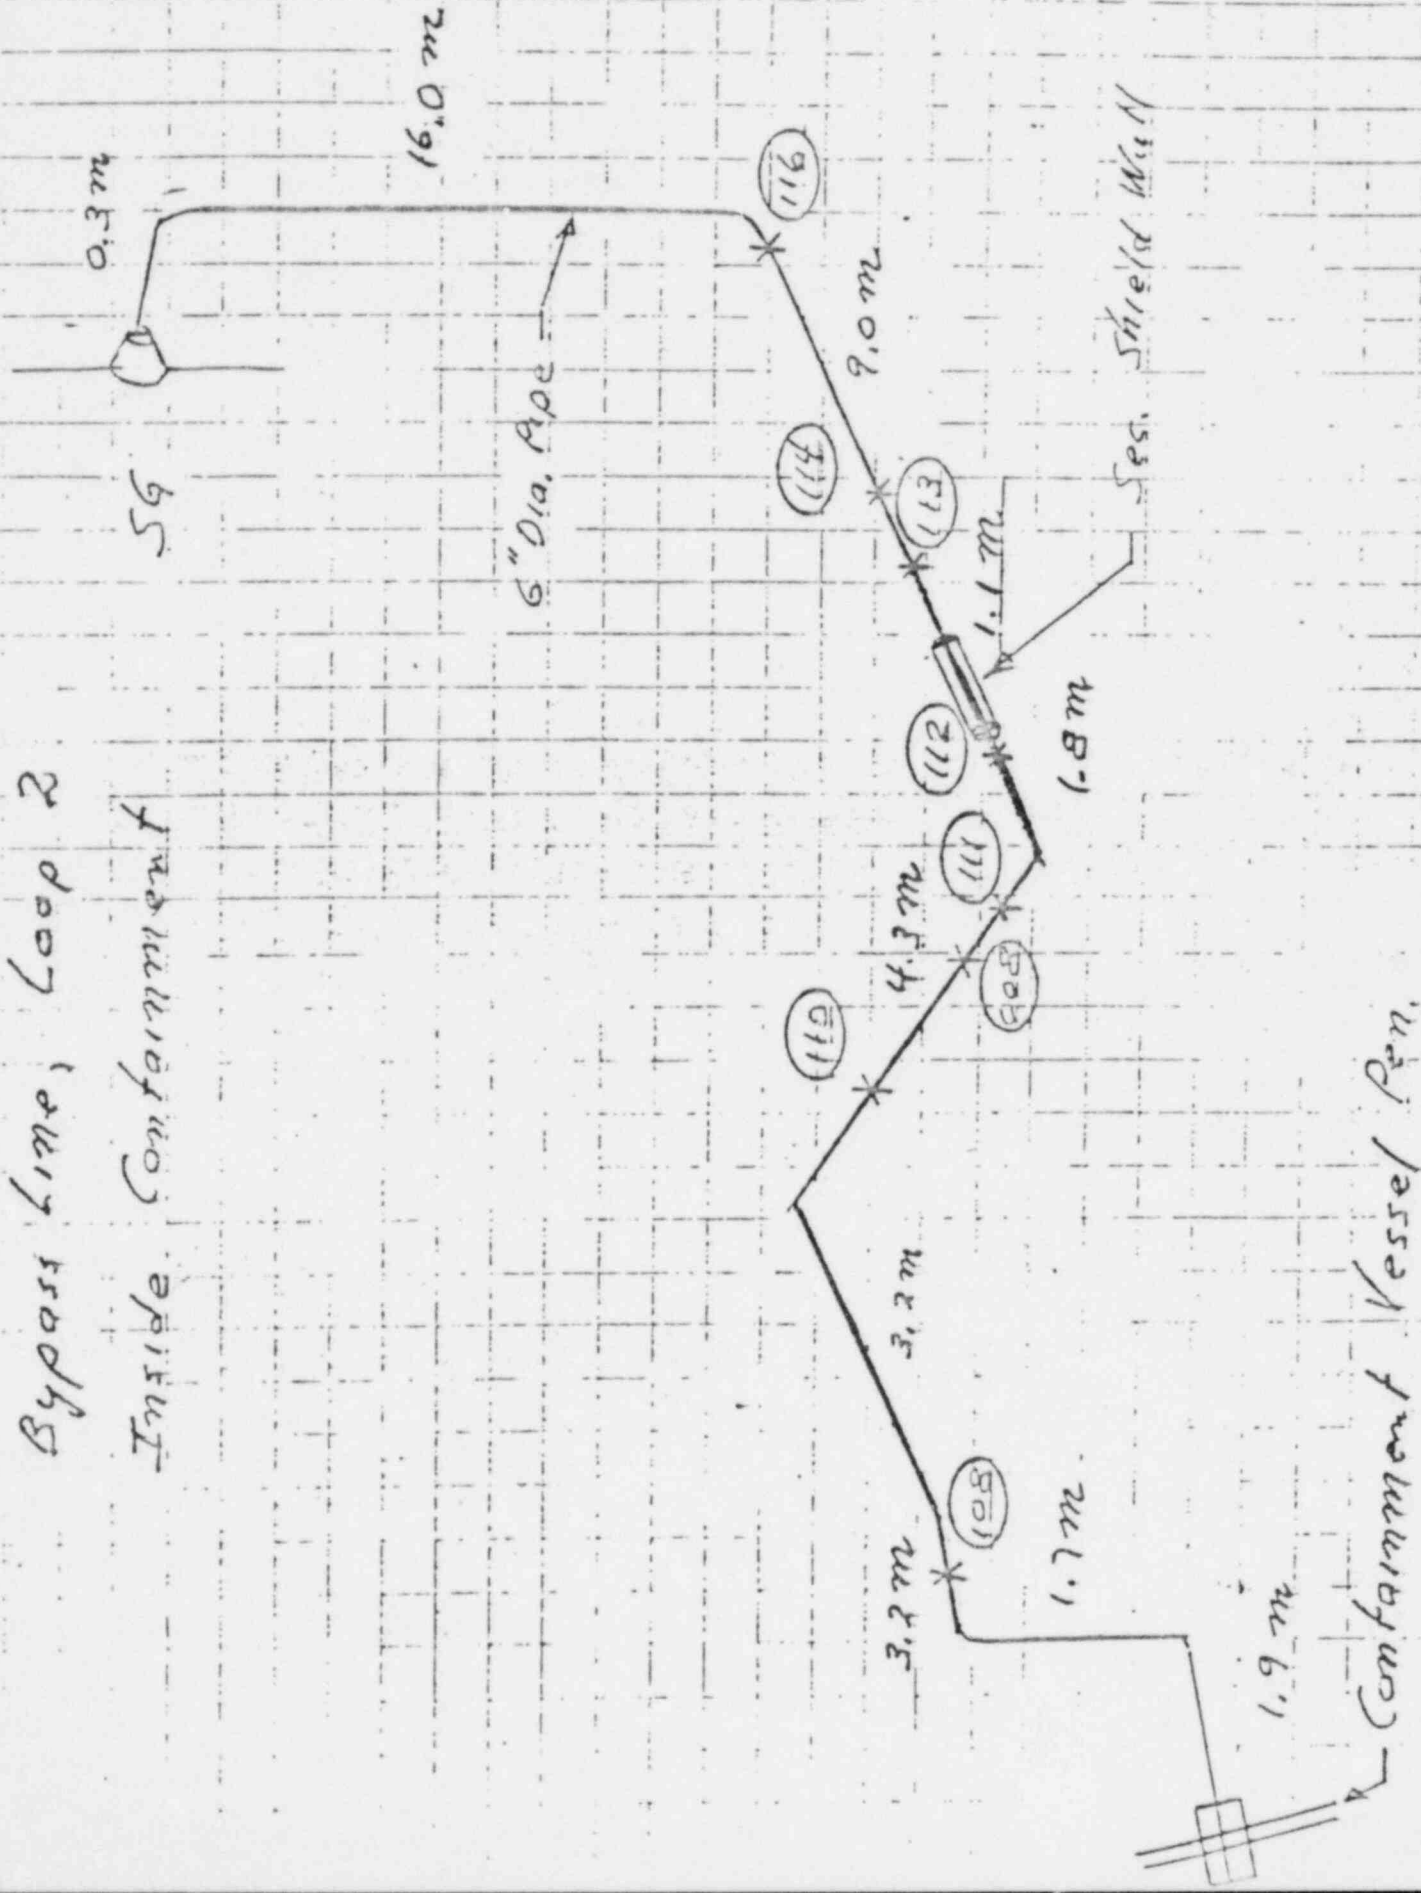
Figure 2, KRSKO

The extent of the damage to the loop 2 bypass piping inside and outside containment, is presented in Table 1. In Figure 2, the numbers in ovals identify the pipe hangers which were affected. On both Figures 2 and 3, the length in meters of the pipe sections are given. A bulge or blister was observed in the bypass piping, in the horizontal section, downstream of the secondary shield wall, approximately midway between the shield wall and elbow in Figure 2. The bulged region was approximately six to eight inches long, with the bulge located on the top side of the pipe. At the bulge, the pipe diameter was increased approximately one quarter inch.

- o EMBEDMENT PLATES MOVED, BOLTS LOOSENEED, PIPE CLAMPS LOOSENEED AND MOVED, (AFFECTED HANGERS ARE IDENTIFIED BY NUMBERS IN OVALS),
- o PIPE CHANGED LOCATION
- o PIPE BULGED 1/4 INCH NEAR SECONDARY SHIELD WALL.

With respect to KRSK0 plant repair, the section of bypass piping, containing the bulge, between and including the second and third upstream elbows was replaced. Also the hanger damage was repaired.
