Millstone Nuclear Power Station, Unit No. 3
 Reporting of Potential Significant Deficiencies
 in Design and Construction: Solid State Protection
System - Undetectable Failure (SD-26)

NORTHEAST UTILITIES SERVICE COMPANY
MILLSTONE NUCLEAR POWER STATION
UNIT NO. 3

Solid State Protection System - Undetectable Failure

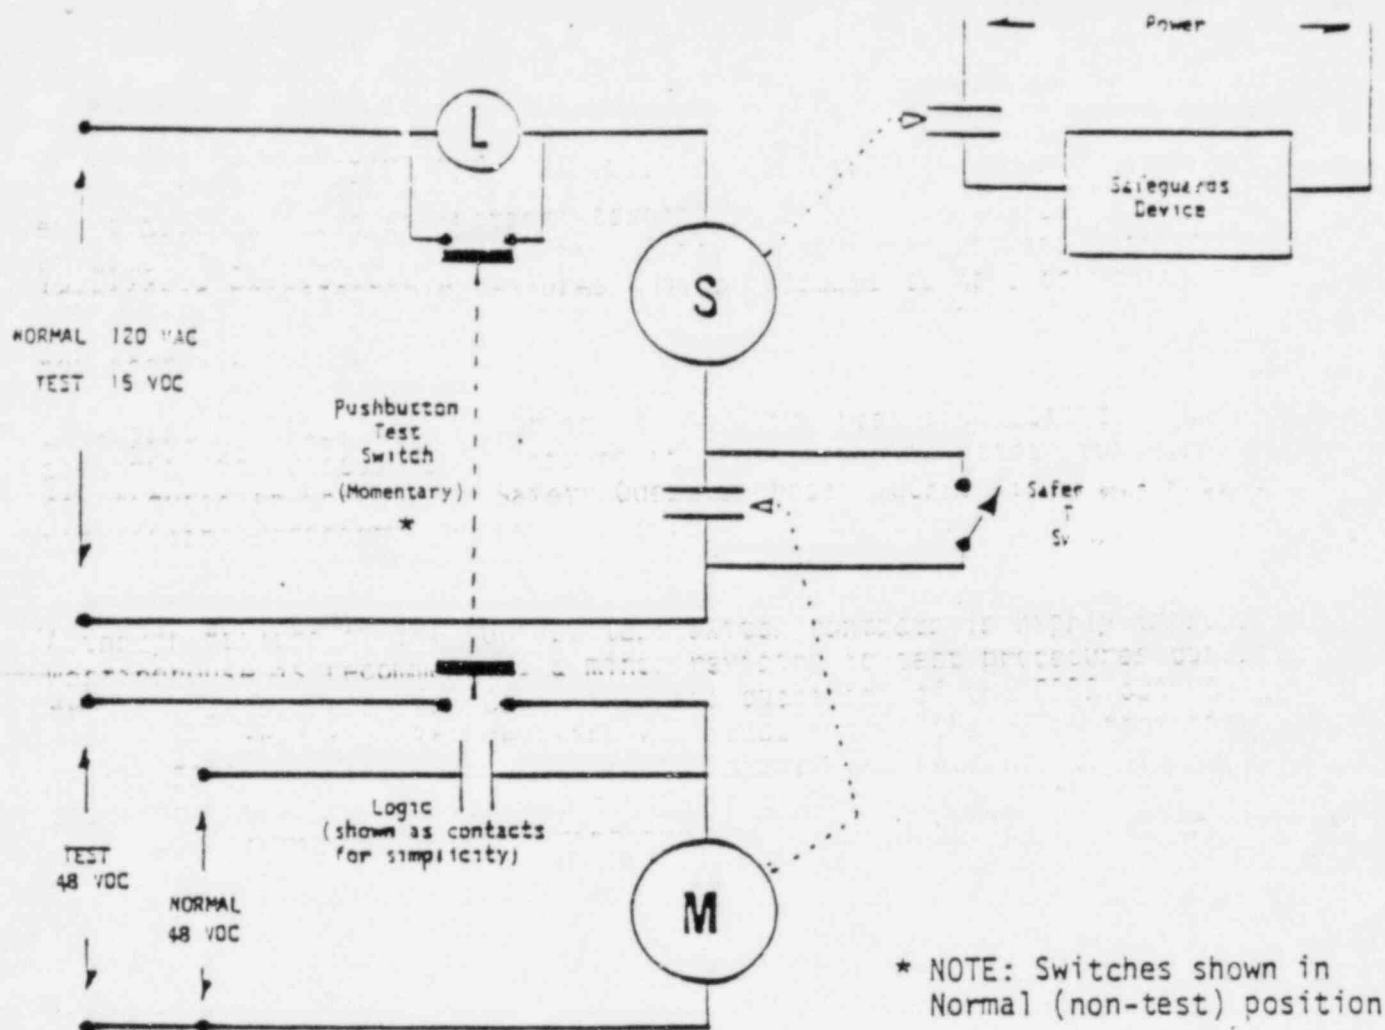
SIMPLIFIED SKETCH OF TYPICAL SAFEGUARDS ACTUATION RELAY TESTING IN THE SSPS

As mentioned above, output relay coil continuity is confirmed at the SSPS, without operating the relay, by reducing the circuit voltage to 15VDC from 120VAC. As shown in the sketch, operation of the master relay by means of the pushbutton test switch also removes the shunt from the SSPS proving lamp and allows the 15VDC to energize it to confirm the continuity of the output relay coil.

Upon completion of the master relay and output relay coil continuity tests, 120VAC circuit voltage is restored. However, if the switch contacts which shunt the proving lamp should fail to reclose as expected, 120VAC would be applied to the lamp in event the system were called upon to operate. Depending on the output relay coil impedance and the number

of output relays being operated by the master relay contacts, the current through the lamp could cause it to burn open before the output relay(s) energized. In such an instance associated Safeguards devices in the affected train would not actuate. Since, during circuit analysis, all identified nondetectable failures must be assumed to have occurred, the redundant Safeguards actuation train must be assumed to be similarly, if not identically, failed.

NORMAL OPERATION: Logic "contacts" close to pick up Master relay M. Master relay contacts close to apply 120 VAC to Slave relay S. Slave relay contacts close to power the Safeguards device.

- Relay mode selector switch (not shown) to TEST position switches slave relay power from 120 VAC to 15 VDC. Master relay power remains 48 VDC.
- Pushbutton test switch contacts (1) pick up Master relay M (2) removes lamp shunt so that 15 VDC is applied to Slave relay coil thru proving lamp L.
- Slave relay is not picked up because of reduced voltage of 15 VDC.

PROBLEM: If contacts shunting proving lamp L do not reclose when pushbutton is released and system is return to Normal, then 120 VAC would be applied to Slave relay coil thru the proving lamp if Safeguards actuation were called for by the Logic "contacts".

Although failure of the subject test switch contacts is highly improbable, Westinghouse is recommending a minor revision to test procedures conducted from the Safeguards Test Cabinets where operation of the SSPS output relays is verified. The revision will ensure that the relay test circuits in the SSPS operated properly when the system was returned to its normal operating mode. The procedure changes are described in Attachment III and are recommended until Westinghouse completes a review of its consideration of design changes.
