VIRGINIA ELECTRIC AND POWER COMPANY
RICHMOND, VIRGINIA 23261

October 25, 1982

REMOVAL OF NORTH ANNA UNIT NO. 1
REACTOR COOLANT SYSTEM FLOW SPLITTER PLATES

STABILITY OF U.T. INDICATIONS REMAINING IN THE
FLOW SPLITTER BOSSES OF LOOPS A, B AND C
NORTH ANNA UNIT 1

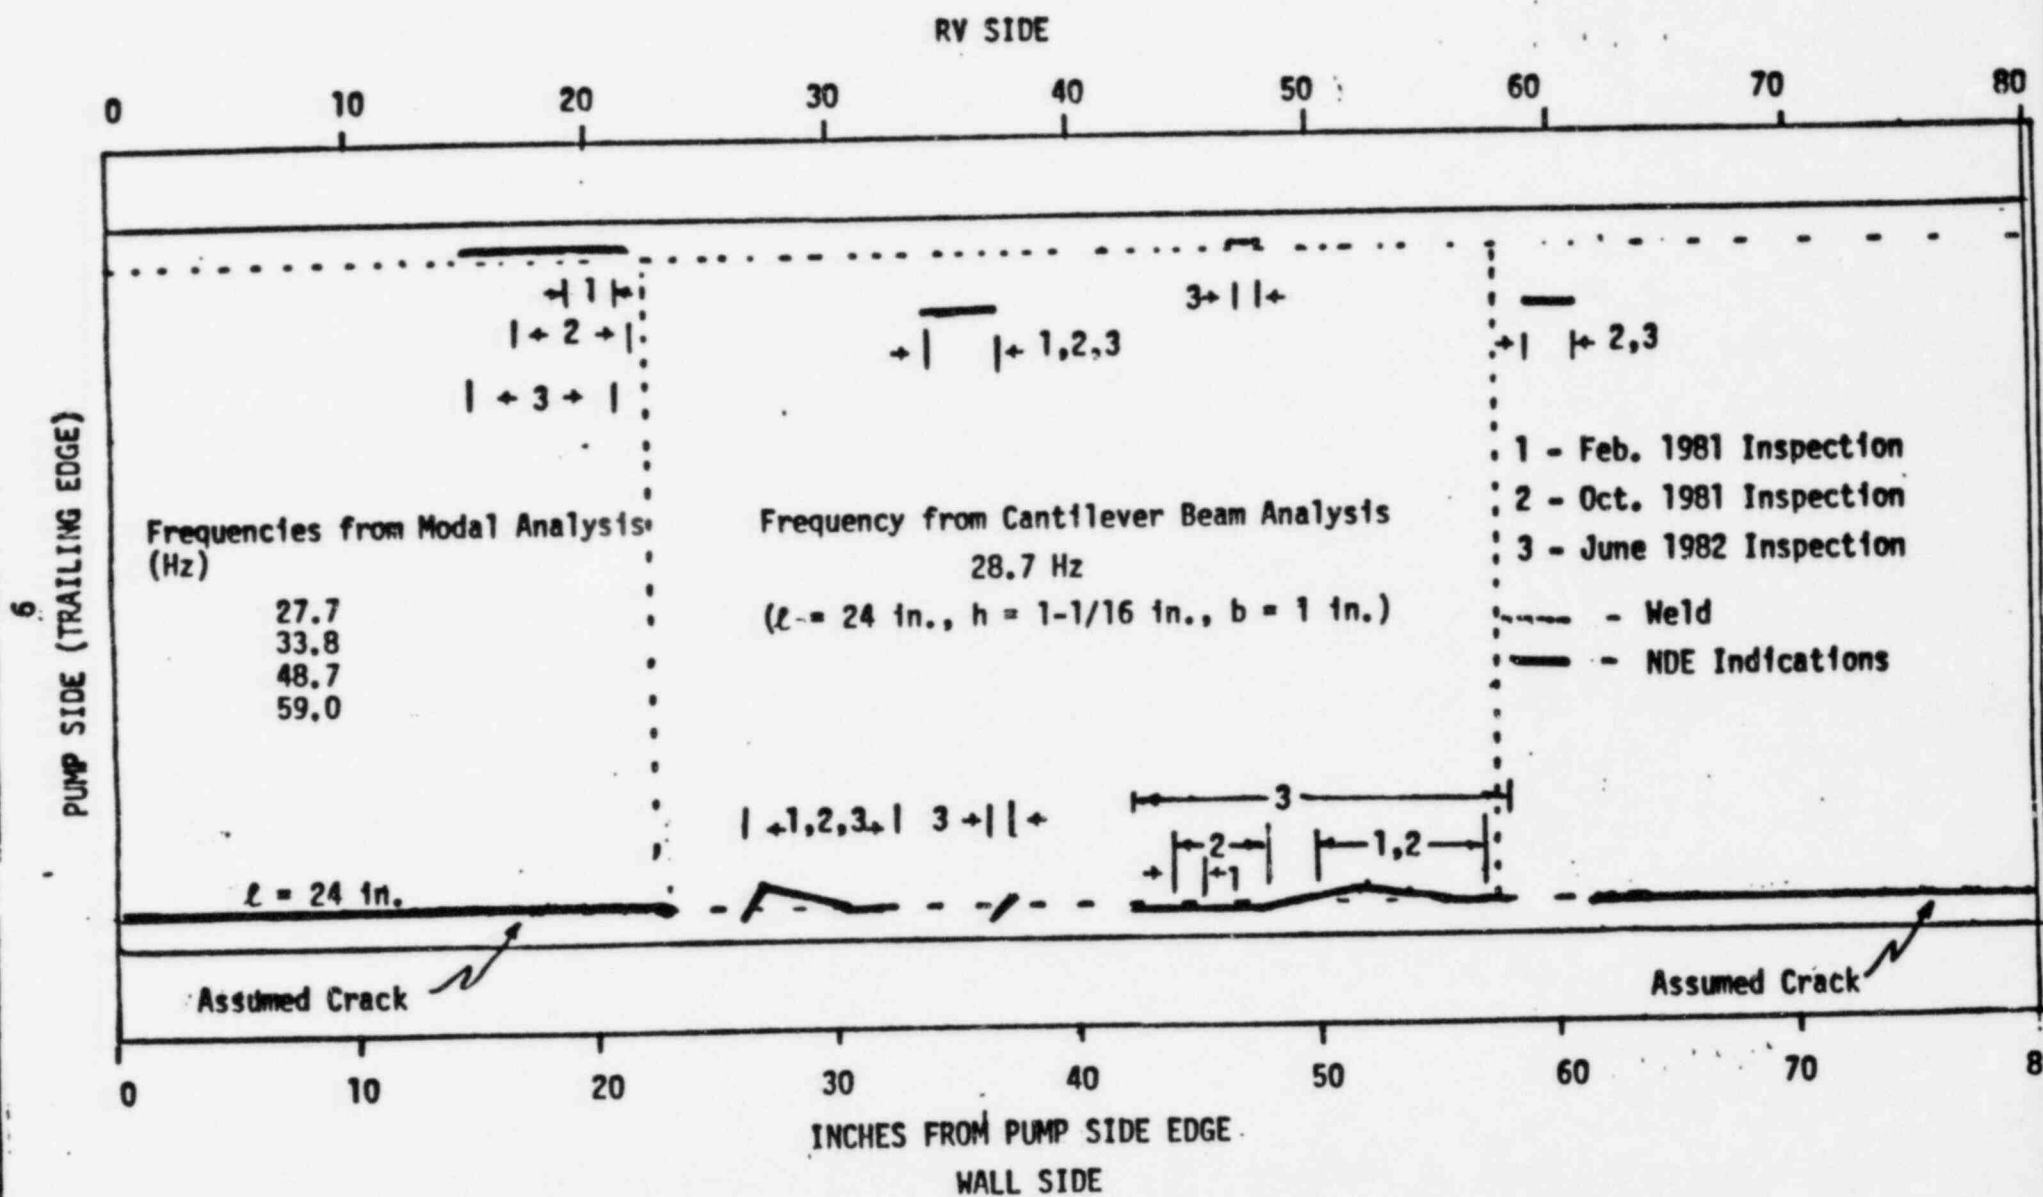
The first natural frequencies in Figures 1 and 2 were calculated assuming a cantilever beam having a length of 24 inches (see Figure 1) and a fixed-ended beam having a length of 16 inches (see Figure 2).

Figure 1 Results of Modal Analysis for the Wall Side, Loop A, Assuming Cracks extend to the edges compared with cantilever beam analysis.

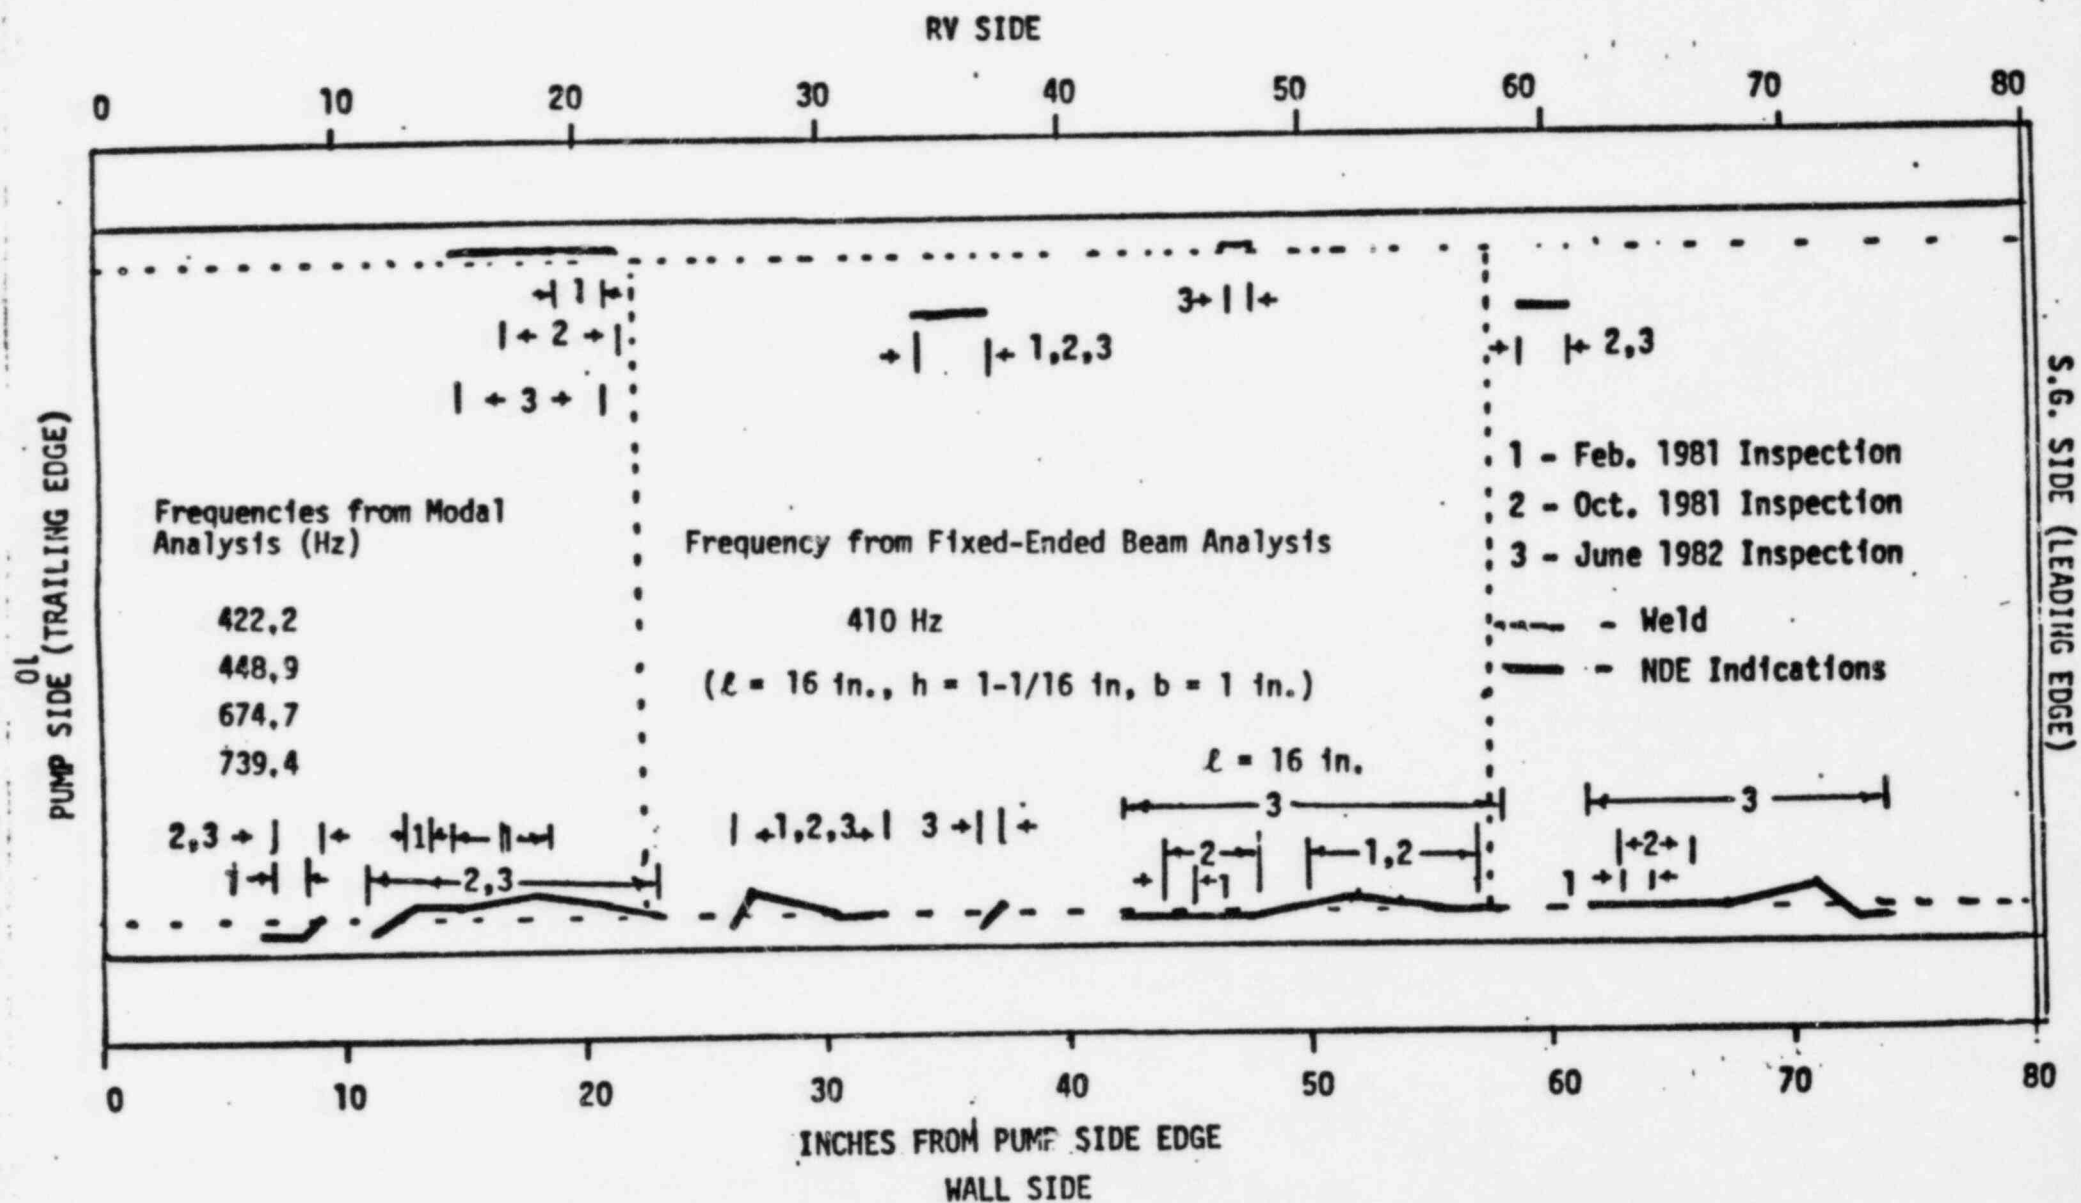
Modal analyses of the remaining bosses of loop A embedded with the U.T. indications measured June, 1982 were performed. Two models were considered in the analysis. The first model contained continuous flaws and distributed flaws as shown in Figure 1 along with the calculated natural frequencies. The lengths of the continuous flaw are 24 inches from the trailing edge and 18 inches from the leading edge, respectively. The second model contained distributed flaws which are identical with those of the U.T. indications. Those flaws are shown in Figure 2 along with the natural frequencies.

Figure 2 Results of Modal Analysis for the wall side, loop A compared with Fixed-Ended Beam analysis (based on June 1982 U.T. results)

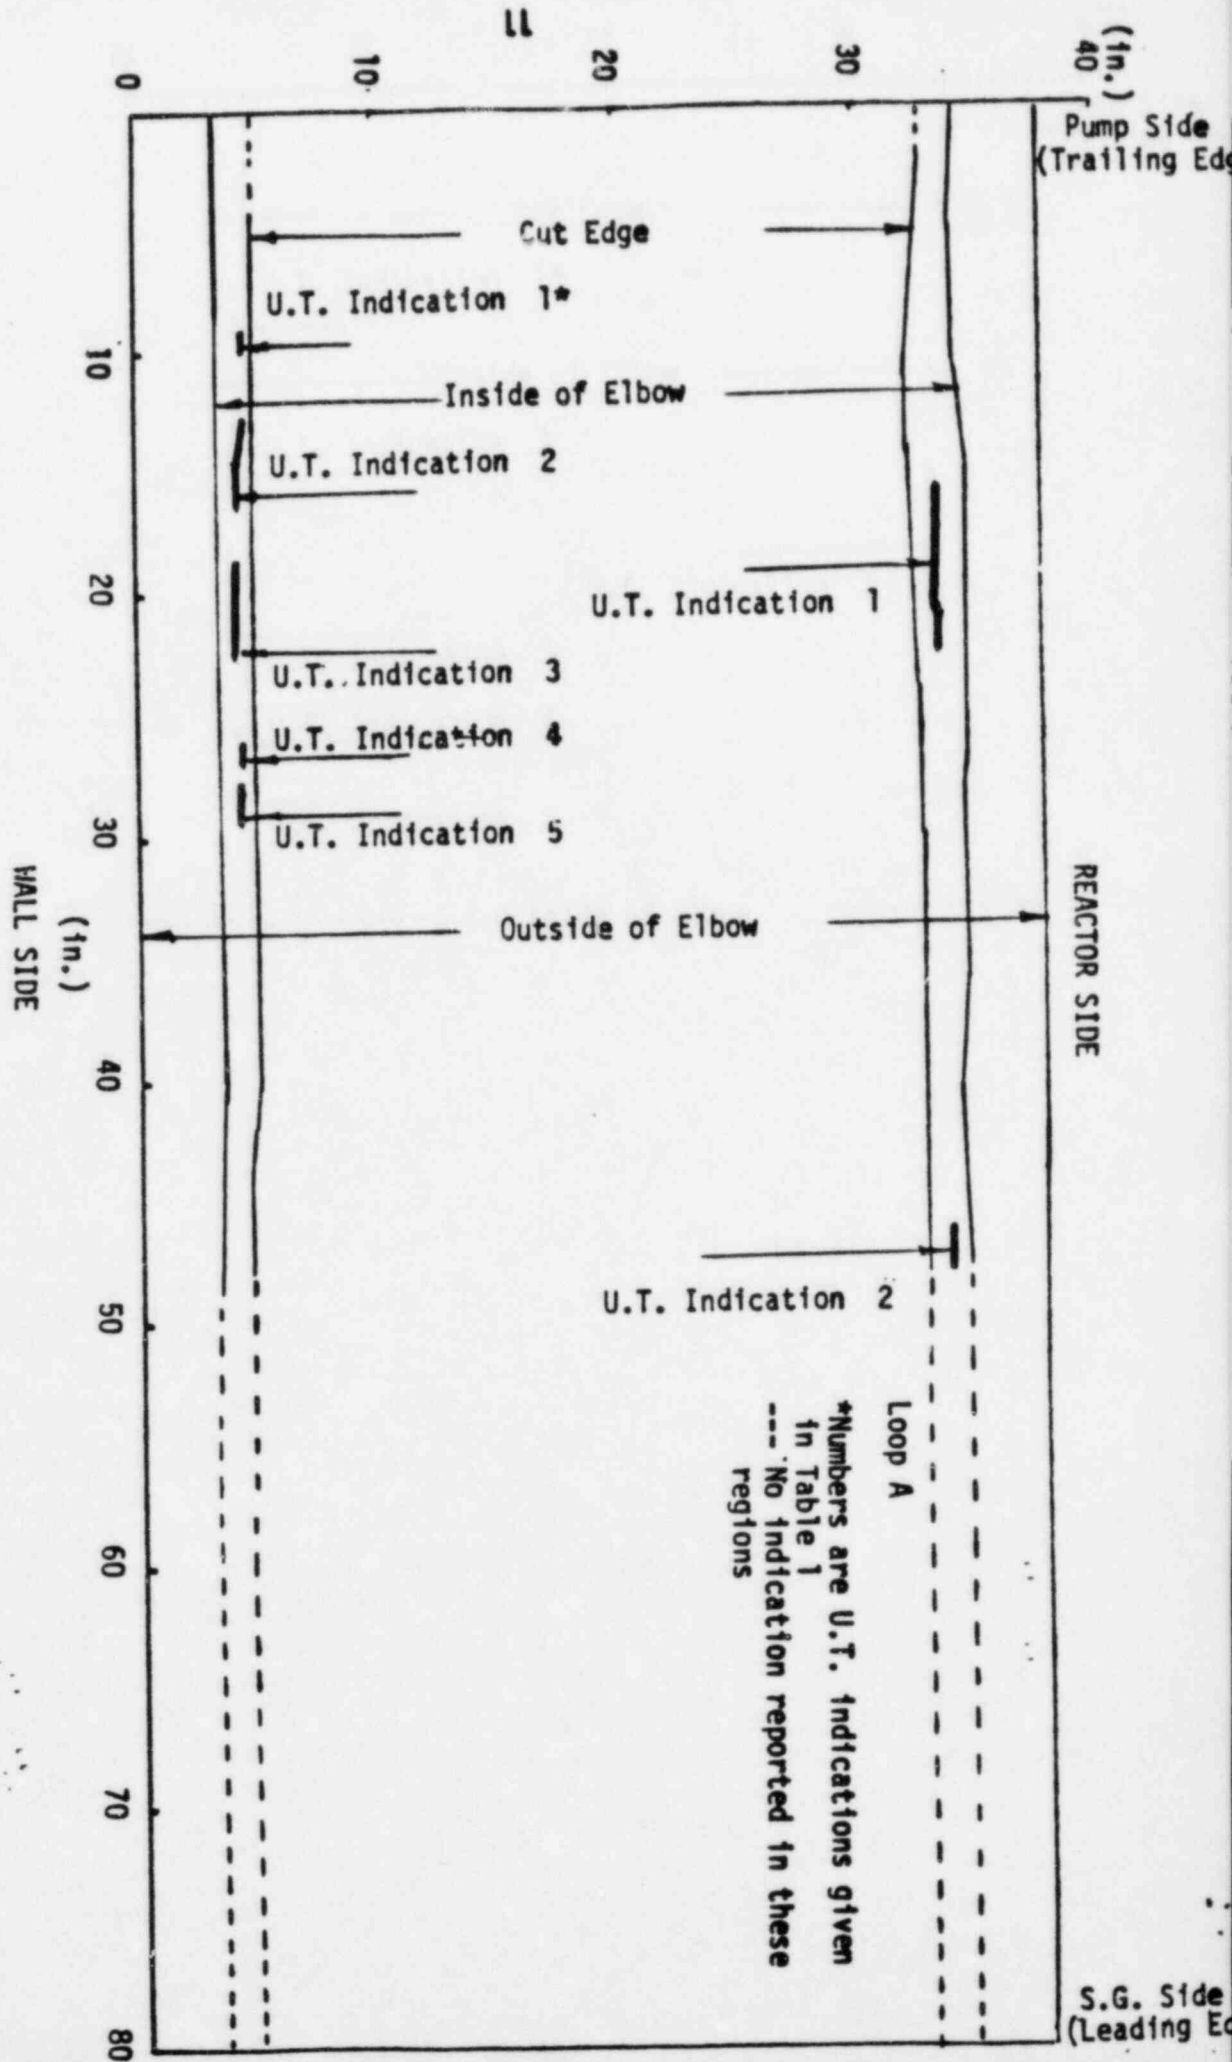
Fig. 3 U.T. Indications Remaining in Loop A Bosses

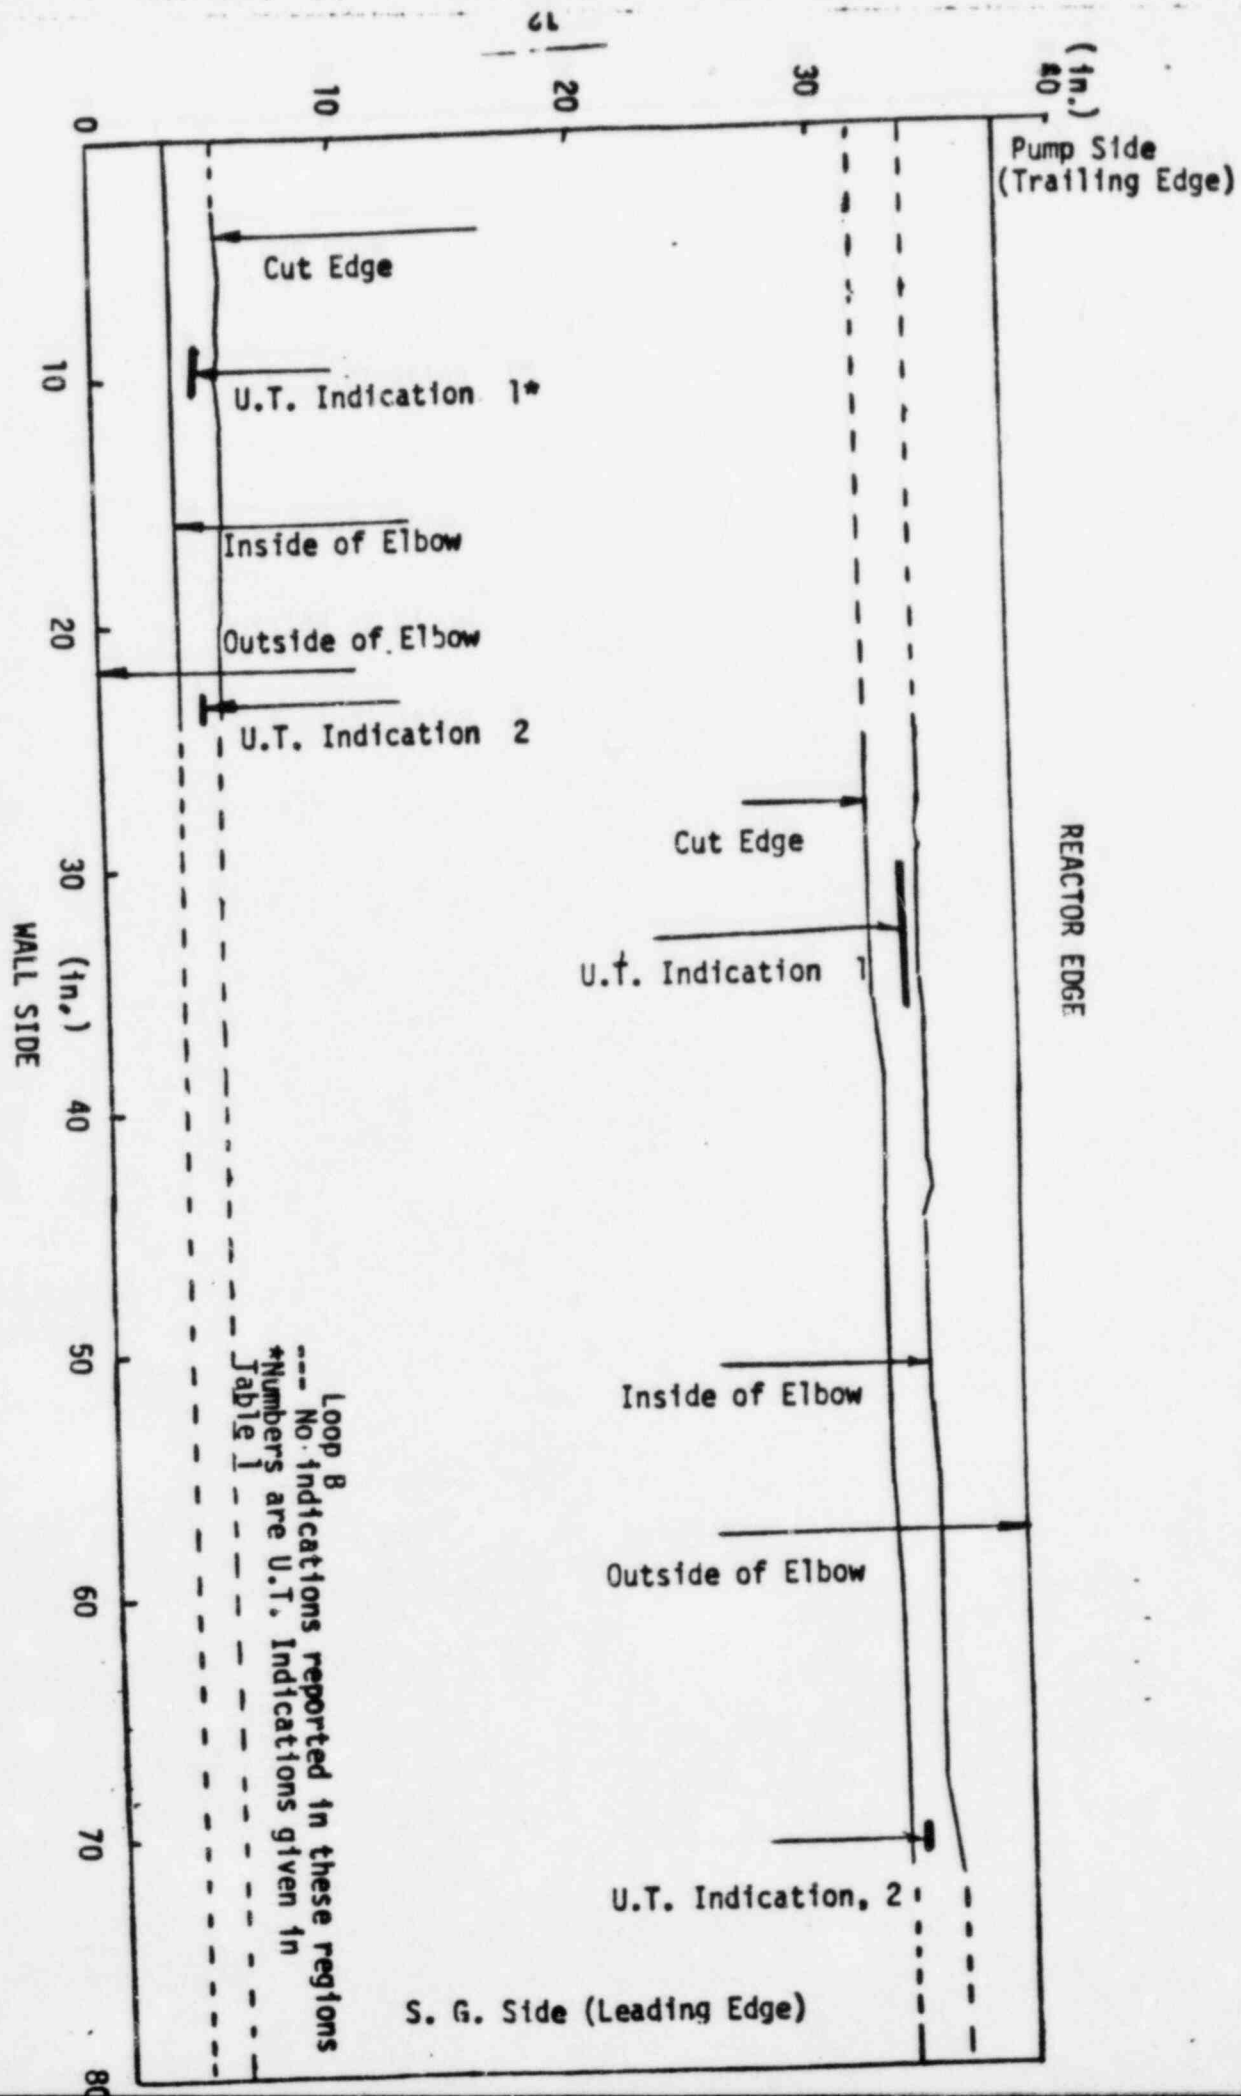
Figure 4 U.T. Indications Remaining Loop B Bosses

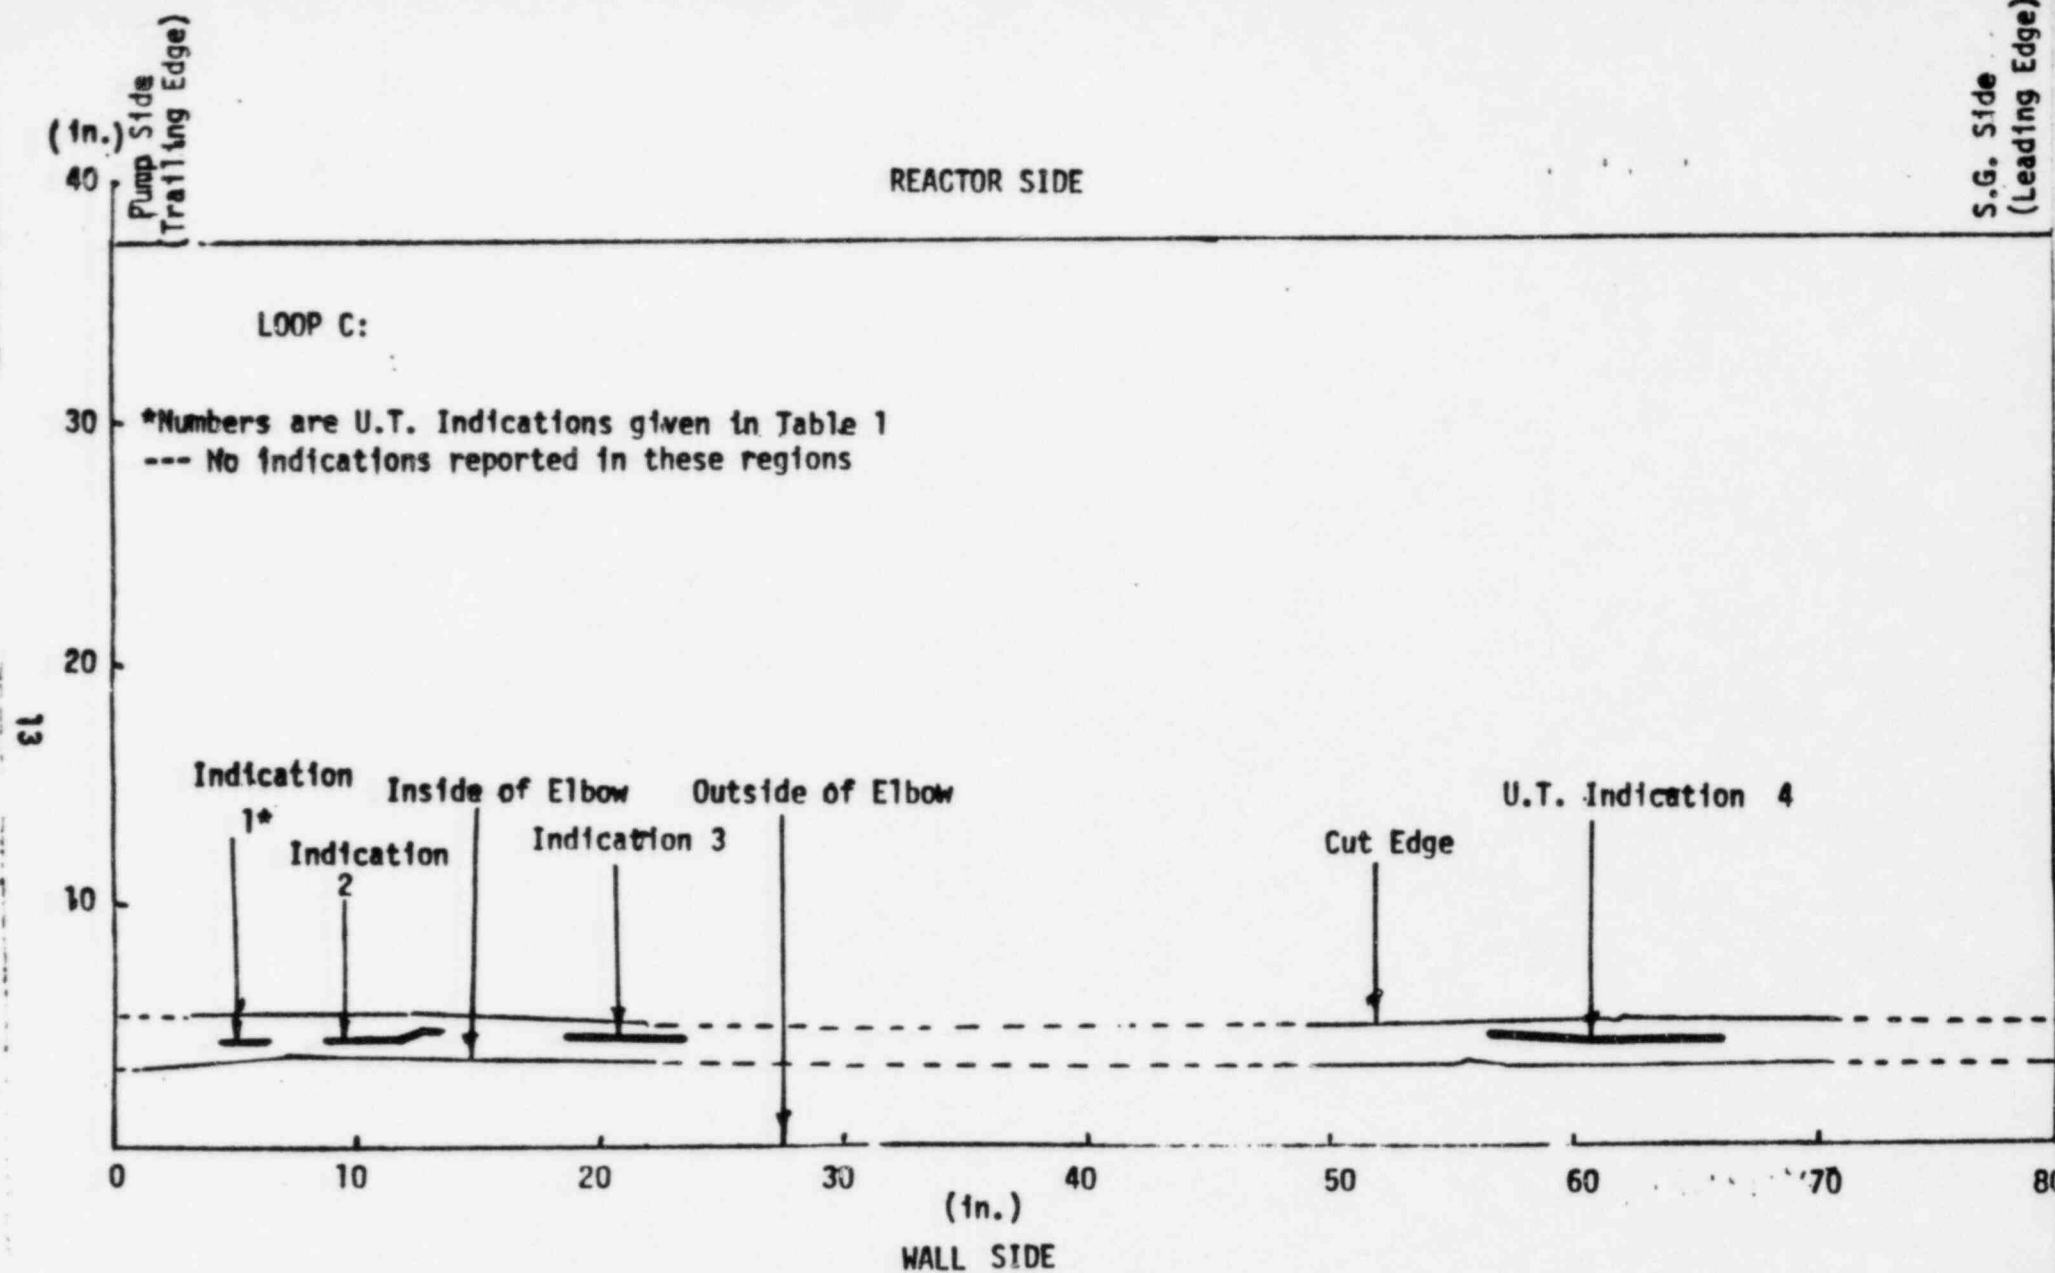
2. Stress analysis and fatigue crack growth calculations were performed for the portion of the boss defined by the U.T. indications in loop C and having a frequency less than 1000 Hz. The result shows that the fatigue crack growth for 40 years service is negligible.

Fig. 5 U.T. Indications Remaining in Loop C Bosses
