Subject: Oconee Nuclear Station
Docket No. 50-269

Duke Power Company
Oconee Nuclear Station

Report Number: RO-269/82-18

Three of the six Pressurizer Safety Valves on the Oconee Units were declared inoperable due to improper ring settings.

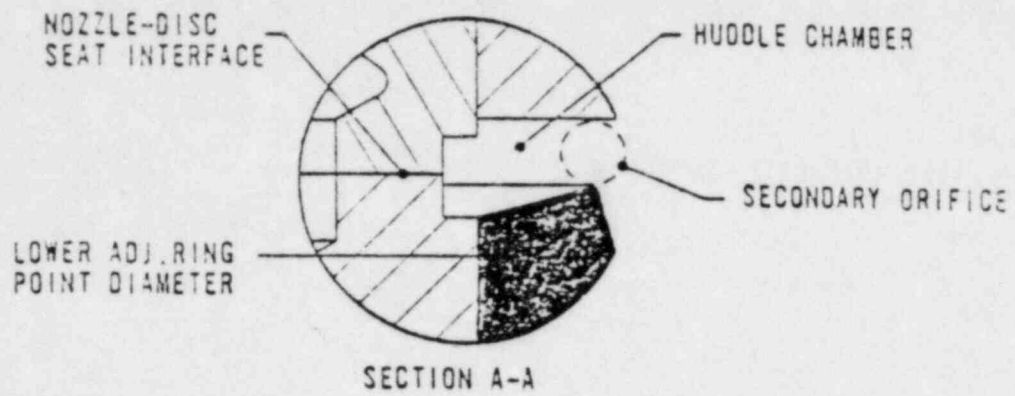
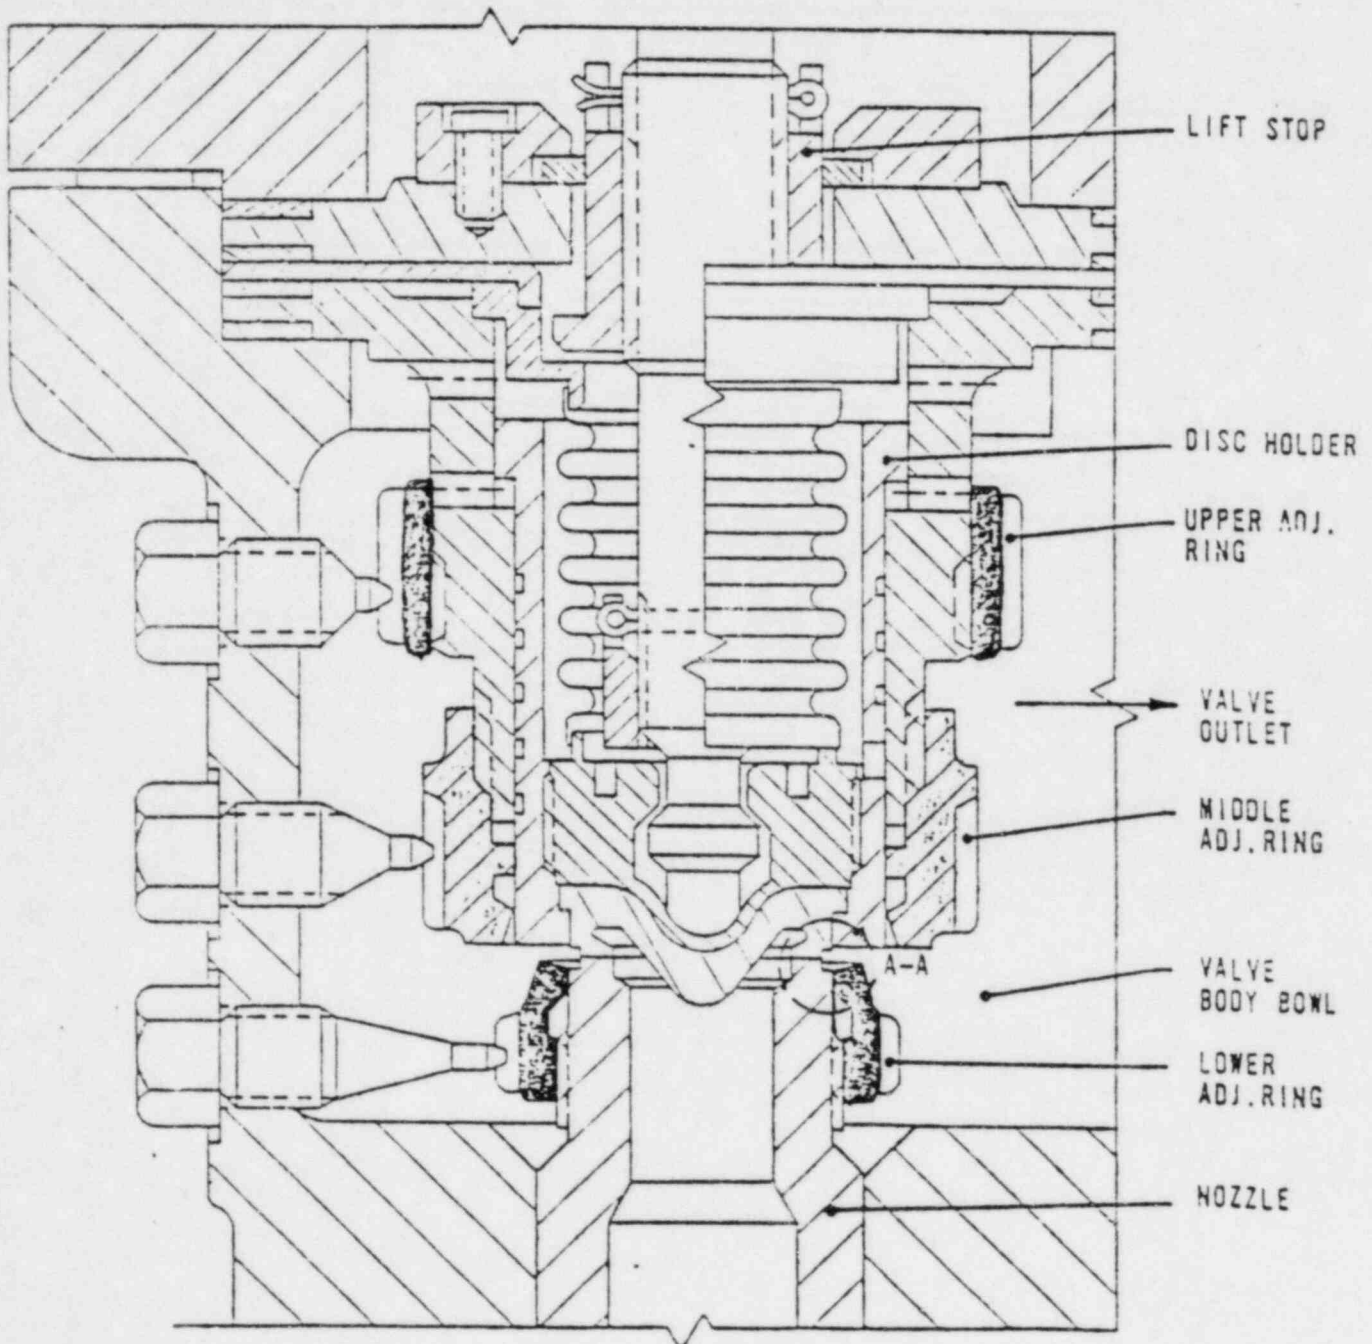
FIGURE 1

NUREG-0737 Item II.D.1 required that a relief and safety valve test program be conducted to verify operability of these valves under postulated accident conditions. As a participant in this program, Duke Power was provided the results of the testing, including the testing of Dresser 31739A Safety Valves with short inlet piping as are used at Oconee Nuclear Station. The results of the testing showed that Dresser Safety Valve performance was affected by backpressure and ring settings (upper, middle, lower as seen on Figure 1). A preliminary assessment of preliminary test reports was provided to the NRC on July 1, 1982.

During the EPRI tests the Dresser 31739A valve was shown to achieve less than rated lift in the presence of high backpressure when the "huddle chamber" shown in Figure 1 was opened up with ring settings of -13, 0, -48 (lower, middle, upper). In the tests the percent of rated flow achieved was significantly higher than the percent rated lift achieved (which is reasonable since valves are conservatively derated from actual expected flow). In actual plant conditions high backpressure is caused by high relief flows, so if relief flow is reduced, then the backpressure is also reduced.
