Subject of this Document: Investigation of Failed Tubes from "B" Steam Generator of the R. E. Ginna Nuclear Power Plant

Investigation of Failed Tubes from "B" Steam Generator
of the R. E. Ginna Nuclear Power Plant*

Carl J. Czajkowski

May 1982

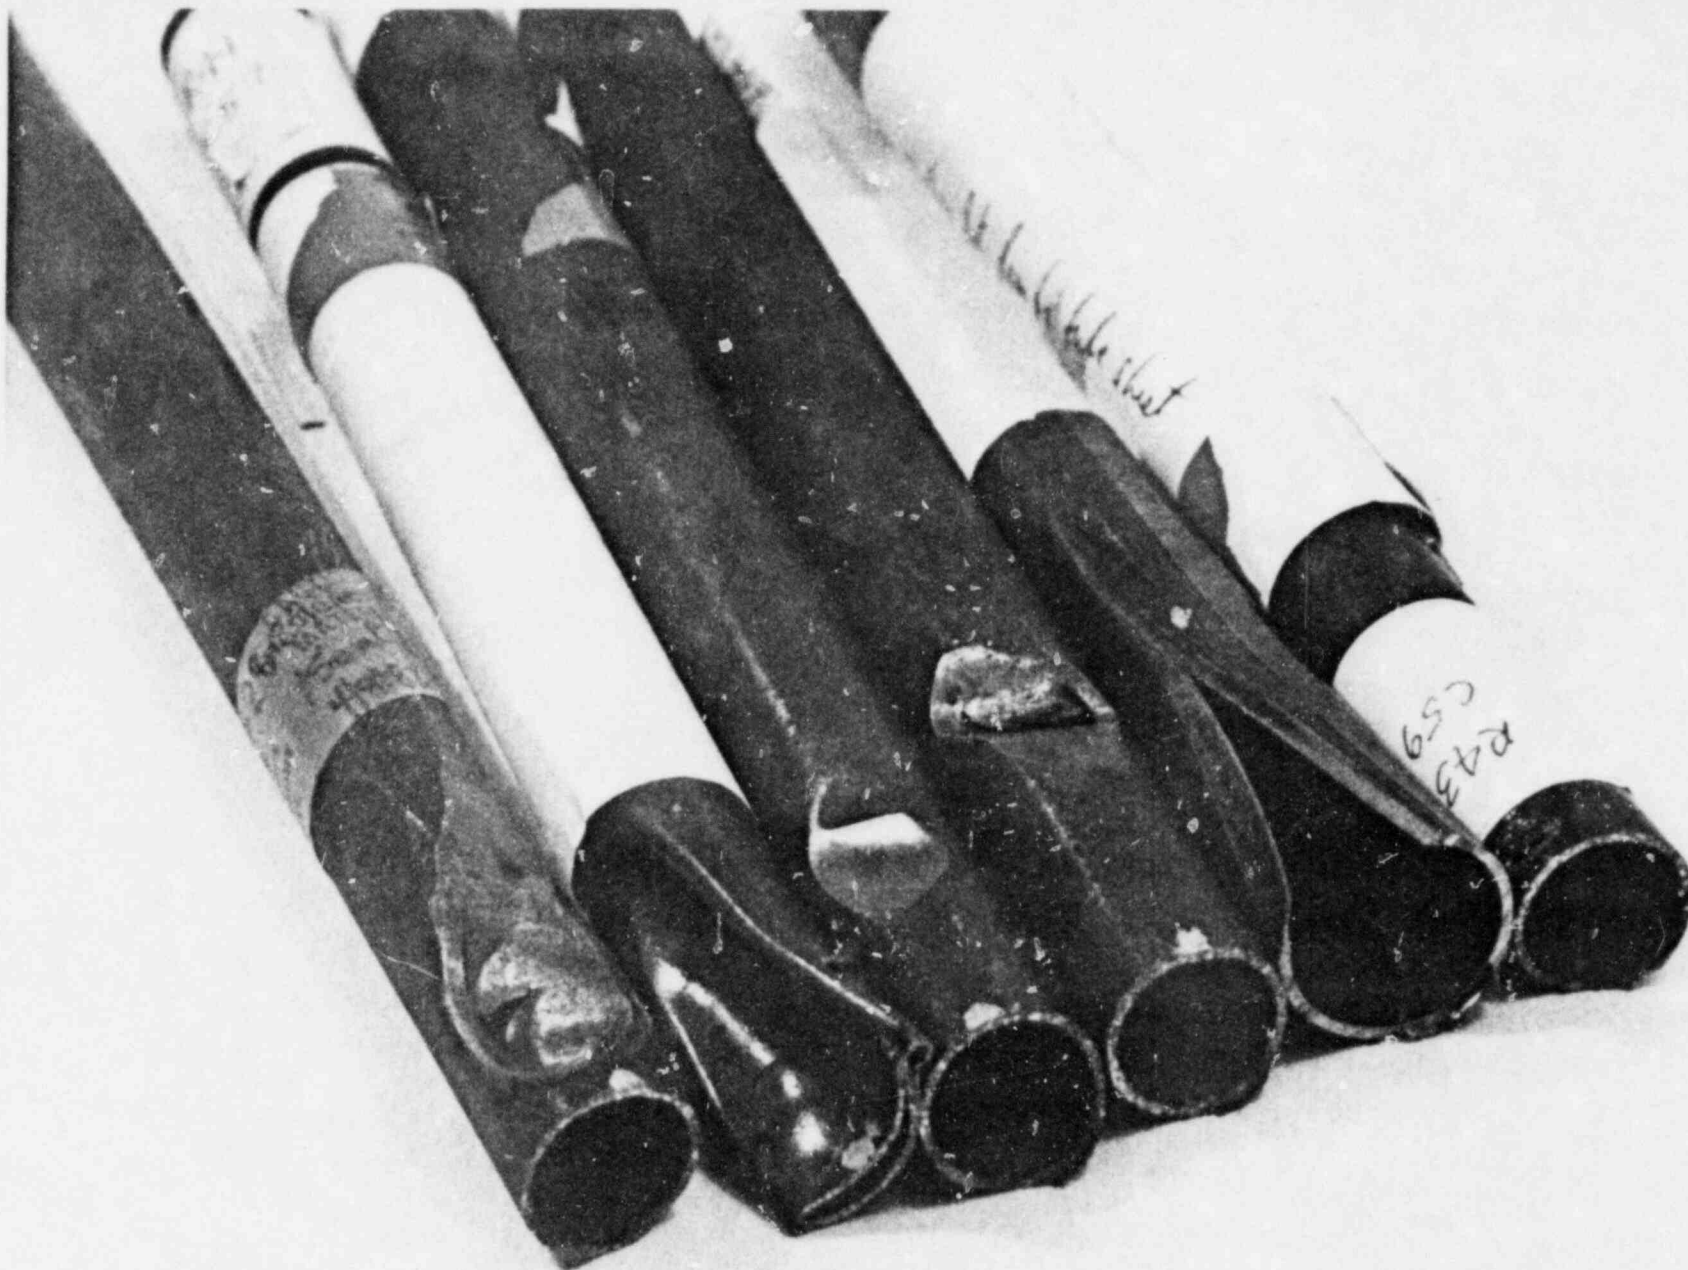
Figure 1 depicts six tube sections received by BNL. The figure gives a good cross section of the types of damage encountered by the steam generator tubing in service. NOTE: the light colored dot, on the specimens, indicates that portion of the tube facing the shell of the steam generator.

Figure 1. Photograph of "as received" ~10" long sections of damaged tubes from Rochester Gas and Electric's (RG&E) GINNA Station

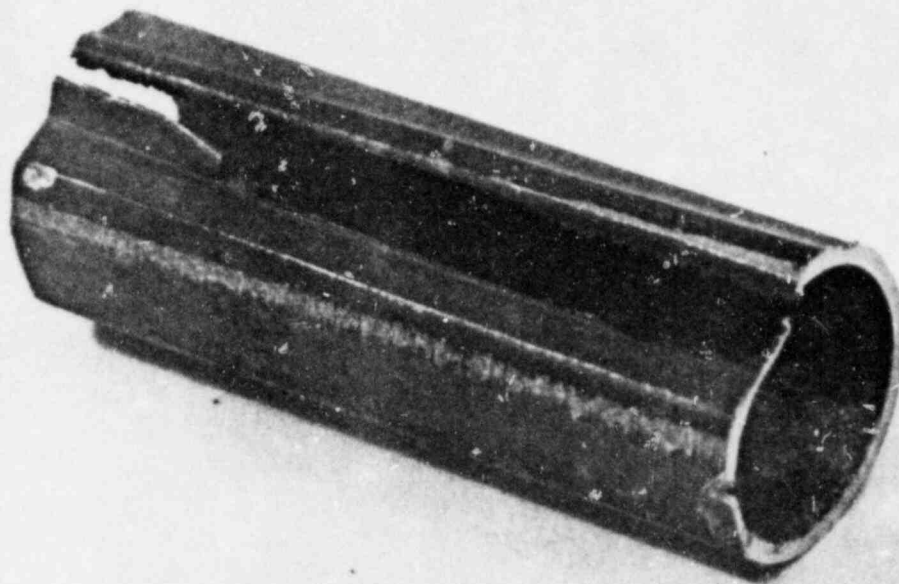
The photographs (Figures 2-6) portray areas of the various tubes which have been worn away by a probable abrasion mechanism. These tubes are on the inner rows of the steam generator (Figure 7) and the longitudinal wear patterns (with circumferential striations) are consistent with two tubes rubbing together for an extended period of time.

Figure 2. Photograph of specimen #7 from tube R43-C55 (GINNA) depicting through wall wear from a probable abrasion mechanism

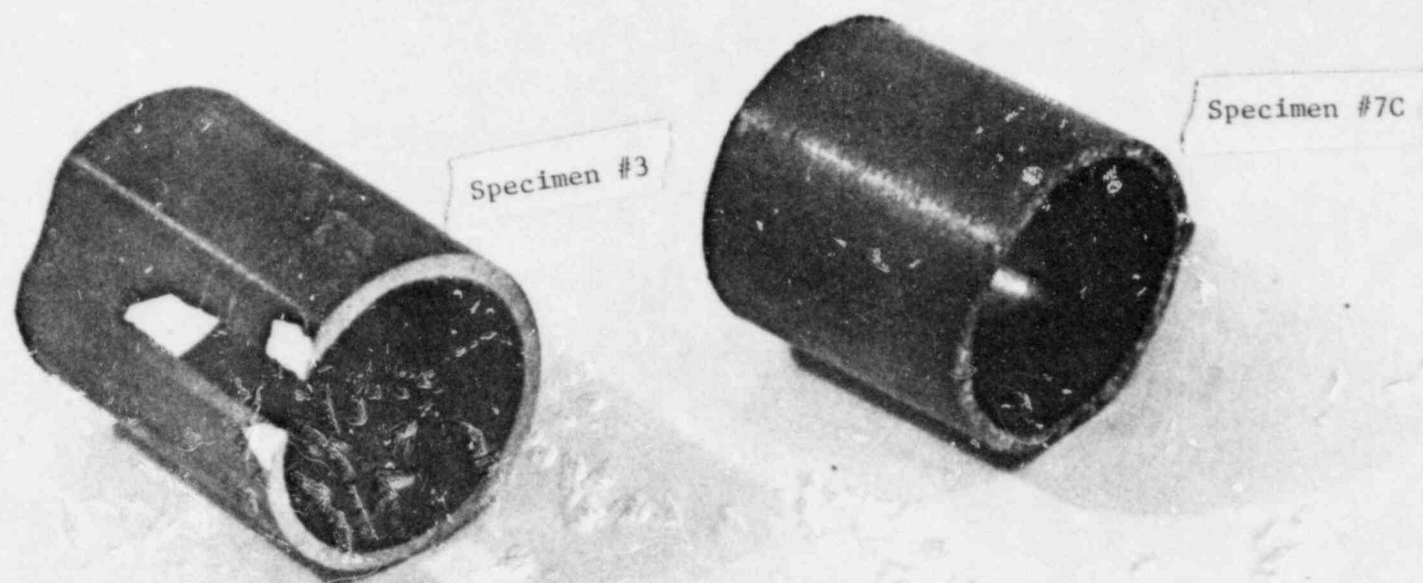
Figure 3. Photograph of specimen #3 from tube R43-C56 and #7C from tube R42-C55 (GINNA)

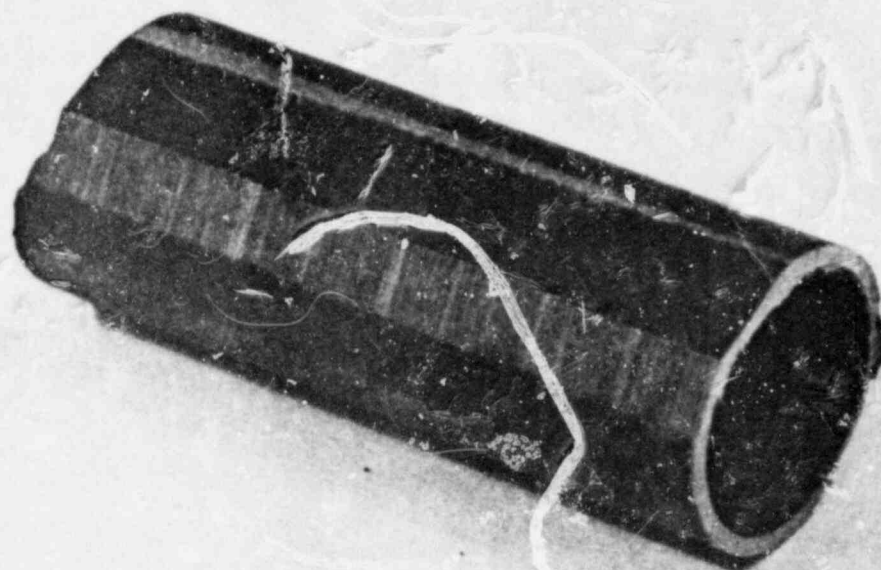
Figure 4 . Photograph depicting areas of apparent abrasion on
specimen #6 of tube R44-C54 (GINNA)

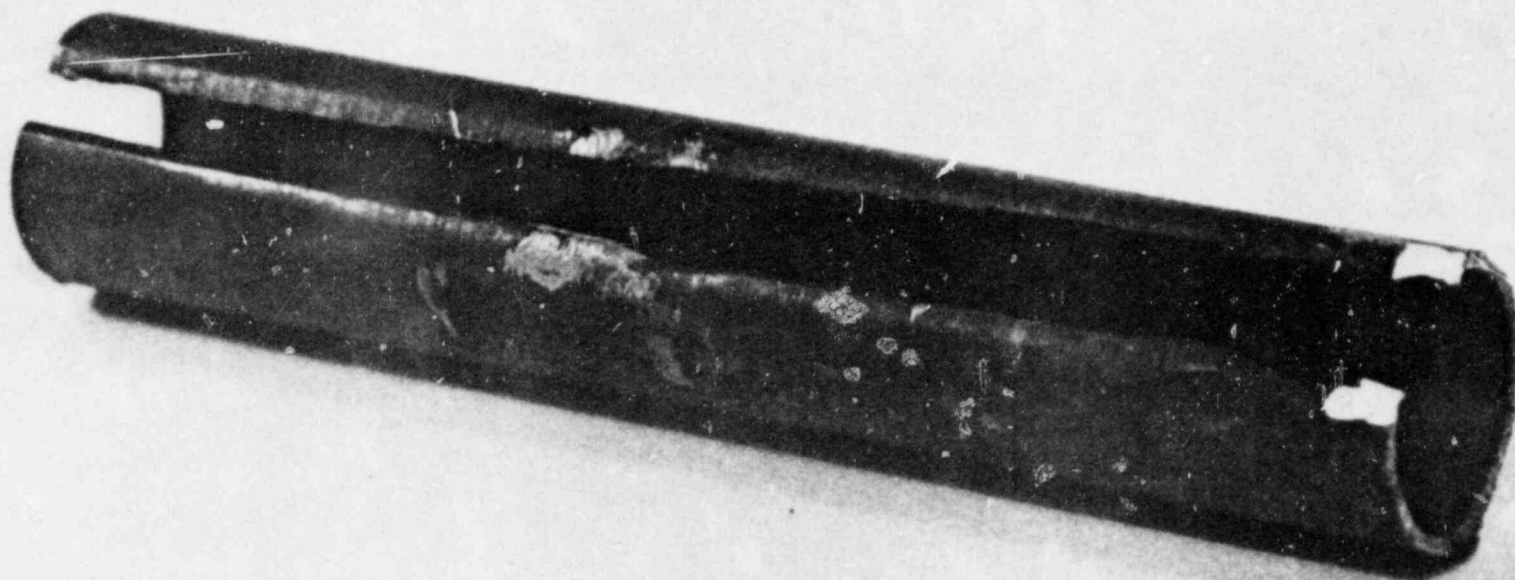
Figure 5. Photograph depicting severely abraded areas "through wall" on tube R43-C56 (GINNA)

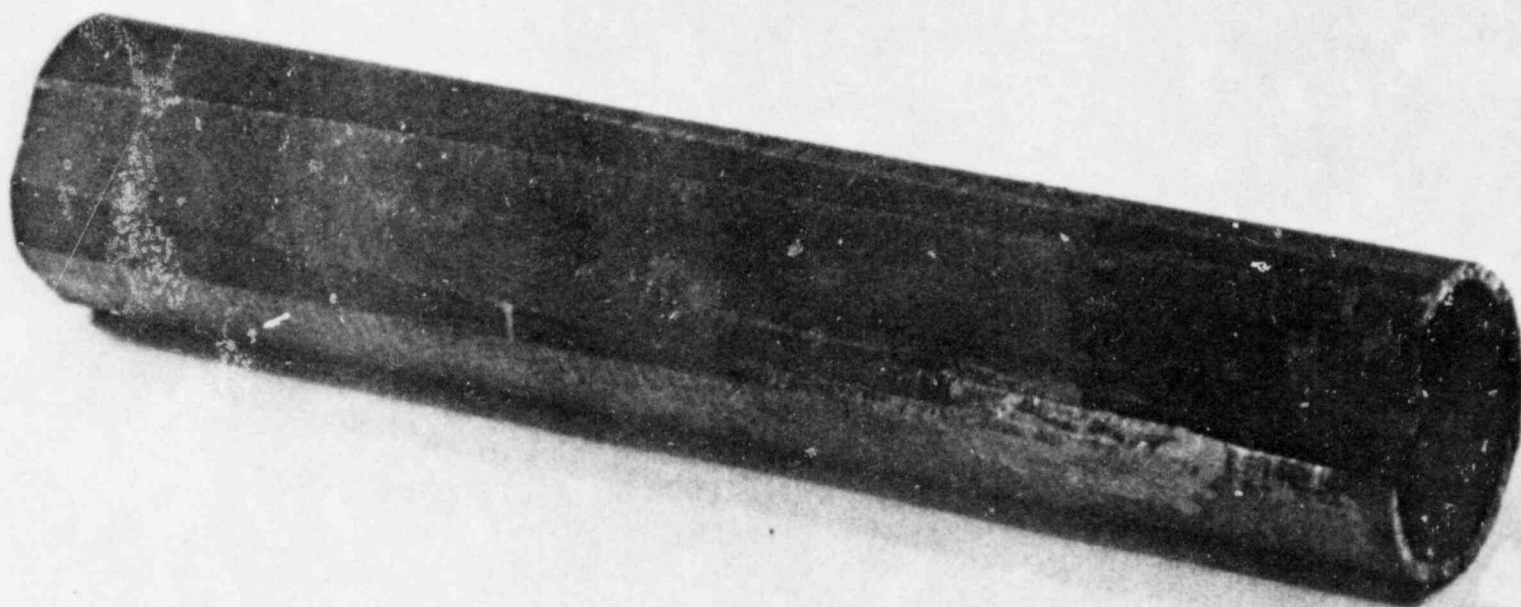
Figure 6. Photograph of severely abraded area and "through wall" thinning on specimen #1 of tube R43-C54 (GINNA)

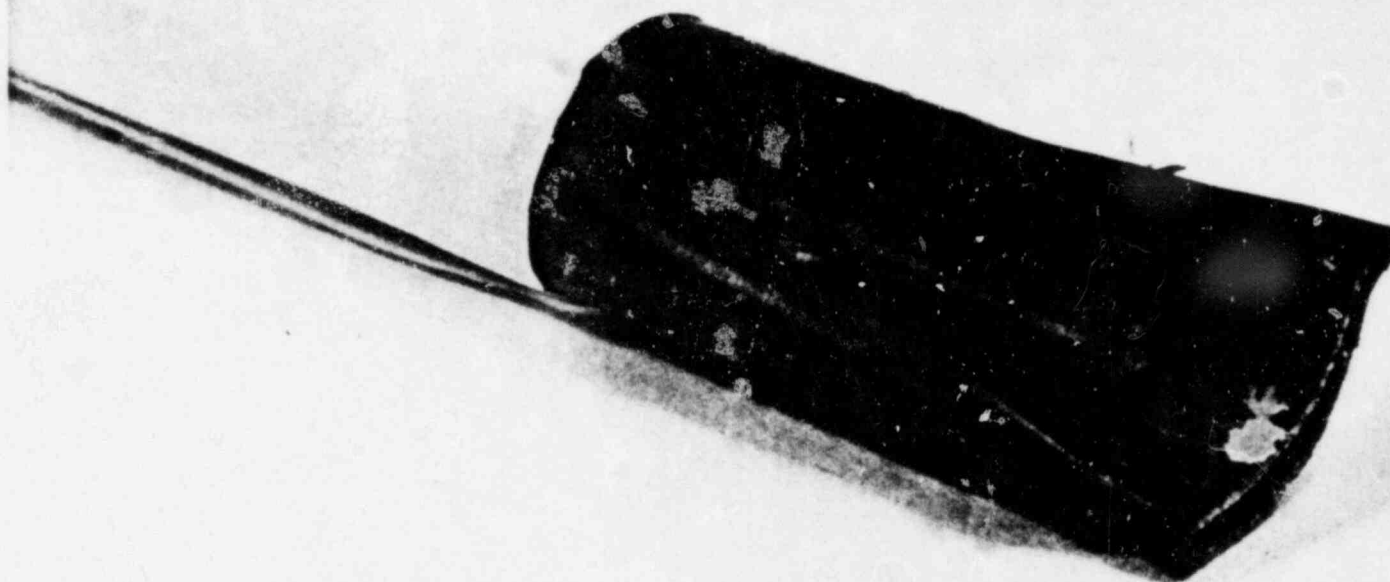
One of the tube sections received (R44-C57), had an area of full collapse in the area of the tube sheet junction (Figure 8). This tube is in the outer periphery of the tube bundle (Figure 7) and the concave portion of the collapse faces the shell of the steam generator. The next two photographs (Figures 9-10) show an impact and wear mechanism which occurred on tubes away from the area of the leak (#4 wedge area) in the #6 wedge area. (Fig. 11) The severest damage occurred on the tube where its circumference faced the steam generator shell. The wear patterns were consistent with the rubbing of one tube by another tube of approximately 7/8" outside diameter.

Figure 8. Photograph of collapsed area
in tube R44-C57 (GINNA)

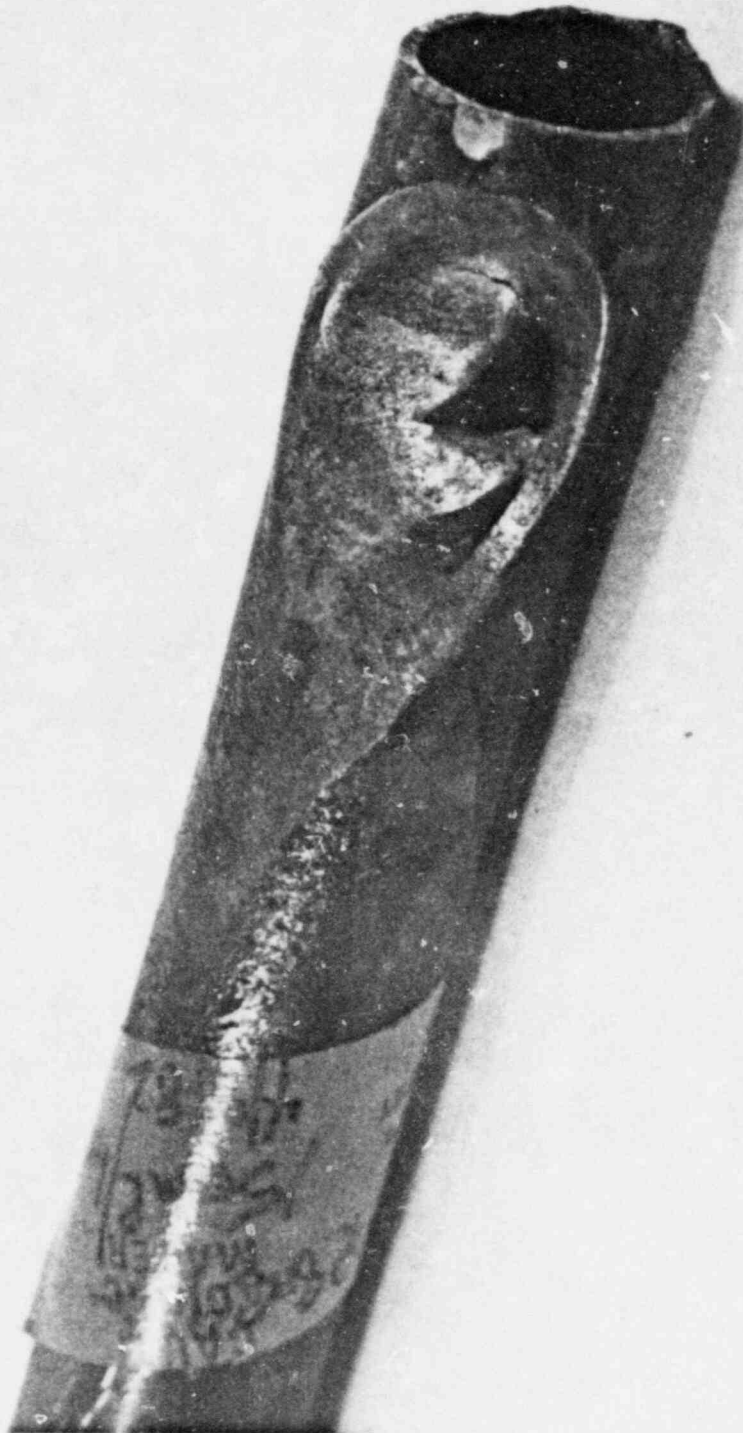
Figure 9. Photograph of apparently rubbed
area in tube R8-C92 (GINNA)

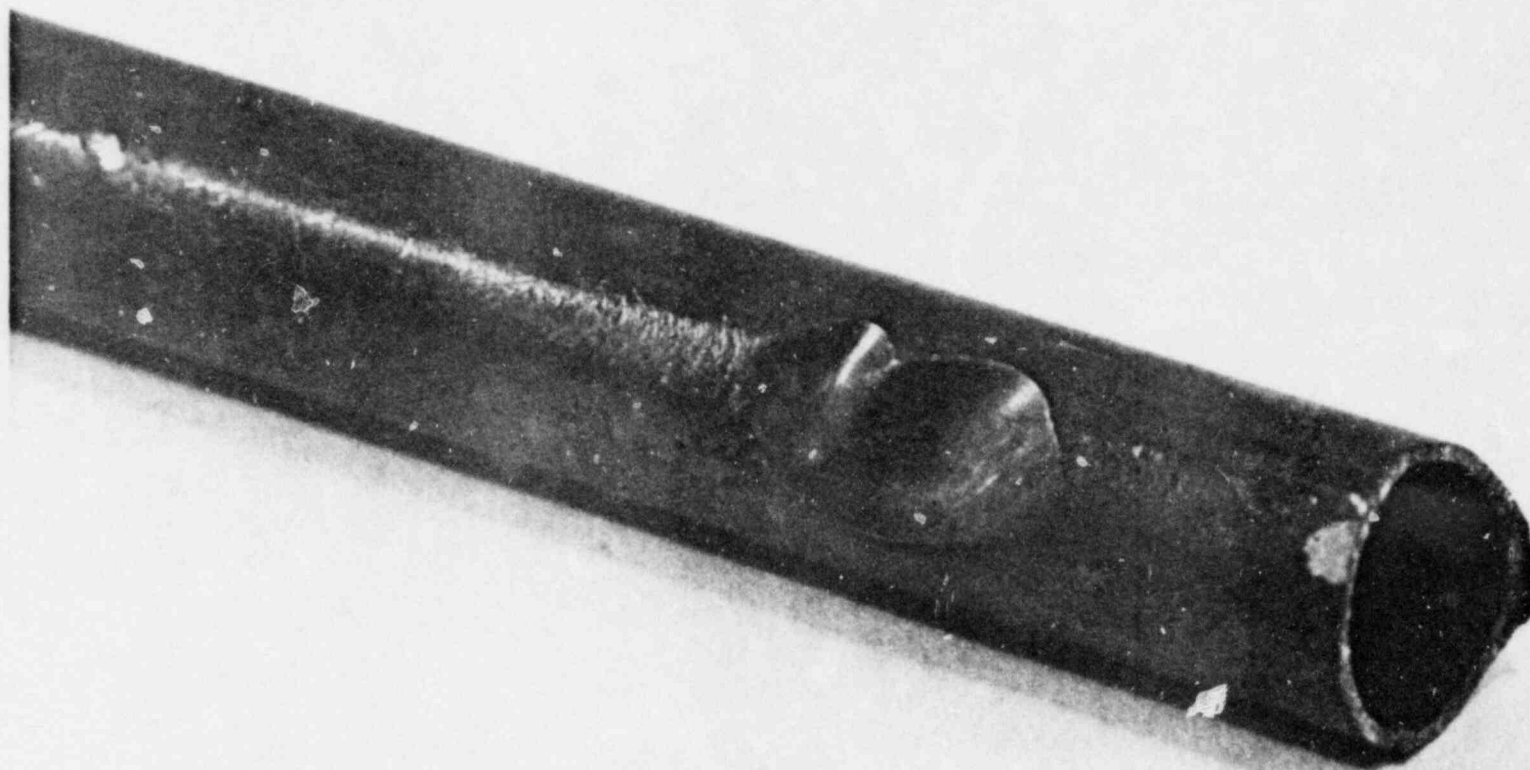
Figure 10. Photograph of abraded area in tube
R10-C91 (GINNA)

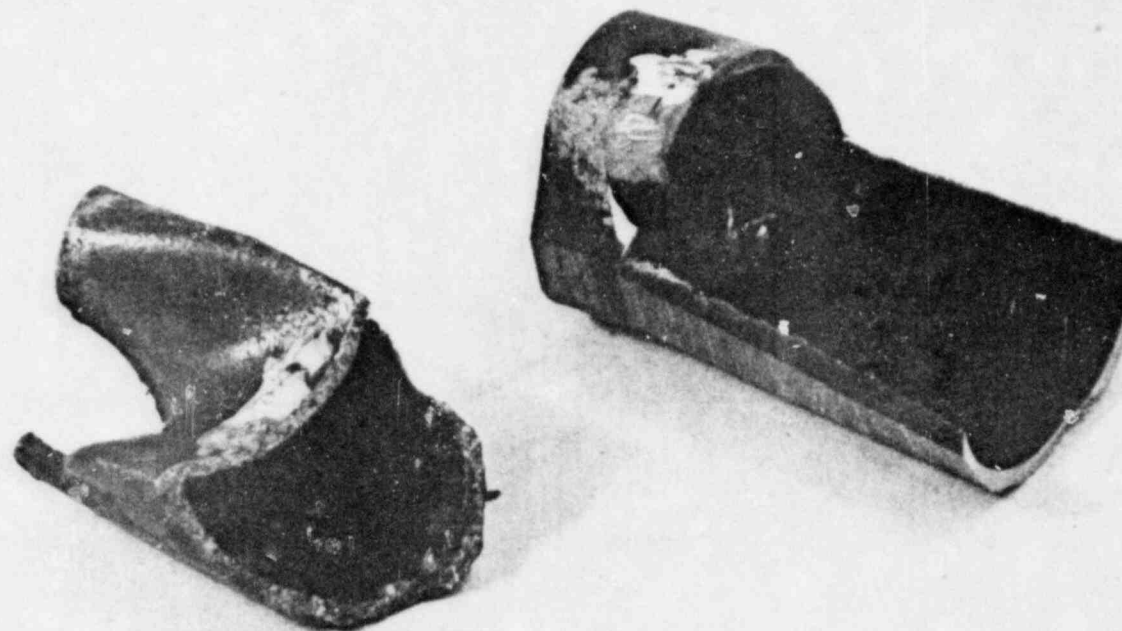
Figure 12 depicts the severe impact damage which occurred on tube R44-C54. Again, it is evident that the most severe deformation occurred on the side of this outer periphery tube facing the shell.

Figure 12. Photograph of two pieces of tube R44-C54 portraying considerable deformation

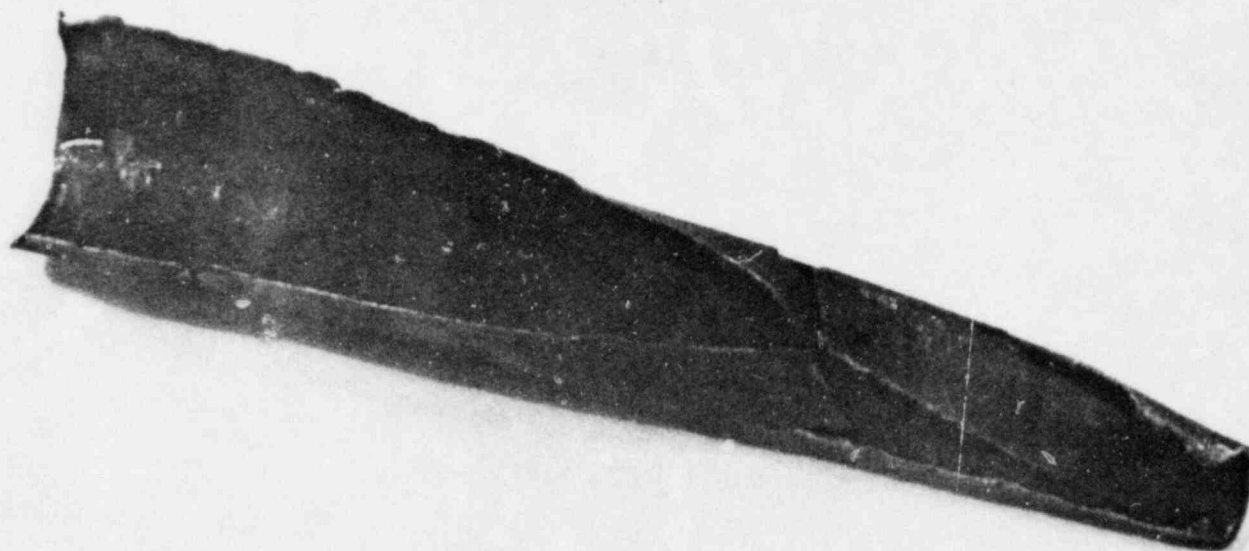
Figure 13 is a photograph of a severed section from tube R44-C55. This tube displayed severe impact type damage and wall thinning.

Figure 13. Photograph of severely deformed area in tube R44-C55 (GINNA)

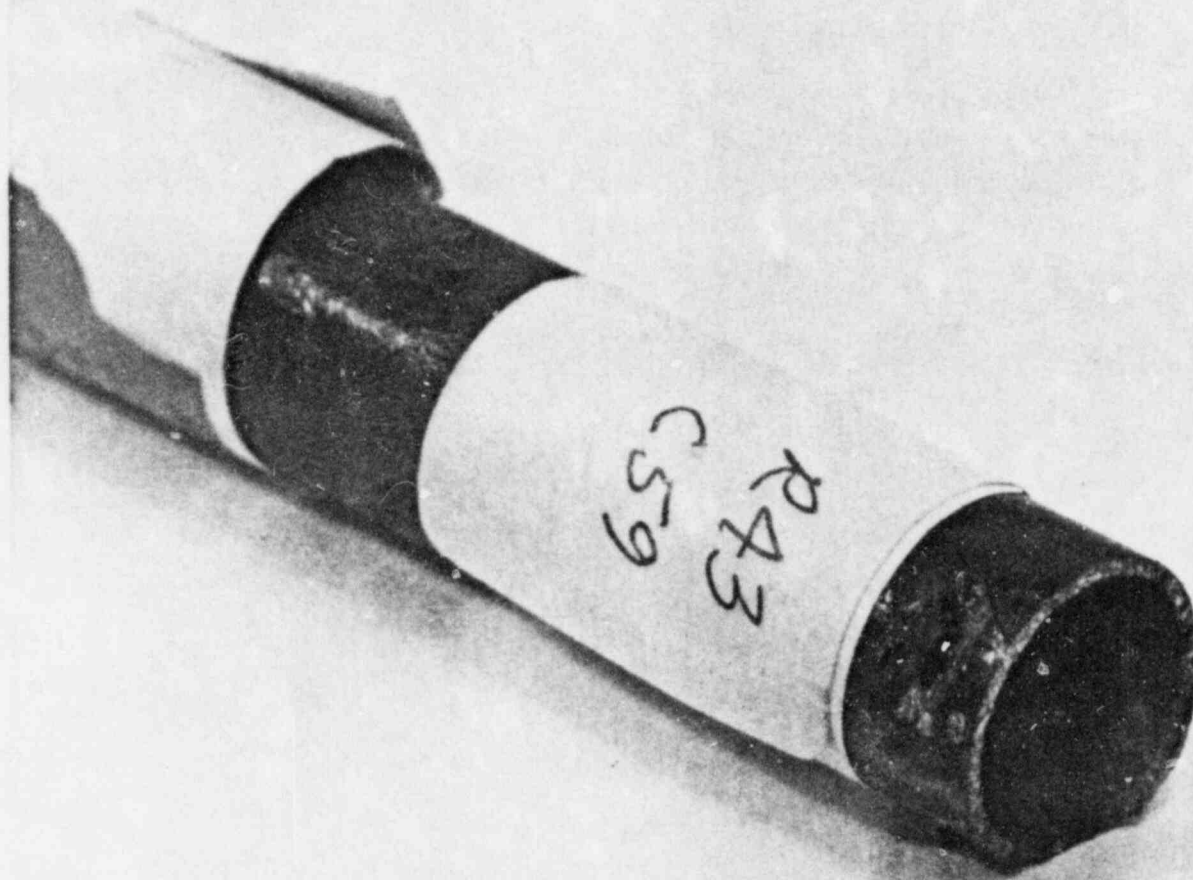
Tube R43-C59 (Figure 14) displayed a chisel-like cut and an impacted area (not shown on photo). The impacted area was approximately 1/2" diameter and hemispherical in shape. It was later determined that the cut was caused by a "miscut" of an electric discharge machining device, which was used to cut the tube section free from the steam generator, and did not occur in service.

Figure 14. Photograph of probable "miscut" of
Electric Discharge Machining (EDM)
apparatus on tube R43-C59 (GINNA)

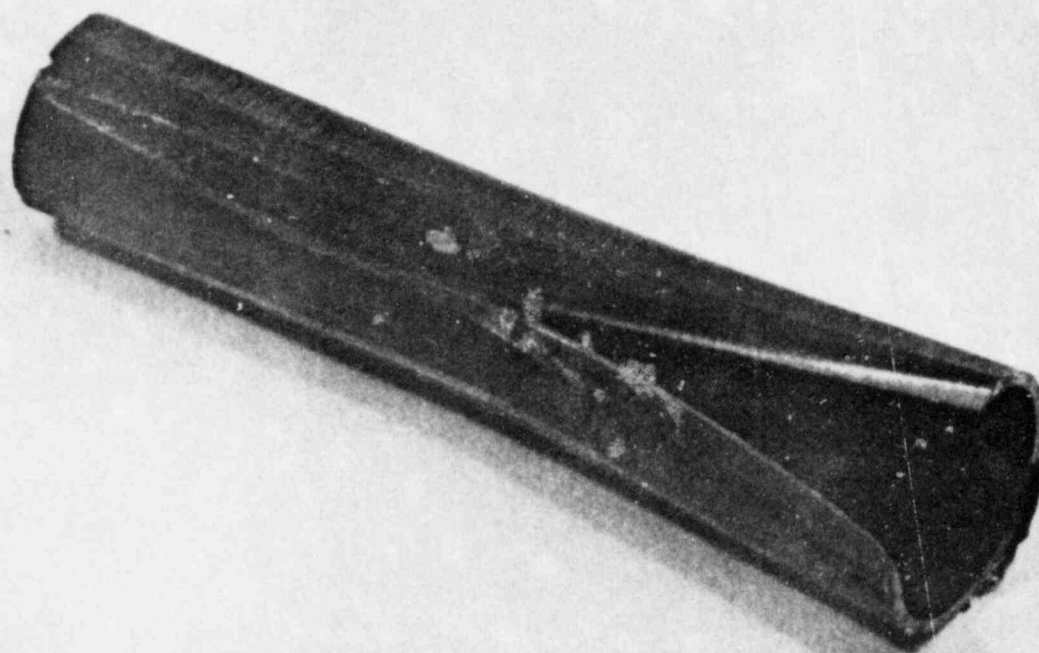
The bottom half of the "fishmouth" fissure (R42-C55) is displayed in Figure 15. Longitudinal wear scars (with circumferential striations) are quite evident in the photograph. These wear patterns are consistent with similar areas found on other inner steam generator tubes. There were no areas of impact evident on this tube.

Figure 15. Photograph of "fish mouth" crack
in tube R42-C55 (GINNA)

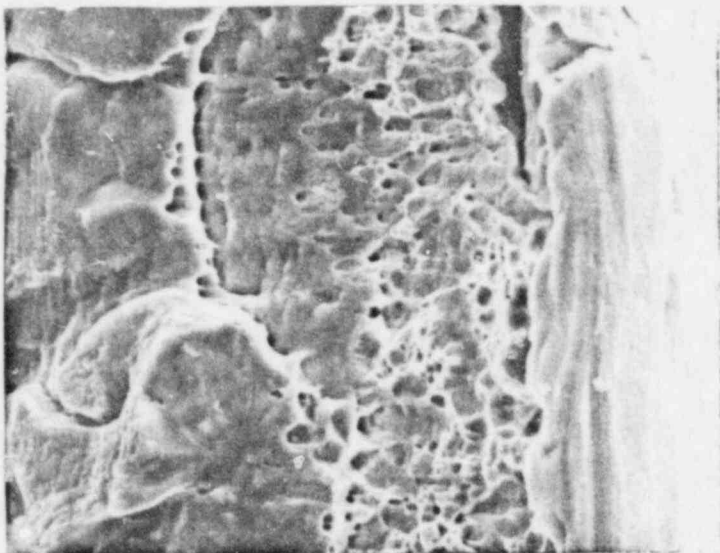
The "fishmouth" fissure on tube R42-C55 was sectioned (Figure 16) for both SEM and optical examinations. Figures 17-24 are typical SEM photographs of the face of the "knife edge" fissure starting near the center of the "fishmouth" and moving along its length to the crotch of the crack. It is clearly seen in Figures 17 and 18, that the mode of failure was a ductile overload mechanism. The normally circular dimples (if a uniaxial tensile test were performed) are somewhat elongated, which is evidence of a pipe bulge prior to break. The elongated dimpled structure of the fracture disappeared the farther away the "fishmouth" was scanned from the center of the fissure, as seen in Figures 19-22. An impacted area was noted in specimen #3 (Figure 21), which appeared to have occurred after the tube failed. This occurrence would be consistent with the postulation that loose objects were present in the steam generator at the time of failure. Figures 23 and 24 are SEM photographs of the transition zone (end of crack) in specimen #4. It is evident by the photographs, that the end of the crack also displayed ductile overload features with no evidence of fatigue contribution.

Figure 17. SEM photo of knife edge on R42-C55. Typical of "bulging" prior to ductile overload specimen #1

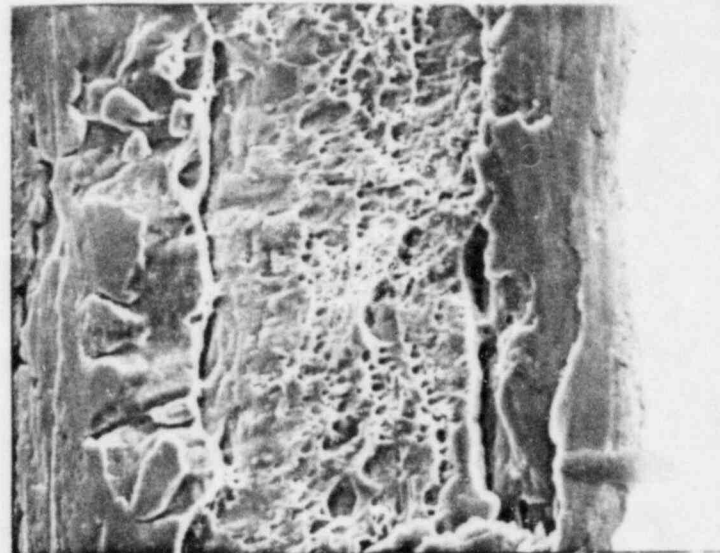
Figure 18. SEM photo of knife edge on R42-C55. Elongation of dimples less pronounced. Specimen #2

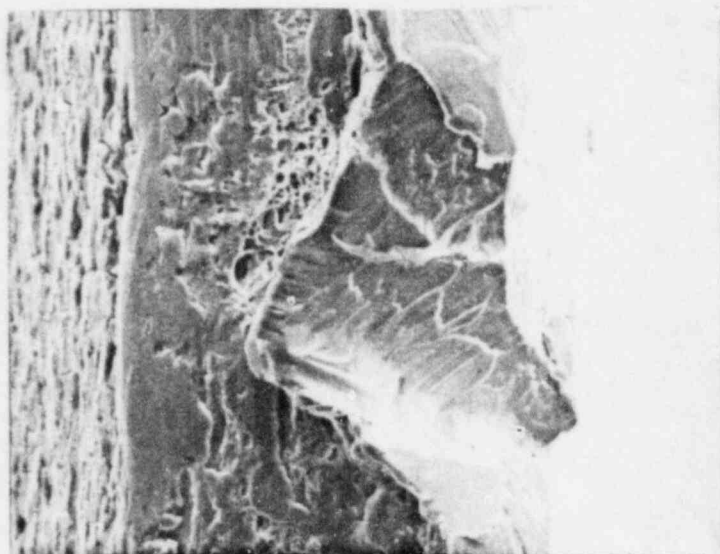
Figure 21. SEM photo of knife edge on R42-C55 depicting impact after break. Specimen #3

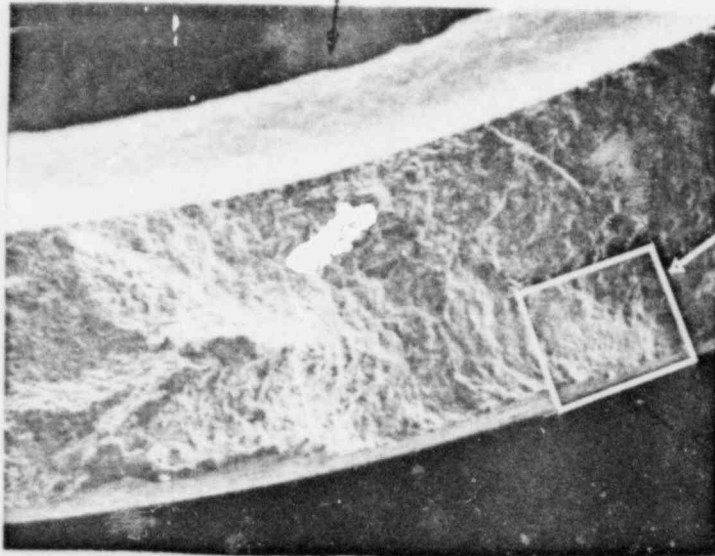
A section of tube R44-C56 was also examined by SEM. This tube had been collapsed and broken at the tube sheet and had also been severed by the tube support plate. The section viewed was the cross section of the tube, where it was severed just below the tube support plate. The majority of the fracture face was featureless and had a tamped appearance. One interesting feature was noted on the specimen, however, shown in Figures 25-27. Chevron marks were evident (Figure 25) on the surface of the fracture, which led to a cyclically fatigued area on the specimen (Figures 26 and 27). This type of structure would be consistent with a tube breaking by the tube sheet and then "whipping" about in a turbulent flow, causing a fatigue type failure of the tube by the upper tube support plate.

Figure 25. SEM photo of "chevron" marks
(indicative of fatigue failure)
on Tube R44-C56 (top) near tube
support plate

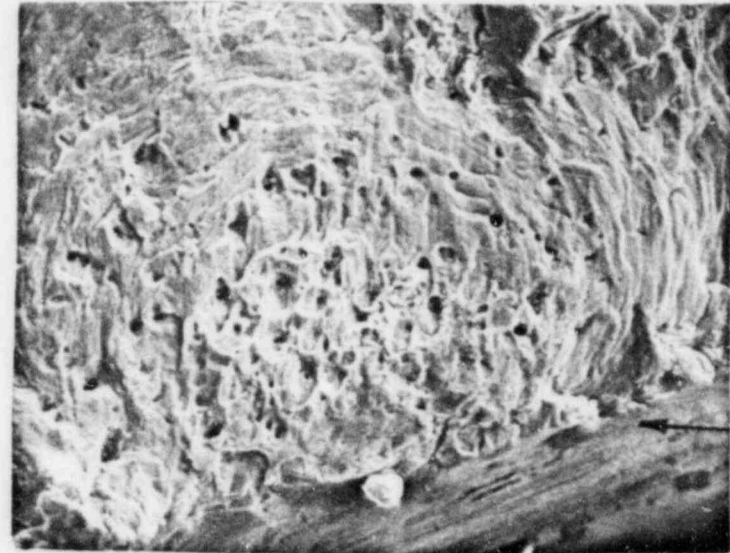
Figure 26. SEM photo of probable initiation
site for cyclic fatigue failure
of tube R44-C56

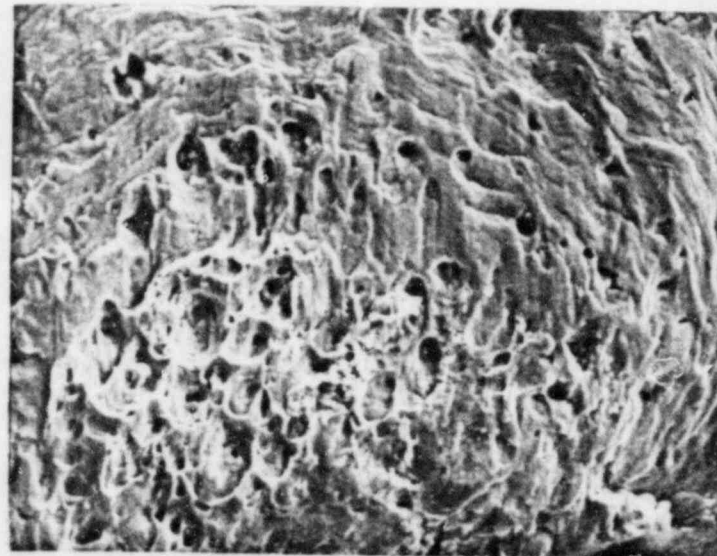
Figure 27. Higher magnification SEM photo
of "initiation site" - Tube R44-C56

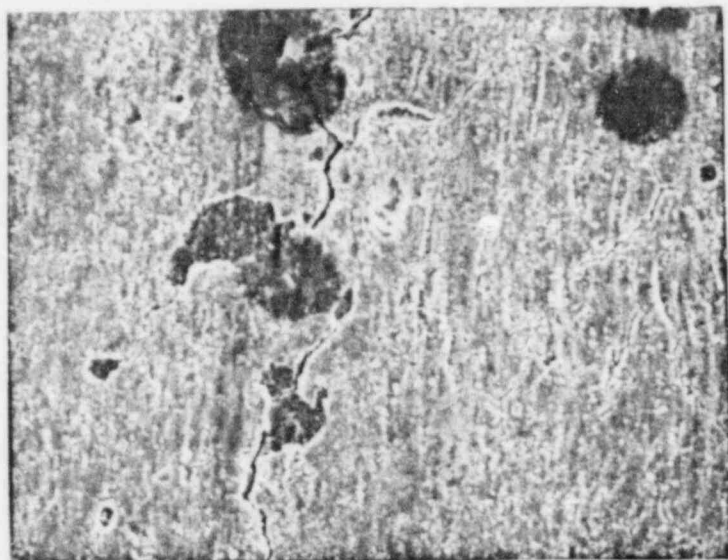
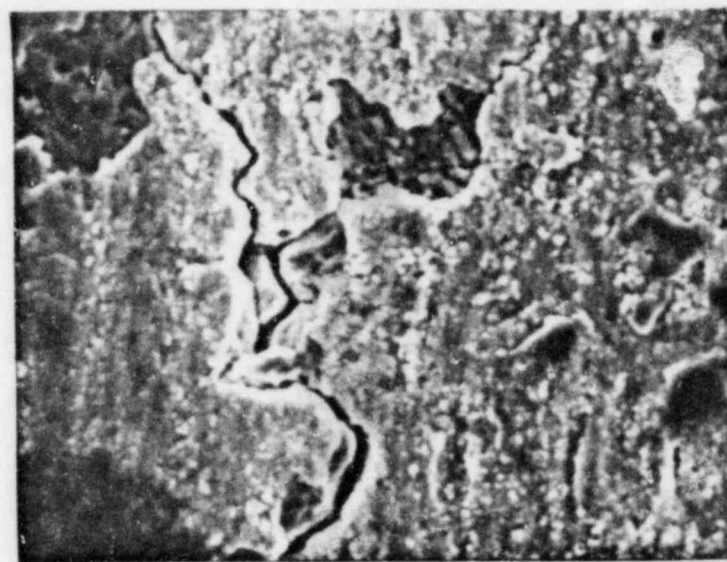
An examination of the inside surface of tube R43-C59 showed one area, which initially appeared as an intergranular type crack in the tube (Figures 28 and 29). The crack-like indication found on this tube was later

determined to be associated with a prior pickling process (see EDS section).

Figure 28. SEM photo of inside surface of tube R43-C59 depicting area of possible deep etching

Figure 29. Higher magnification SEM photo of inside surface of tube R43-C59

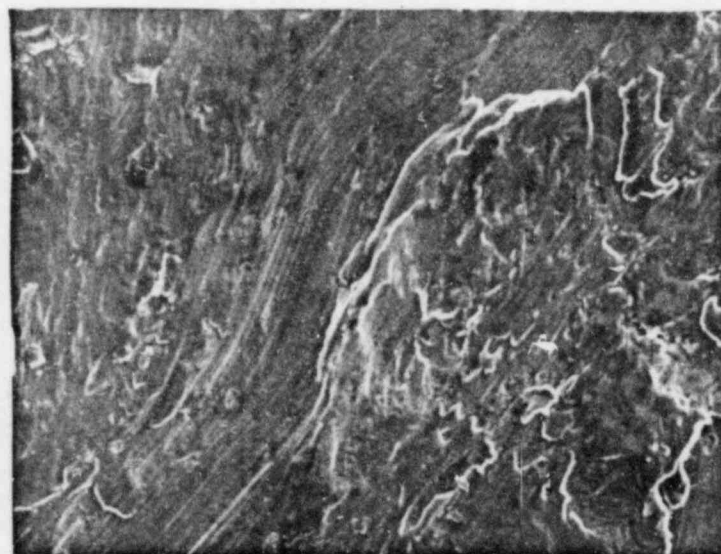
Figure 30 is an SEM photograph of a typically abraded and impacted section of tube R11-C91. Although some wear lines are evident, the section has no predominant distinguishing features.

Figure 30. SEM photo of outside surface of abraded tube R11-C91

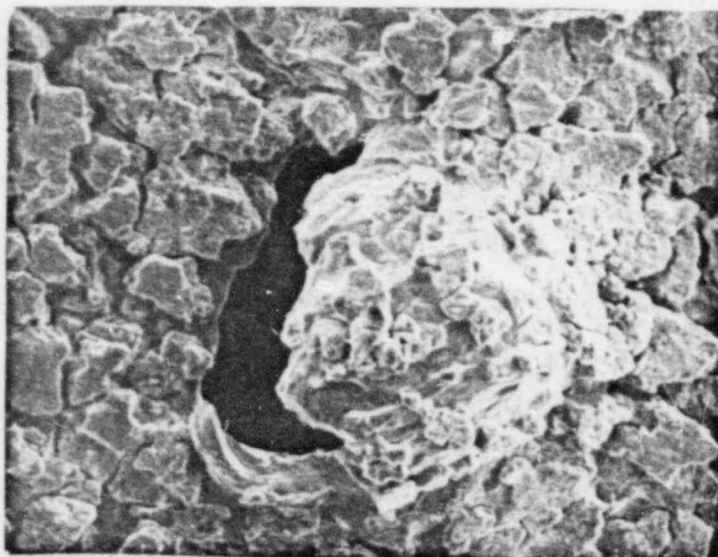
Figure32. SEM photo of inside surface
of tube R8-C92 depicting area
of wall collapse

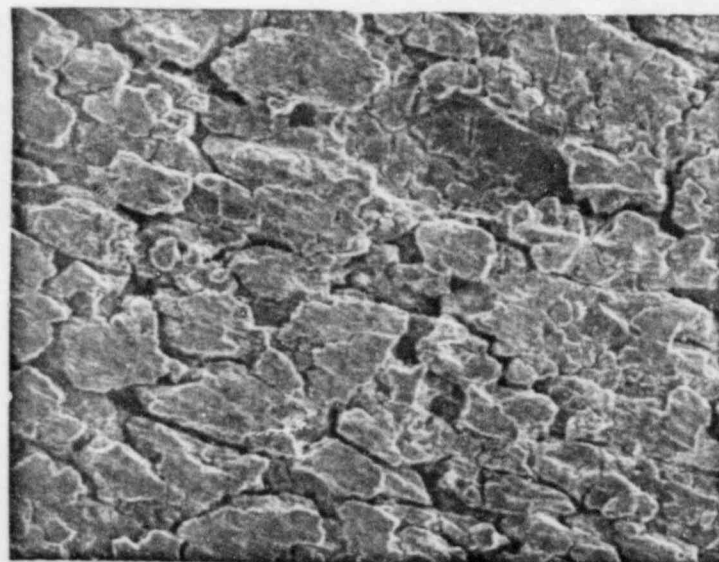
Figure 33 is representative of the type of "etched" structure found on the inside surface of tube R8-C92. This structure was much more prevalent on this tube than the one area found on tube R43-C59. It was probably the result of pickling done on the tubes prior to their installation.

Figure 33. SEM photo of inside surface of
tube R8-C92 depicting "etched"
structure

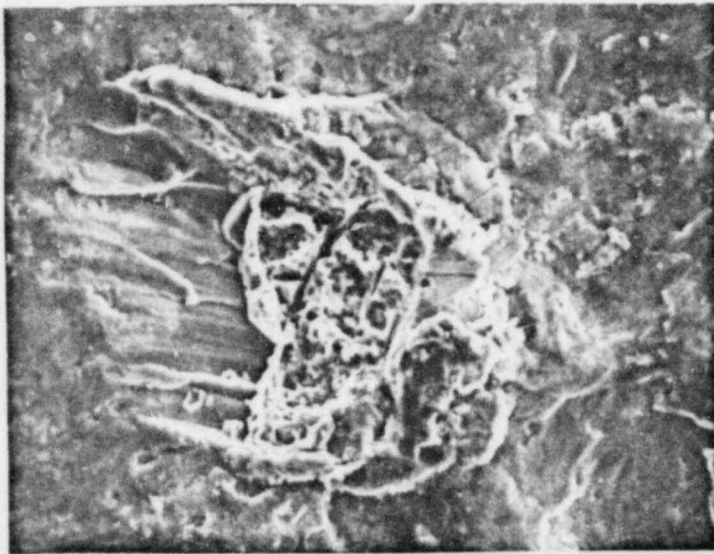
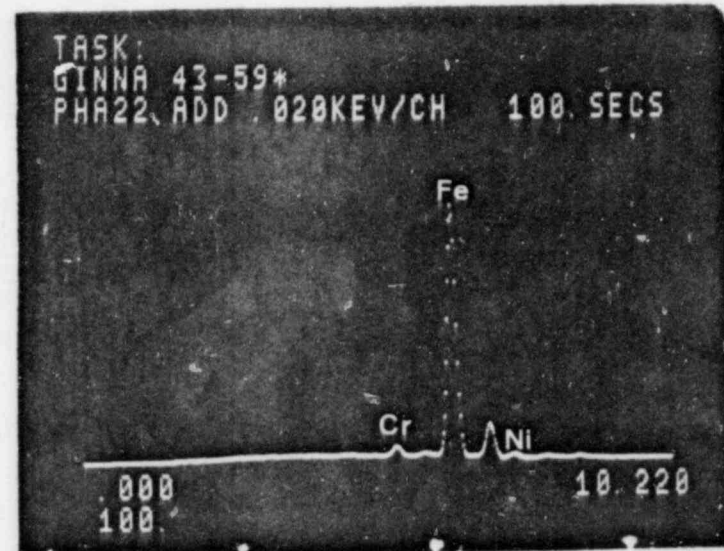
The last set of EDS scans (Figures 34, 35, and 36) display the constituents found on two smears on an impacted area on the outside surface of tube R43-C59. The scan (Figure 34a) is typical of that found on both of the smears and shows an extremely high peak of iron (Fe) relative to chromium and nickel. Since tube R43-C59 is an outer periphery tube, this finding appears to corroborate the hypothesis that the outer periphery tube damage occurred as a result of impact with a carbon steel foreign object.

Figure 34. Imbedded particle found on outside surface (O.D.) of R43-59

Figure 34a. EDS scan of imbedded particle found on R43-59

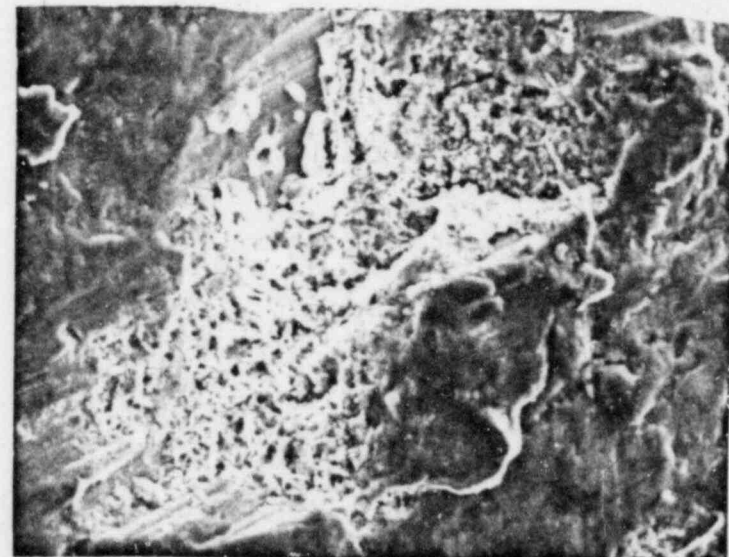
Figure 36. SEM photo of another "smear" of iron (prior EDS scan is typical) found on outside surface of R43-59

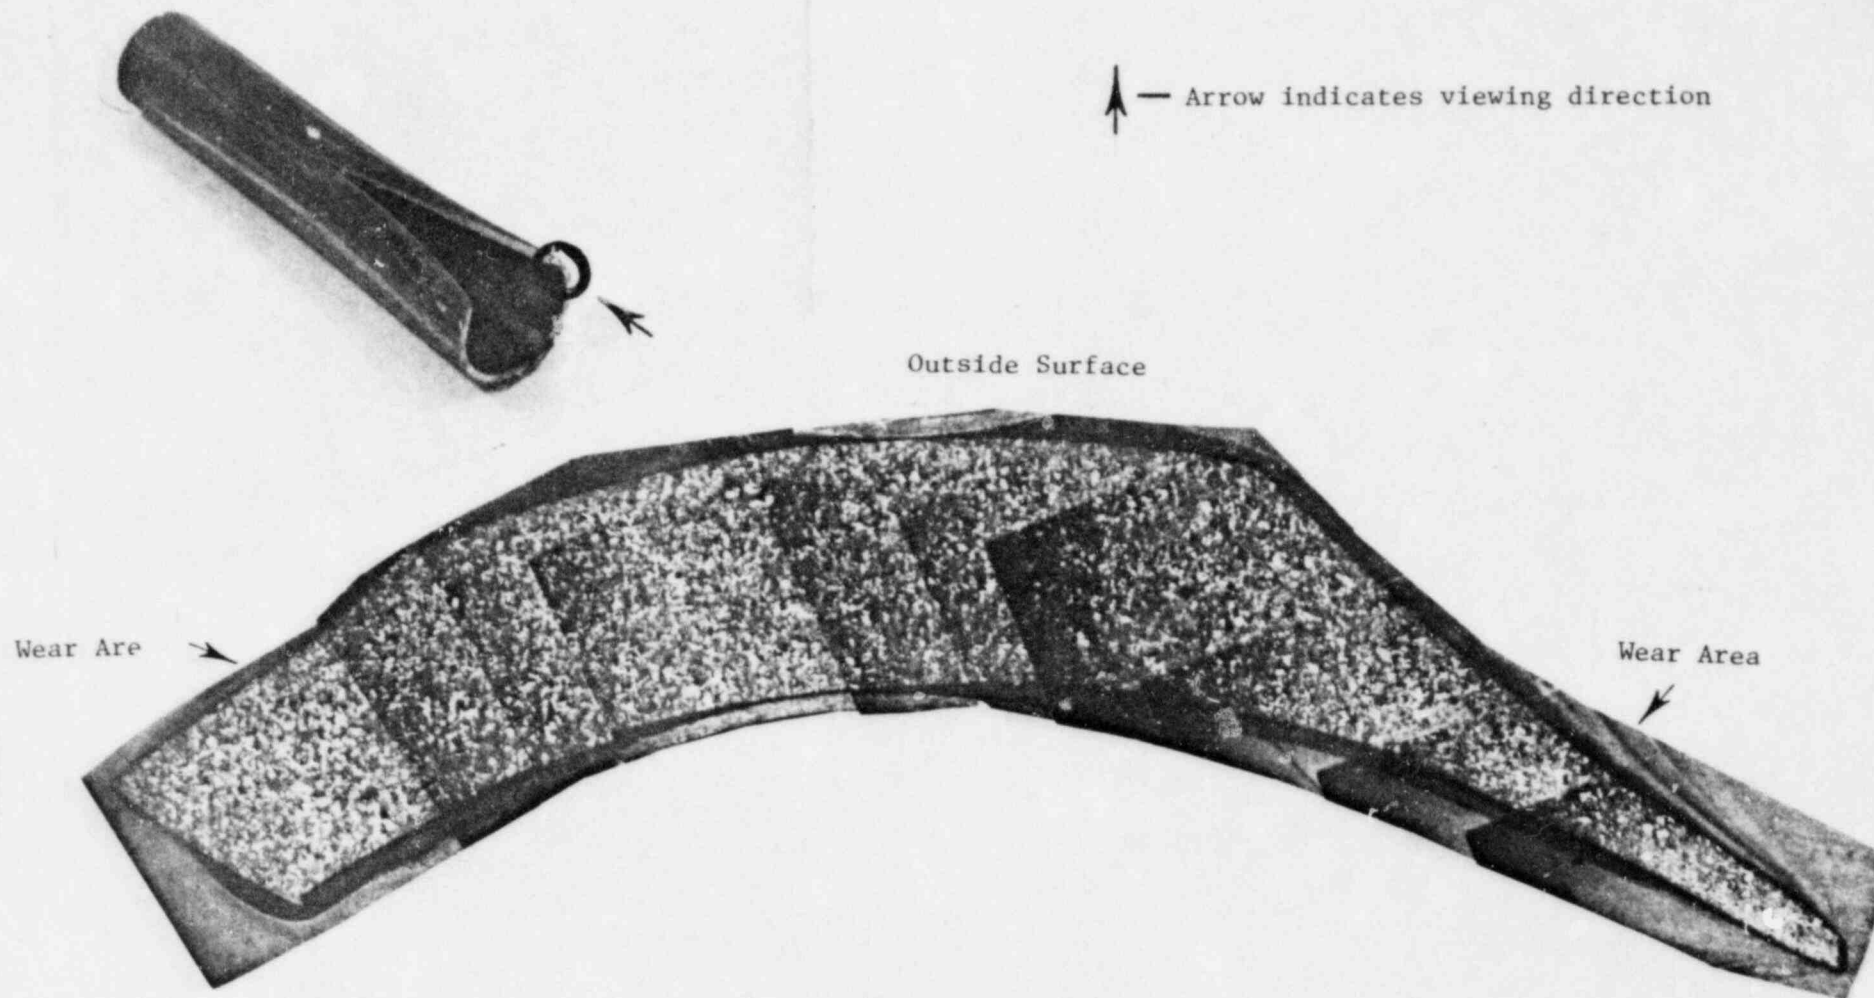
A cross sectional metallurgical mount was made of the number 1 area of the "fishmouth" fracture on tube R42-C55. It was etched with a 10% bromine + methanol etch for 20 seconds (Figure 37). There was no real evidence of cold work on this section, even though the wear patterns on the cross section are quite distinguishable. This type of wear would be consistent with a fretting corrosion mechanism, which would have reduced the tubes cross section by slow grinding over a long time period, coupled with oxidation of the freshly created surface.

Figure 37. Optical photomicrograph of cross section of "Fishmouth" fracture (tube R42-C55) also shown is area of section relative to fracture. (Note: photomicrograph is optically reversed.)

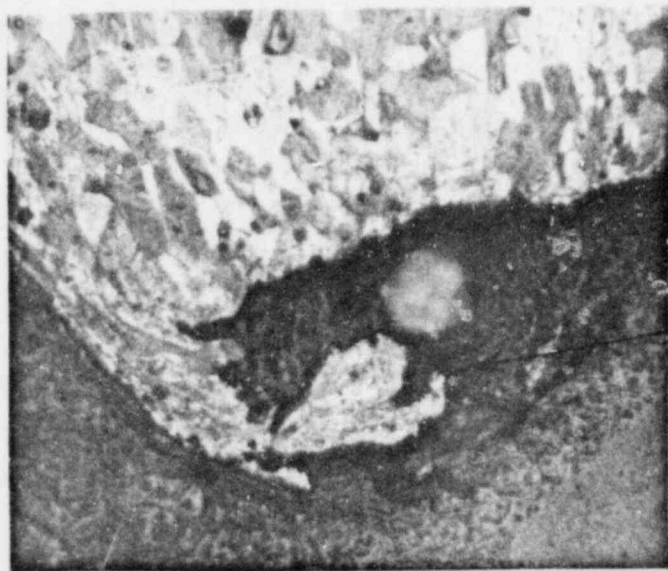
Cold work was in evidence on cross sections of tubes R10-C91 and R8-C92 in small amounts and is depicted on Figures 38 and 39. The most significant areas of cold work were found on tube R44-C57 on a cross section of the collapsed area. Figures 40 and 41 give a good representation on the amount of repetitive cold work that this tube endured. Figure 42 is a full cross section of the tube displaying the amount of structural damage that the tube received prior to the plants shutdown. It is significant to note that cold work was primarily found on the outer (periphery) tubes, with the inner row tubes displaying a fretting corrosion microstructure.

Figure 38. Optical photo depicting area of cold work on tube R8-C92.

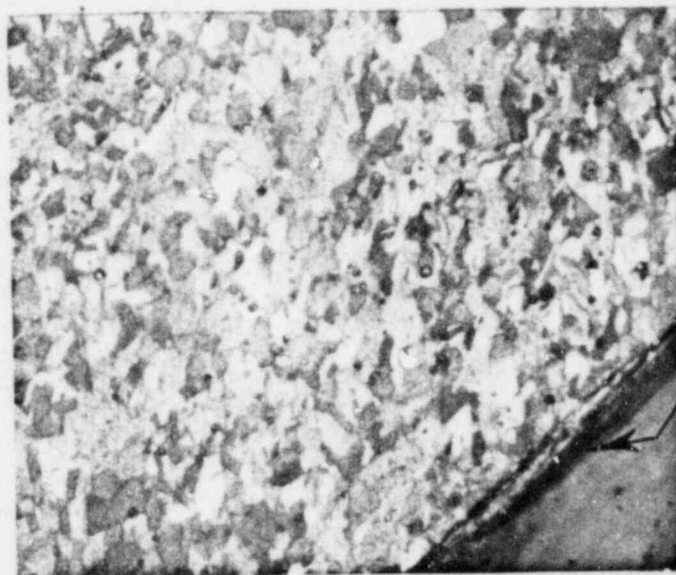
Figure 39. Optical photo displaying area of cold work on tube R10-C91.
