Subject of this Document: Investigation of Failed Tubes from "B" Steam Generator of the R. E. Ginna Nuclear Power Plant

Investigation of Failed Tubes from "B" Steam Generator
of the R. E. Ginna Nuclear Power Plant*

Carl J. Czajkowski

May 1982

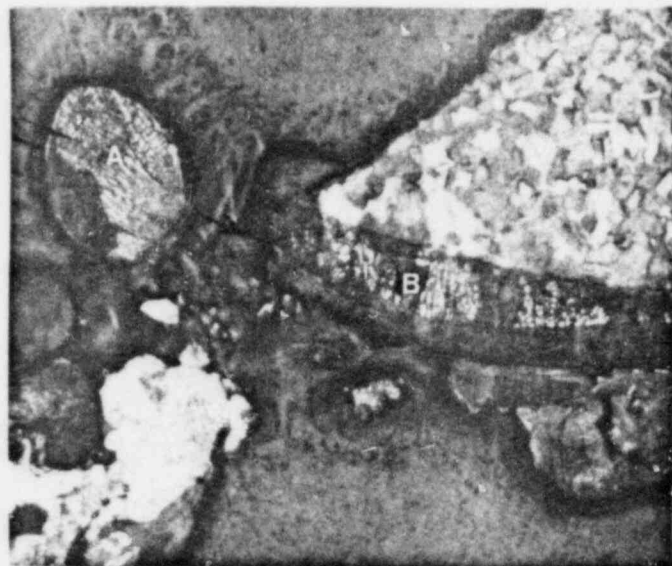
Cold work was in evidence on cross sections of tubes R10-C91 and R8-C92 in small amounts and is depicted on Figures 38 and 39. The most significant areas of cold work were found on tube R44-C57 on a cross section of the collapsed area. Figures 40 and 41 give a good representation on the amount of repetitive cold work that this tube endured. Figure 42 is a full cross section of the tube displaying the amount of structural damage that the tube received prior to the plants shutdown. It is significant to note that cold work was primarily found on the outer (periphery) tubes, with the inner row tubes displaying a fretting corrosion microstructure.

Figure 40. Low magnification photo of cold work on collapsed tube R44-C57.

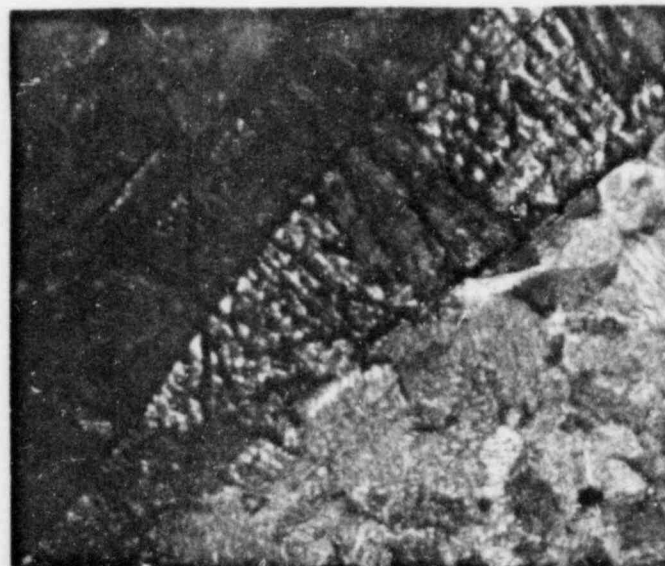
Figure 41. Higher magnification photo of cold work on tube R44-C57 (Area B).

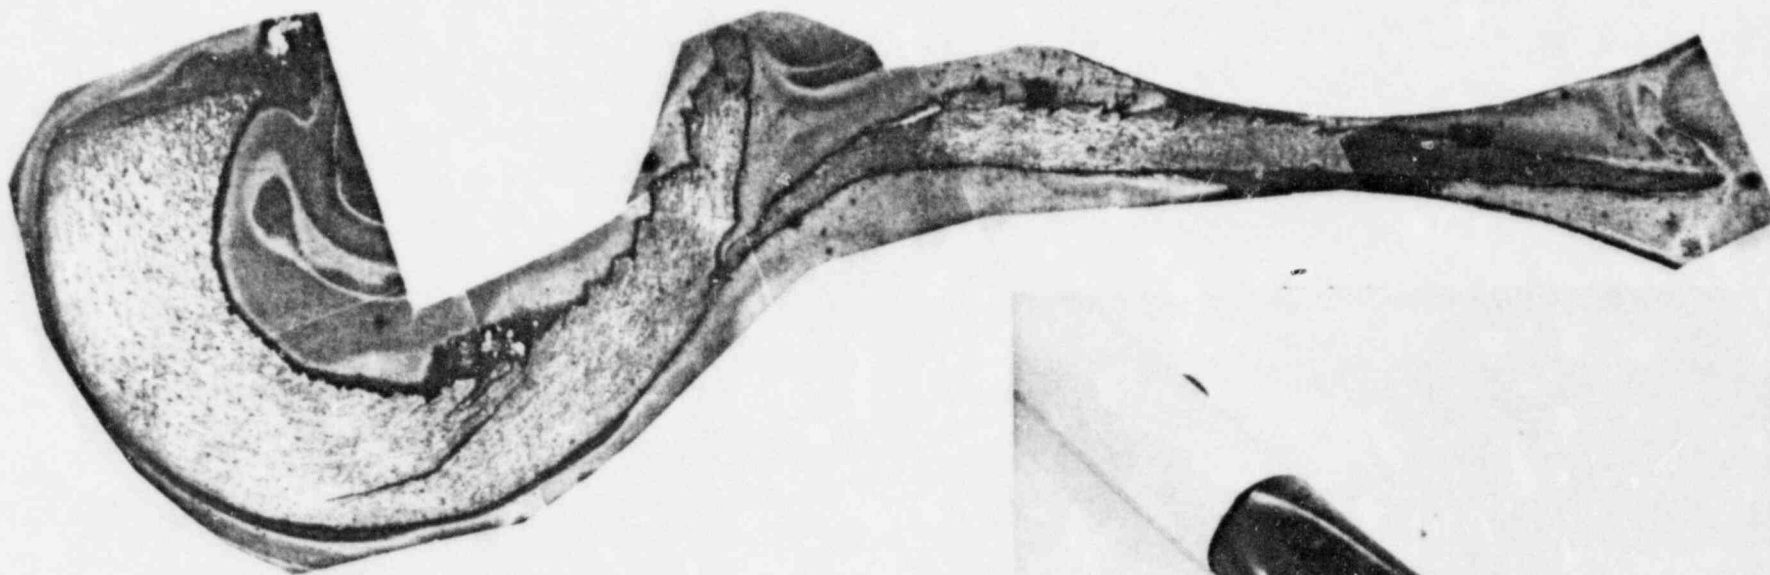
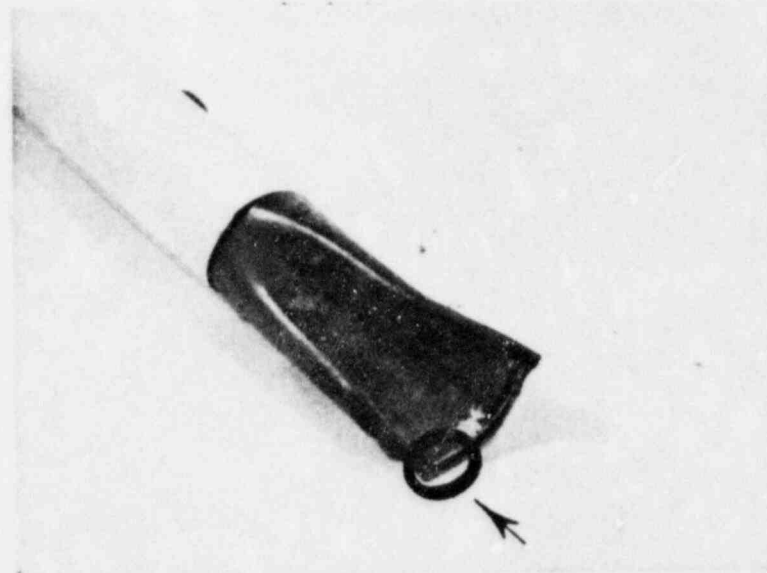
Figure 42. Cross sectional photomicrograph showing extent of damage endured by tube R44-C57. Also shown is area of section taken relative to collapse area.
