LICENSEE EVENT REPORT

SUPPLEMENTAL INFORMATION TO
LER 82-097/03 L-0

Mississippi Power & Light Company
Grand Gulf Nuclear Station - Unit 1
Docket No. 50-416

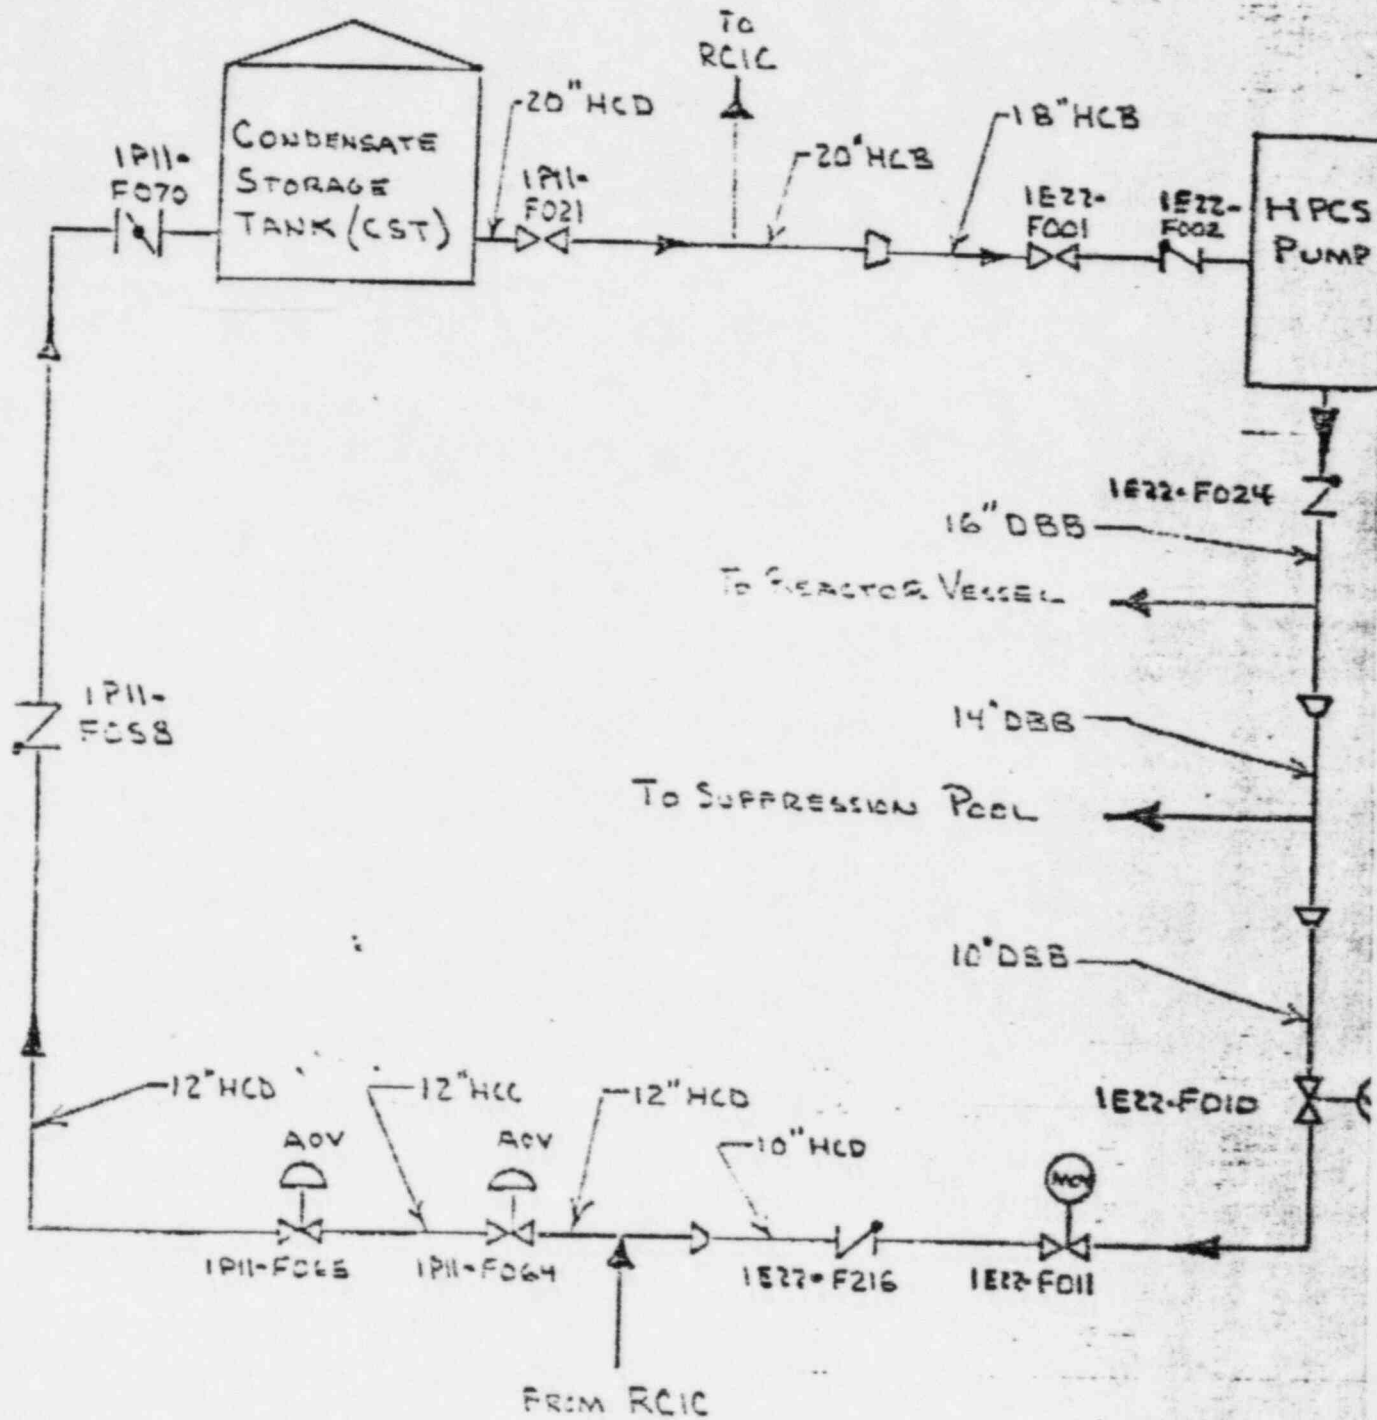
FIGURE 1

On October 2, 1982, with the plant in Cold Shutdown, Operations attempted to perform the HPCS Pump monthly surveillance test to prove operability of the system. The HPCS Pump was aligned to take suction from the Condensate Storage Tank (CST) and pump thru the HPCS test return line back to the CST (See Figure 1). When the pump was started, the operator at the HPCS Pump noticed a waterleak from check valve F216. He immediately informed the control room operator of the leak and requested that the HPCS Pump be stopped. The control room operator, who had opened the F010 and F011 valves and established a flow of 5000 gpm, stopped the HPCS pump and closed the F010 and F011 valves.

A walkdown of the system piping was initiated to determine the cause for the leakage at valve F216. The walkdown revealed the top gasket of valve F216 leaking, possibly due to high pressure. Further inspection revealed valve F070 (at the CST) had a stem seal leak. The local position indicator for valve F070 indicated the valve was closed. The operator, who had verified the valve in the OPEN position prior to starting the HPCS Pump, was questioned about the discrepancy. He stated that when he went to valve F070 to verify the valve was open, he found the valve locked and the indicator showing closed. He notified the control room that the valve was indicating closed but there was an Information Tag (#821063) on the valve handle stating that the "Indicator May Indicate Incorrectly, Do Not Rely On Indicator Pointer". He unlocked the valve and attempted to OPEN the valve. The valve opened about 1/4 turn and stopped. He backed the valve off 1/4 turn and tried to open the valve again. The valve stopped at the same position. With the information tag stating not to rely on the position indicator and his inability to open the valve any further, the operator informed the control room operator that the valve was OPEN but indicated CLOSED.

After the HPCS Pump was shutdown and valve F070 discovered leaking, two operators using a lever arm opened valve F070. The valve had been closed as indicated by the position indicator when the HPCS pump was started.

The root causes of this event are attributed to the lack of adequate retest requirements by the Maintenance Work Order following the work on the F070 valve and improper valve position verification by the operator.

After valves F070 and F216 were found to be leaking, Maintenance Work Orders (MWO M2A695 and M2A696) were issued to correct the leaks. The F070 valve was replaced and the gaskets on F216 were replaced. In addition to the work orders issued, Operations initiated an Incident Report (82-10-07) documenting "An event happening out of the ordinary which is not a violation of plant operating procedures or Technical Specifications but is important for its historical significance or to prevent future incidents" (Section 5.1.1 and 5.2.4 of Administrative Procedure 01-S-06-5 "Incident Reports/Reportable Events"). This incident was not considered reportable because the section of piping involved was the HPCS Test Line and therefore the HPCS system was still operable.

Since the performance of the Maintenance Work Order on August 24, 1982, Technical Section Procedure "Control of Retest Requirements" (09-S-07-6) has been revised to give better guidance to Maintenance Planners on what type of activities require retests and what type of retest are required.

Pratt valves with this type of position indication problem have all been modified and the information tags removed. This is a final report.
