# Public Service Company of Colorado

November 10, 1982  
Fort St. Vrain  
Unit No. 1  
P-82515

REPORTABLE OCCURRENCE 82-042

REPORT NO. 50-267/82-042/03-L-0

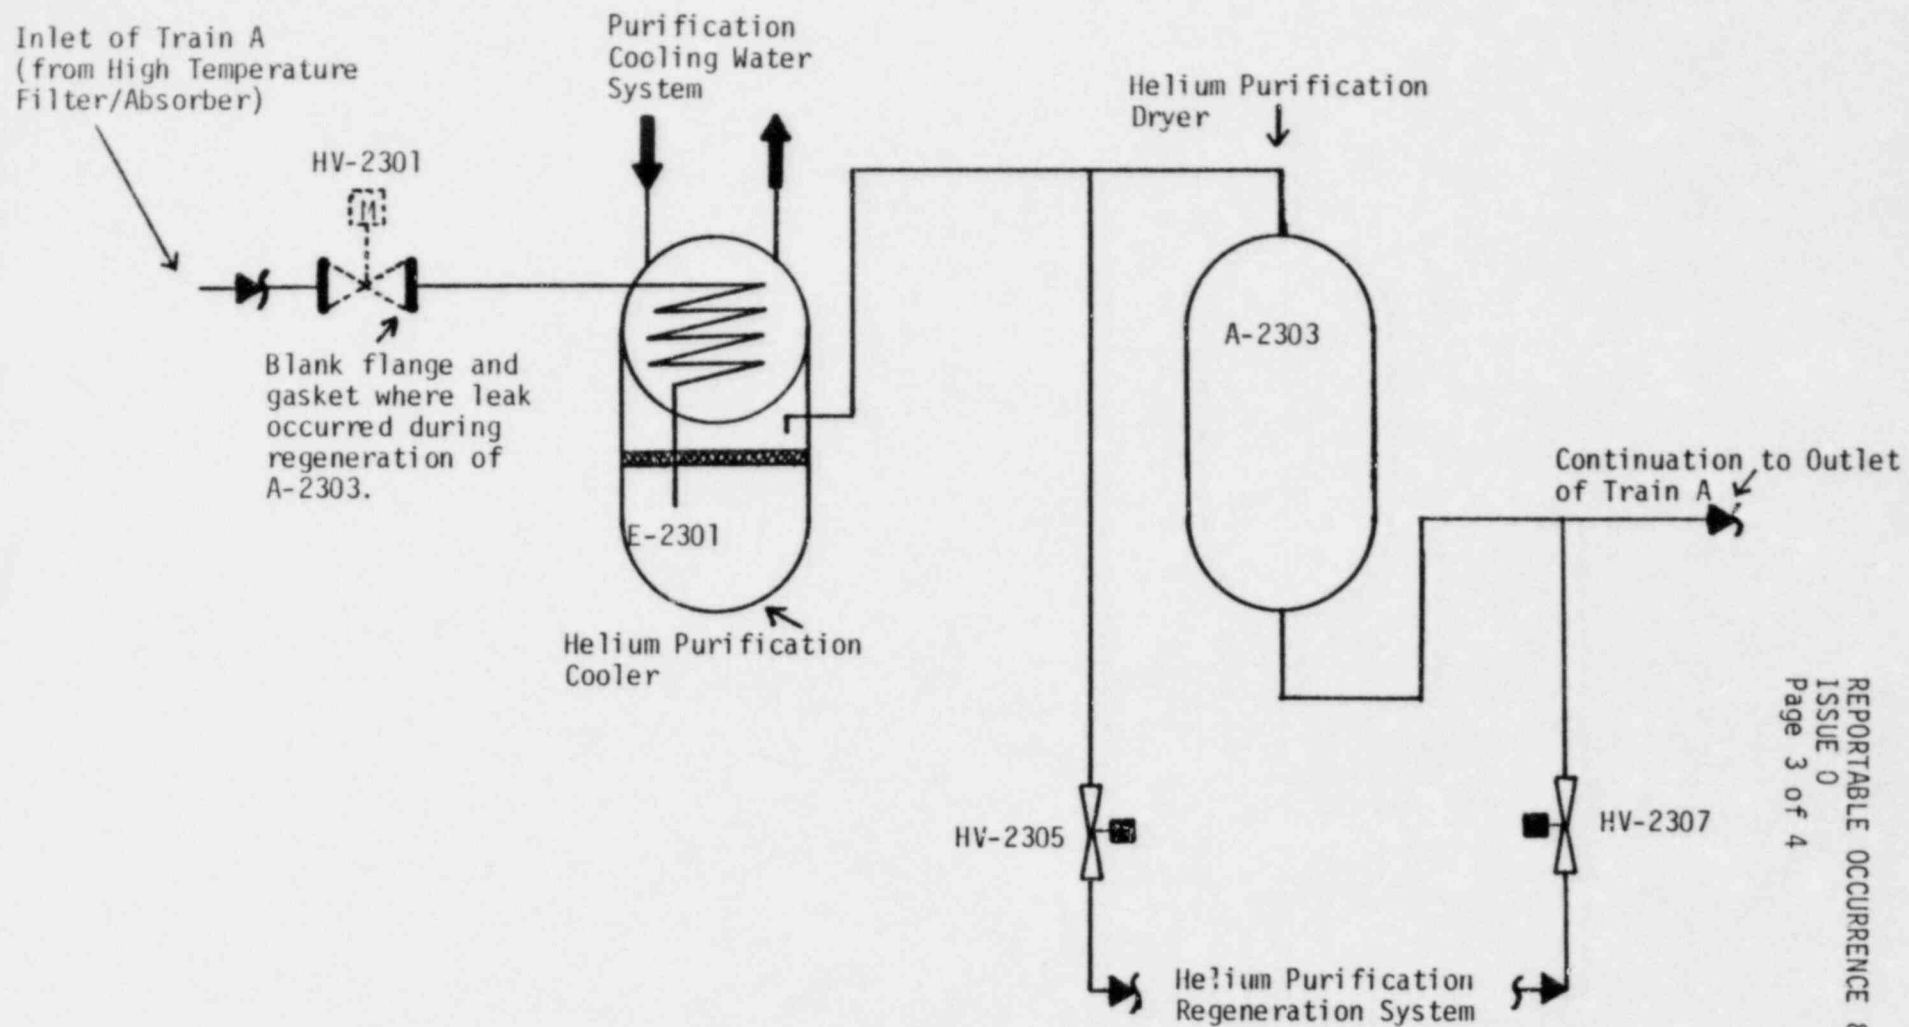
Figure 1: Simplified Section of Helium Purification System  
-Train A-

Upon investigation of the source of airborne gaseous activity, it was found that the blank flange (on the purification side of where HV-2301 was removed) had a leaking seal (See Figure 1). The source of activity was the helium being used to regenerate that purification train's dryer. During dryer regeneration, that particular flange was subjected to approximately 88 psig pressure.

The seal between a blank flange and the purification train "A", where HV-2301 was removed, failed. This failure allowed helium being used to regenerate the train's dryer to escape to the Reactor Building. The associated activity was then exhausted via the filtered Reactor Building exhaust stack to the atmosphere.

When accessible, a new seal was installed on the blank flange which was found to be leaking. The associated secondary cover was replaced on the well where HV-2301 is normally located, until the valve could be re-installed in the system.
