SUBJECT: DOCKET NO. 50-333  
LICENSEE EVENT REPORT: 90-025-01  
Service Water Check Valves

## LICENSEE EVENT REPORT (LER)

Updated Voluntary Report - Previous Report Date 12/17/90

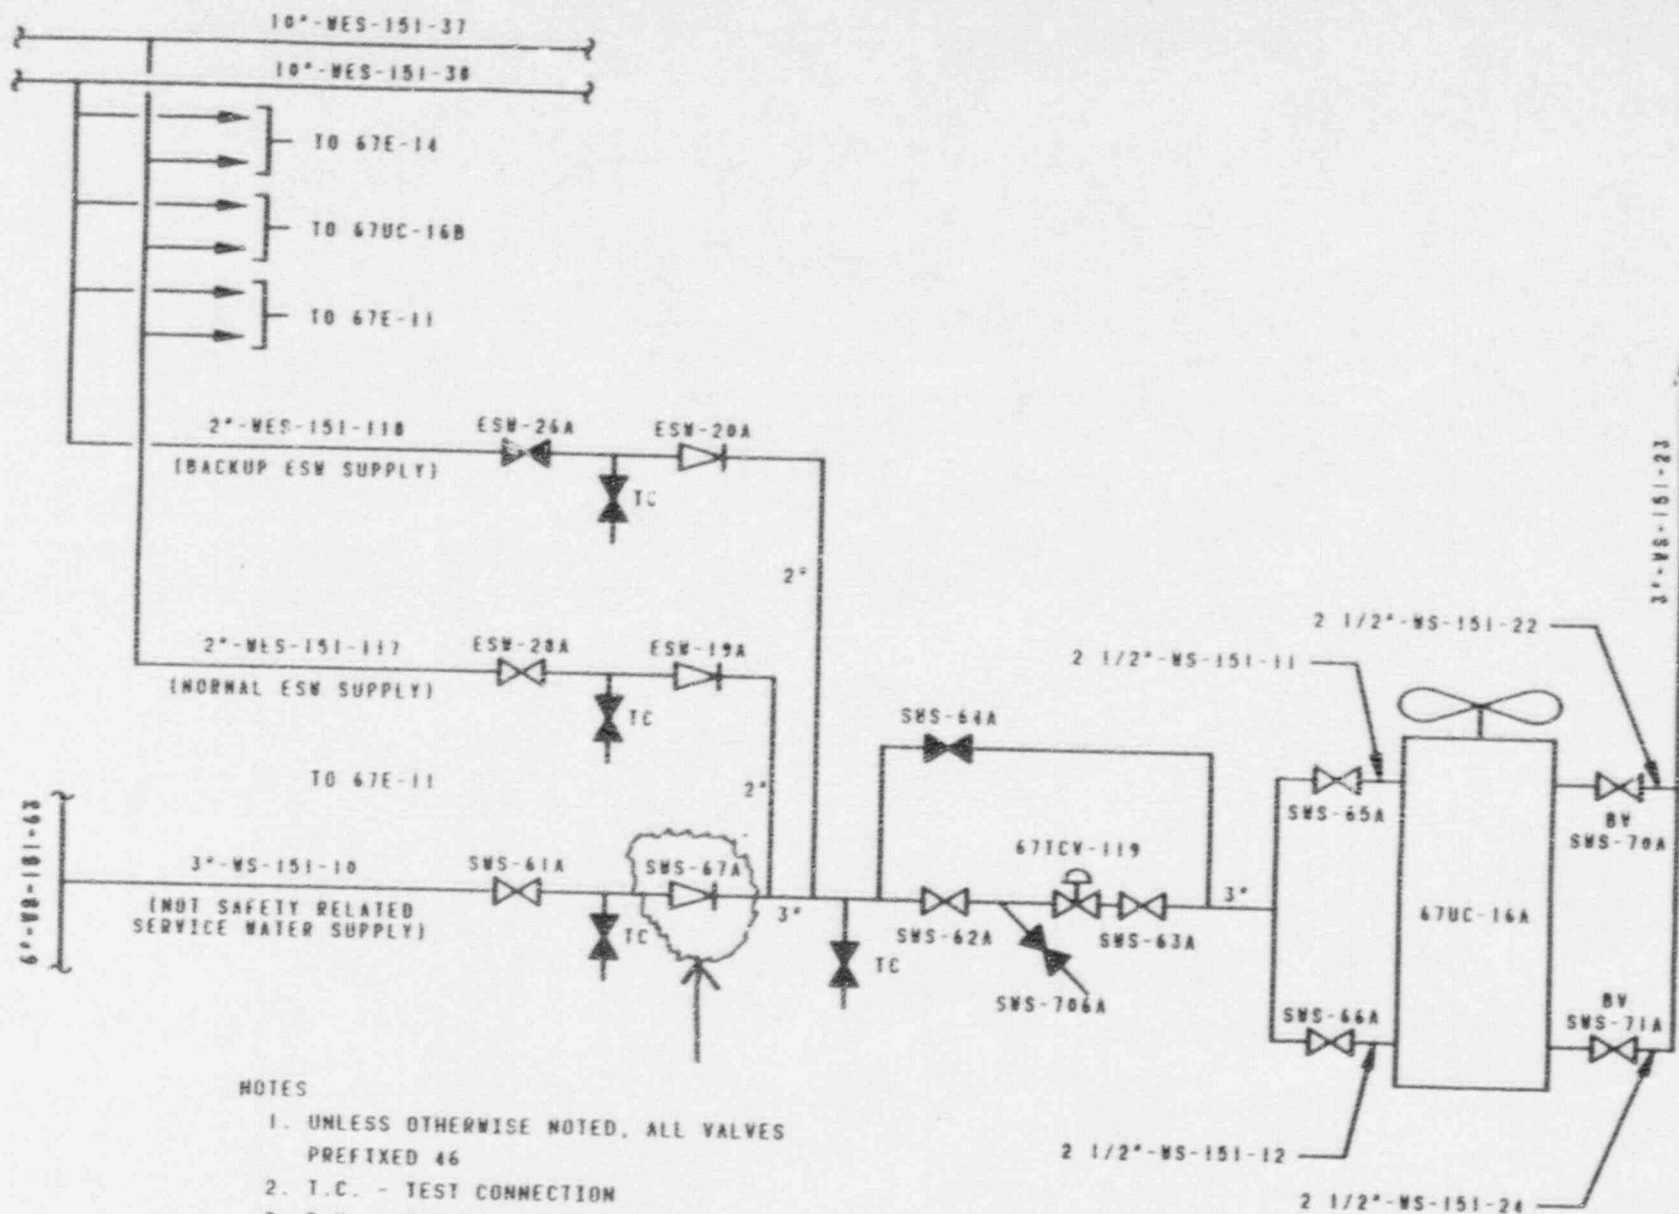
Figure 1 to  
LER 90-025-01  
Docket No. 50-333

Flow diagrams showing the SWS and ESW supply to each heat exchangers are attached as Figures 1 through 4. The tube side of each heat exchanger is normally provided with service water from a 3-inch line that branches off the SWS main header. Teeing into this line, just downstream of the 3-inch swing check valves (which failed to close in this event), are two 2-inch ESW supply lines. One of these supply lines is normally valved-in and is considered safety-related. The other line is normally valved-out and is not safety-related.

ELECTRIC BAY UNIT COOLERS  
67UC-16A

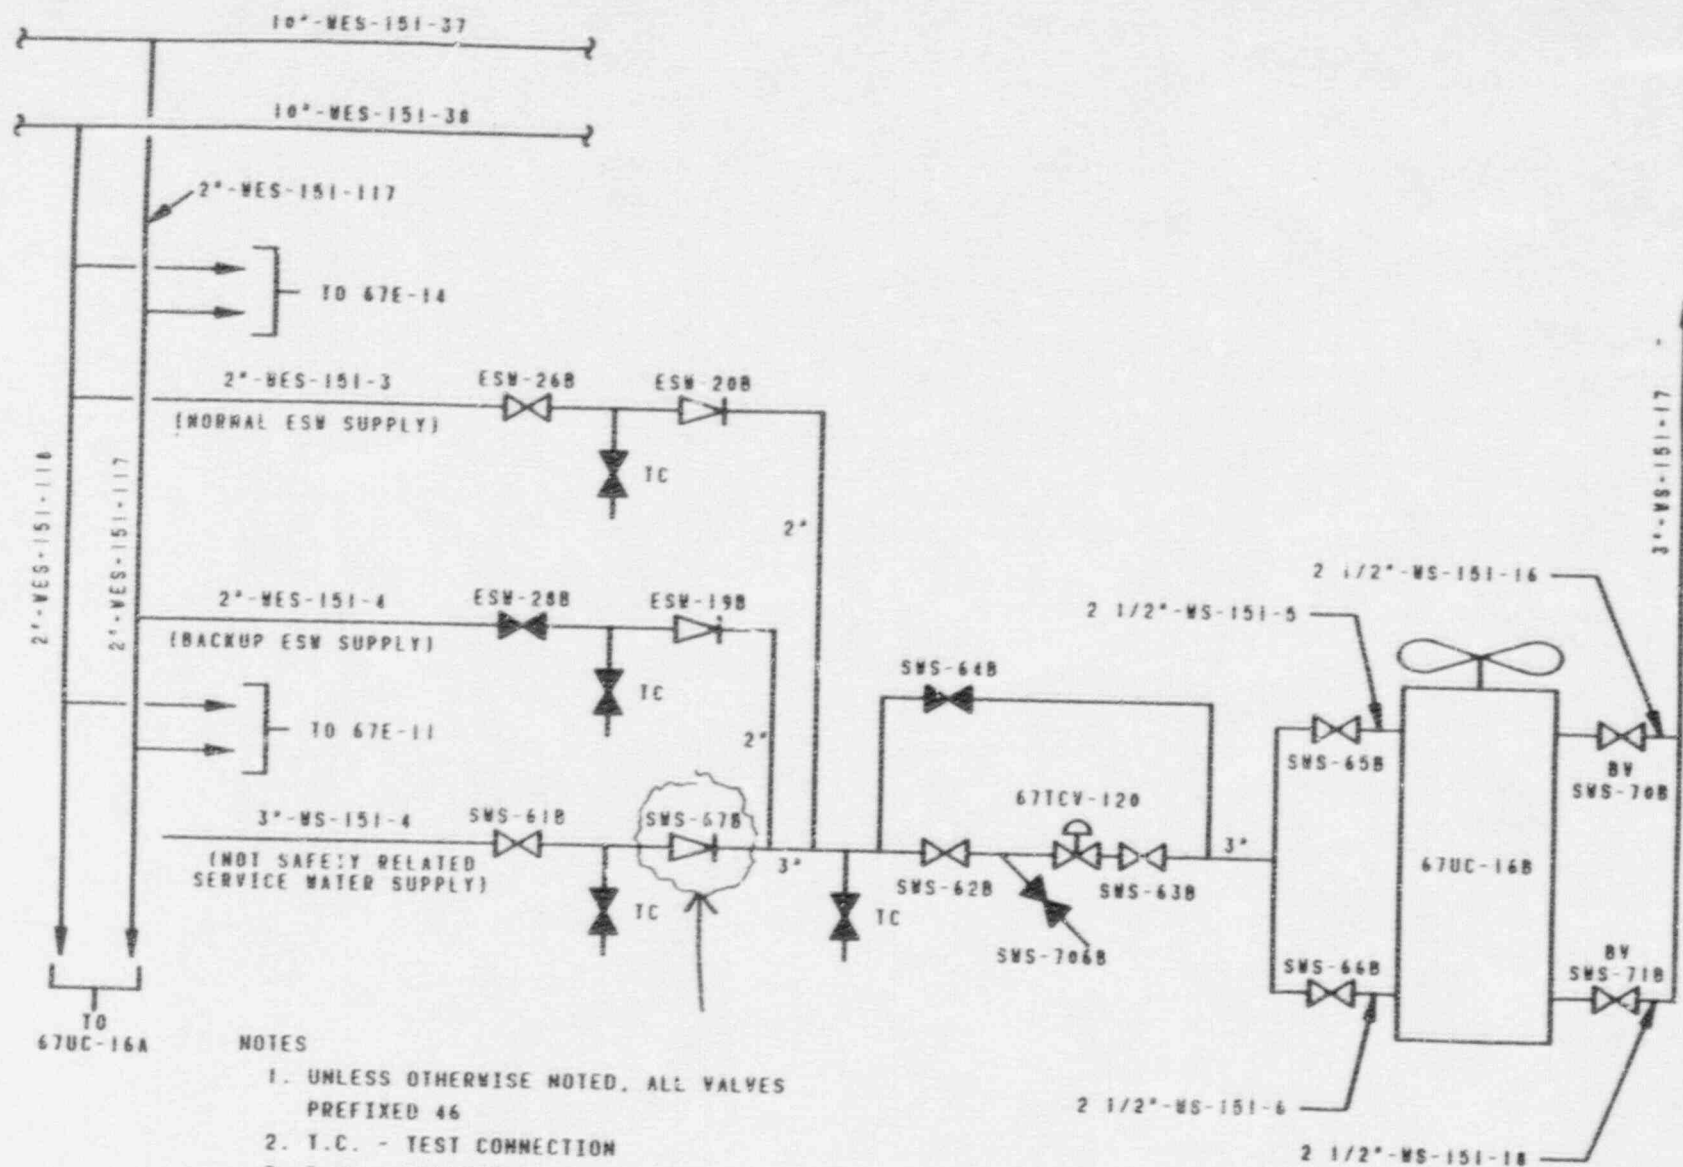
Figure 2 to  
LER 90-025-01  
Docket No. 50-333

ELECTRIC BAY UNIT COOLERS

67UC-16B

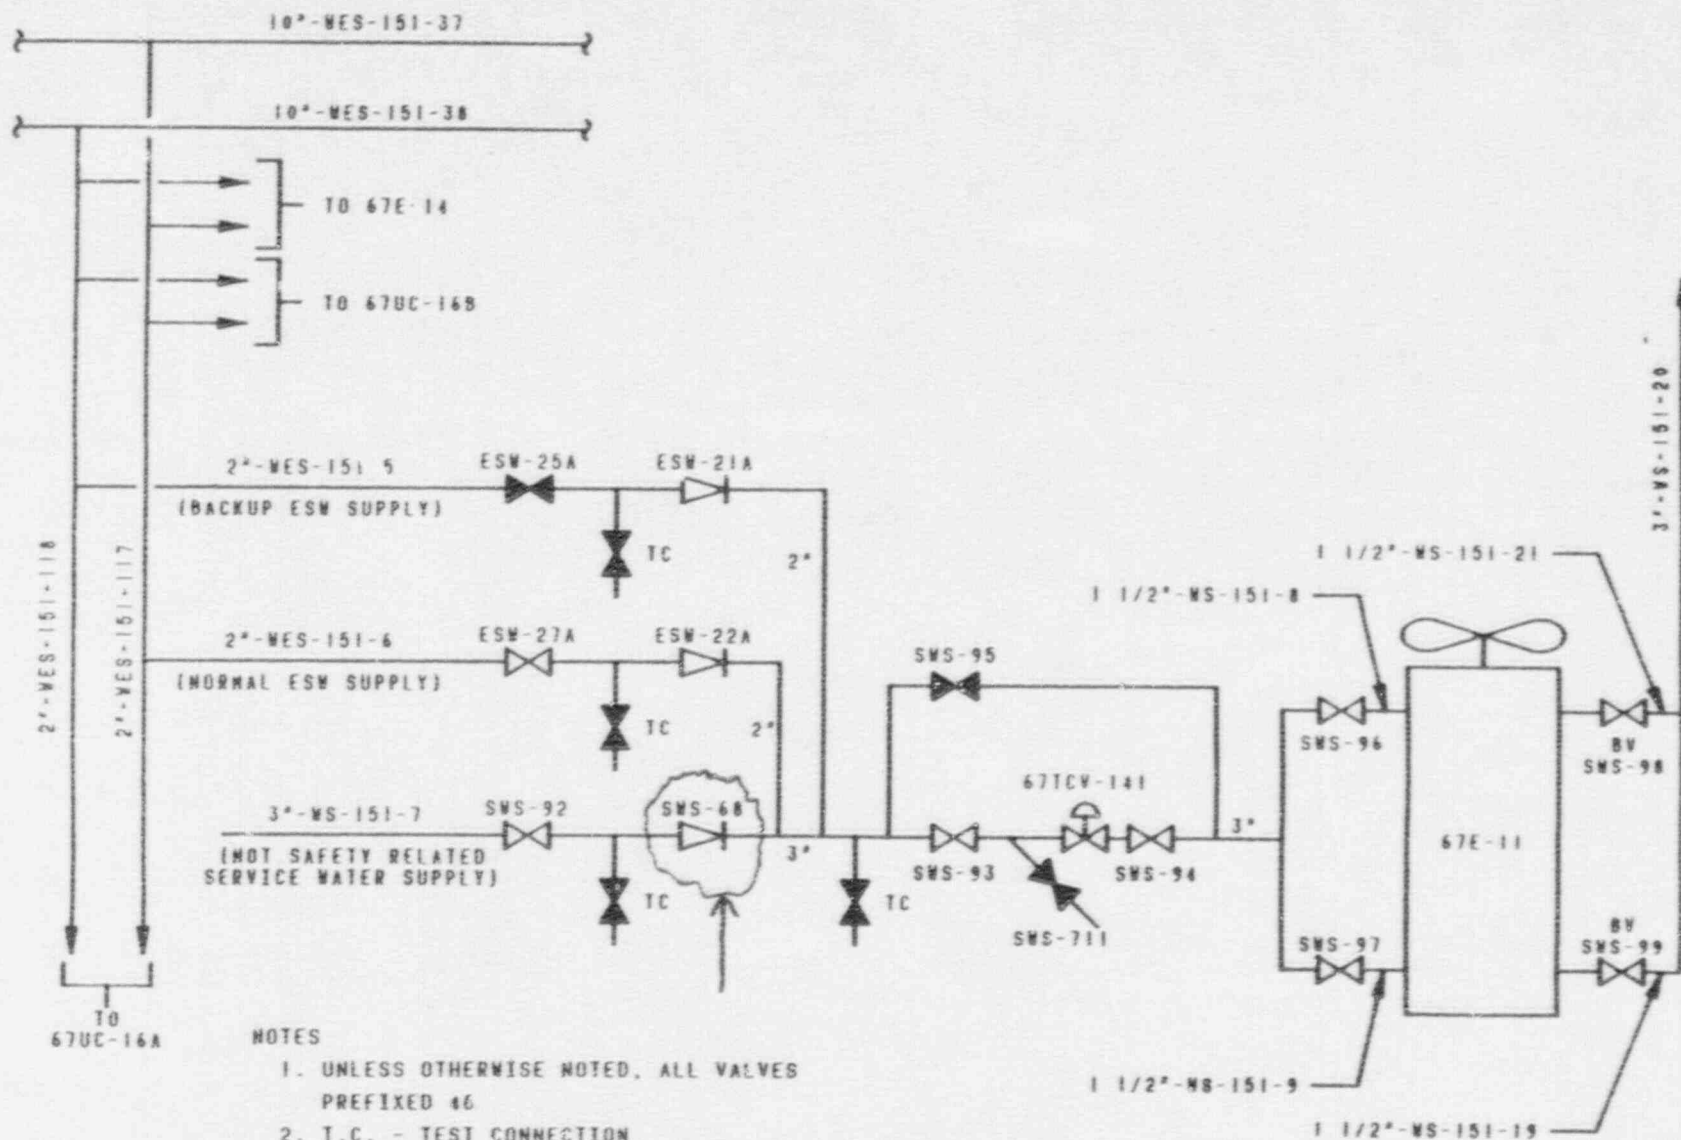
Figure 3 to  
LER 90-025-01  
Docket No. 50-333

## CABLE TUNNEL/SWITCHGEAR ROOM COOLER

67E-11

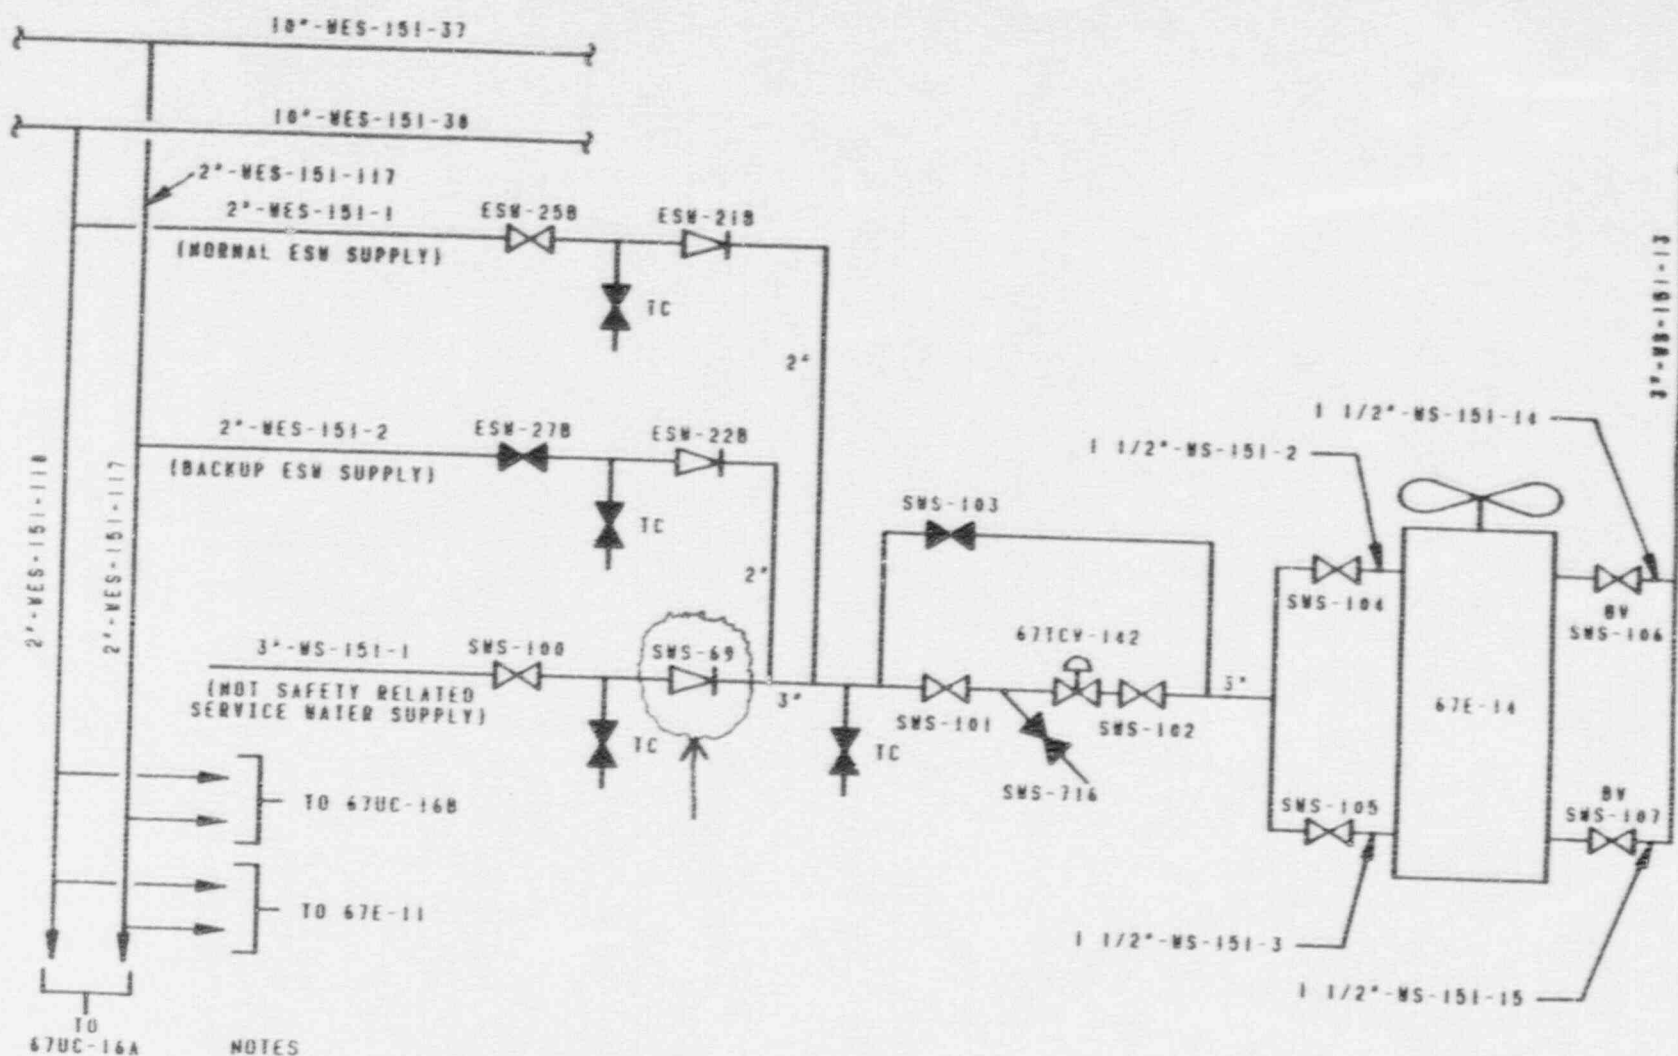
Figure 4 to  
LER 90-025-01  
Docket No. 50-333

CABLE TUNNEL/SWITCHGEAR ROOM COOLER

67E-14

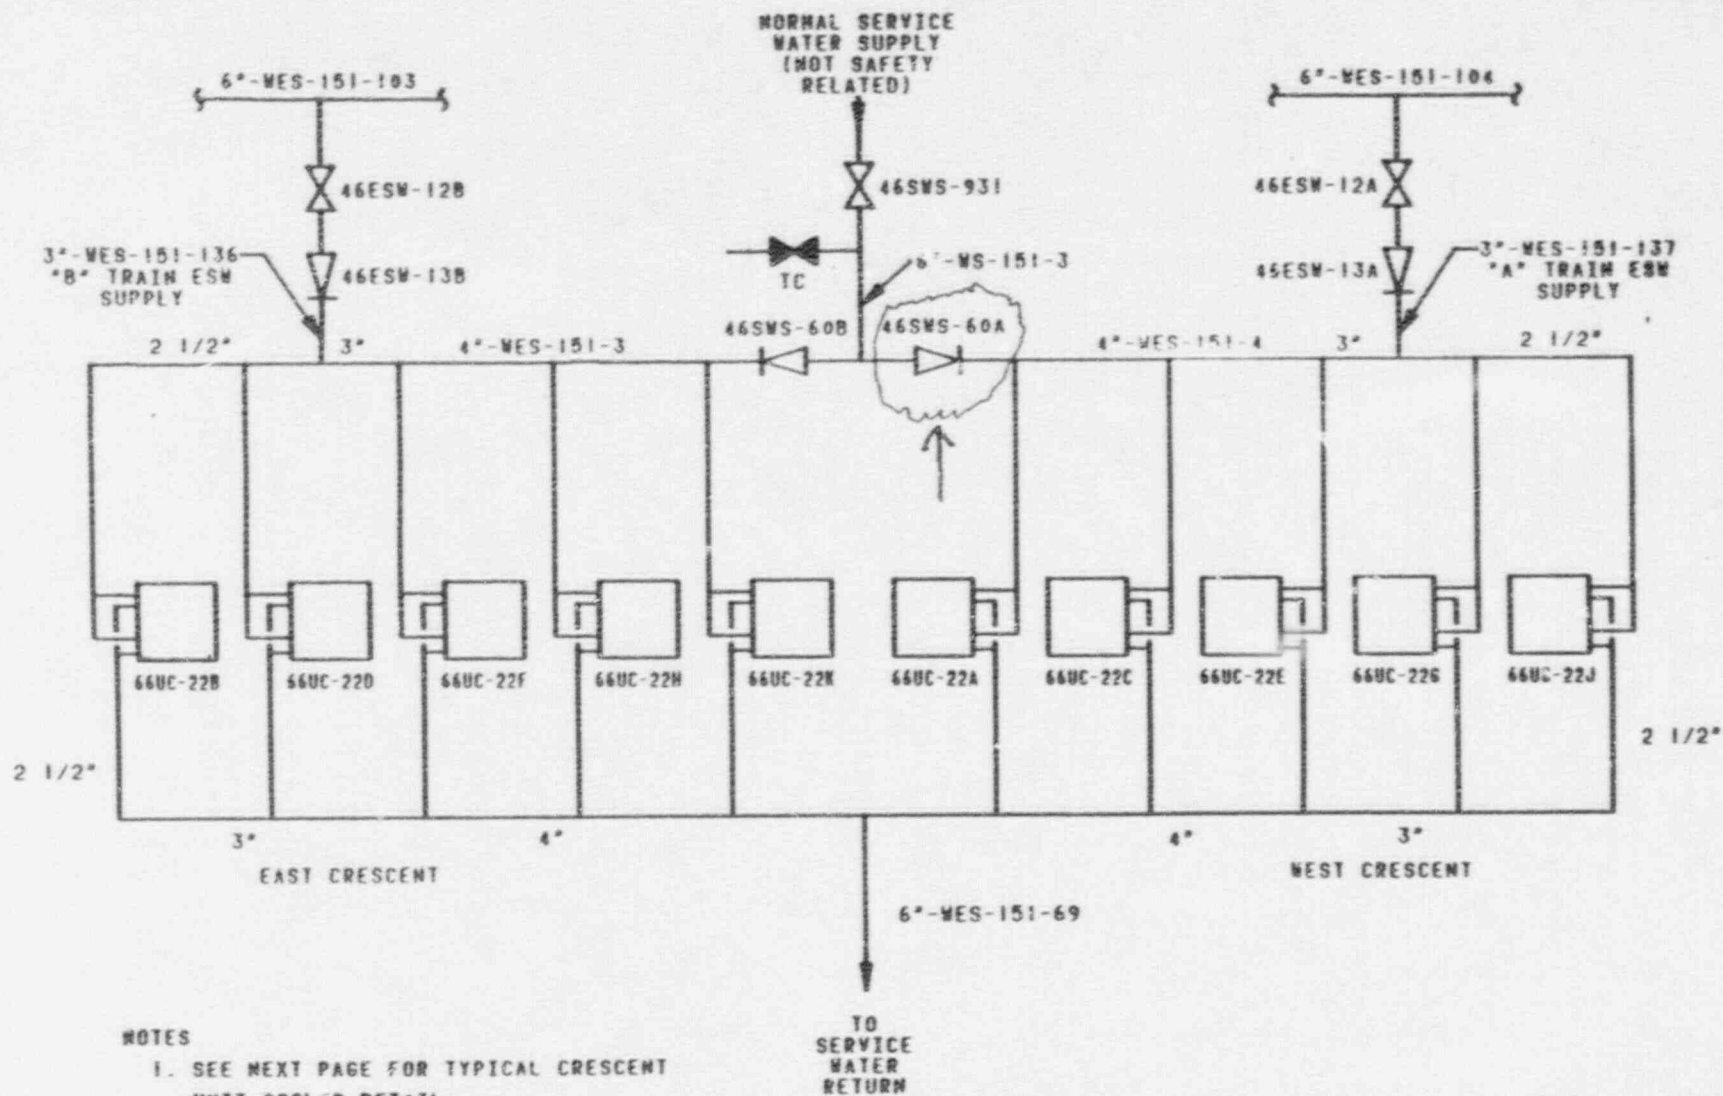
The crescent area unit cooler heat exchangers provide cooling for portions of the emergency core cooling system (ECCS) (BJ, BM, BN, BO) equipment located in the reactor building west crescent (Safety Division 1) (see Figure 5).

(1 per division). The 4-inch header contains the 4-inch swing check valve (46SWS-60A) which initially failed to close under test conditions. Downstream of this valve the header has five tee connections into 2-1/2-inch supply lines to each cooler. The ESW supply also ties into the same header downstream of the failed check valve. Upon initiation of the ESW, the service water check valve 46SWS-60A is designed to close to prevent diversion of ESW from the unit coolers.

## CRESCENT UNIT COOLERS
