MONTICELLO NUCLEAR GENERATING PLANT
Docket No. 50-263 License No. DPR-22

Instantaneous Trip of 480 VAC MCCBs Do Not Meet
Acceptance Criteria Due to Manufacturer's Design

LICENSEE EVENT REPORT (LER)

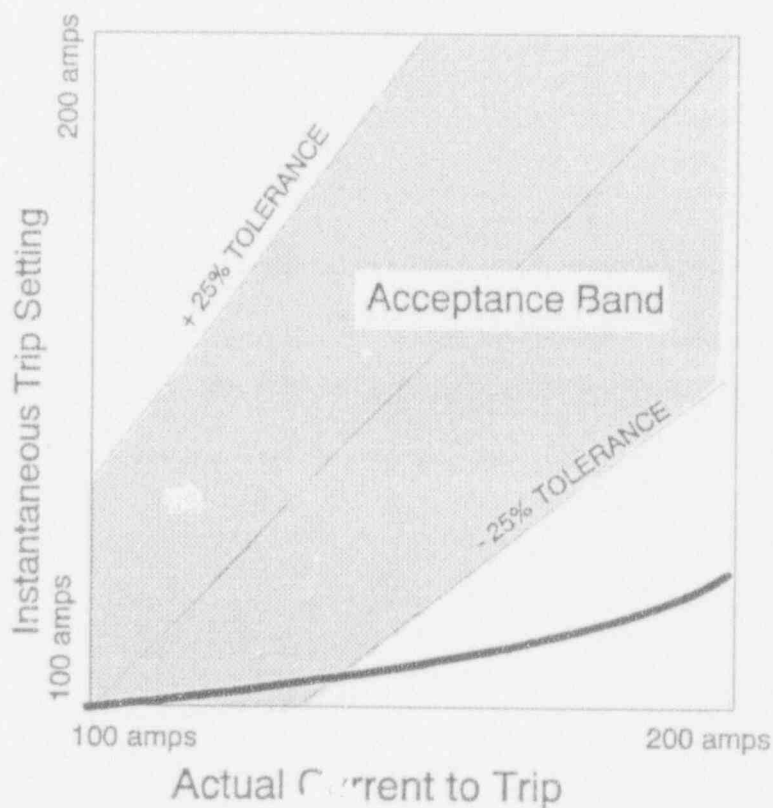
Instantaneous Trip Setting vs Actual Current to Trip

During subsequent testing of the instantaneous trip, breakers were found to deviate from the trip setpoint at higher settings. The deviation was small for low set points and increased as the setpoint was increased (See attached Figure). The results were consistent for each pole (phase) tested. Spare breakers of the same model number were tested; all of which produced nearly identical results. Two additional Klockner Moeller molded case circuit breaker models (including a breaker procured in 1993) were tested and exhibited similar characteristics. These other models, however, were not outside of allowed tolerances. The testing was performed by experienced plant electricians in accordance with the requirements of UL (Underwriters Laboratory) Standard 489. The results were confirmed by an independent testing laboratory.

The primary cause of this event is believed to be the design of the molded case circuit breaker. All Klockner Moeller 480 VAC molded case circuit breakers exhibited the trend shown in the attached figure. The trend was consistent between phases, models and manufacturing period. Breakers manufactured by others did not exhibit this trend. The issue identified does not appear to be the result of degrading equipment. Breakers procured in 1993 exhibited similar characteristics to those procured in 1982. Test data taken in 1982 appears to correspond to current data. Test results were very consistent from pole to pole and from breaker to breaker. These facts lead to the conclusion that age is not a cause of this characteristic.

The discrepancy identified exists only where the instantaneous setpoint is set above the minimum setting. At settings greater than minimum, the trip would occur at currents below the setting. The primary concern of breakers tripping early (at a lower current than desired) is the resultant loss of equipment when no fault or electrical problem exists, for example, during a pump start. Therefore, a review was conducted of those Klockner Moeller molded case circuit breakers with the instantaneous trip setpoints greater than minimum. In all cases, sufficient margin exists above requirements to ensure successful load operation even with the setpoint at minimum. Motor starting, reduced voltage conditions, and fuse/breaker coordination were all considered.

- 1) The industry was informed of this event via Nuclear Network.
- 2) Klockner Moeller was informed of this issue and a breaker was shipped to them for testing.
- 3) An independent laboratory has confirmed our test results on a Model ZM6-33-200.oBi-CNA breaker.
- 4) The preventative maintenance procedure for the 480 VAC molded case circuit breakers was revised for further clarification for testing the instantaneous trip.
