April 22, 1994

SUBJECT: Calvert Cliffs Nuclear Power Plant
Unit No. 1; Docket No. 50-317; License No. DPR 53
Licensee Event Report 94-004
Excessive Corrosion of Incore Instrumentation Flange
Components

TITLE (4)
Excessive Corrosion of Incore Instrumentation Flange Components

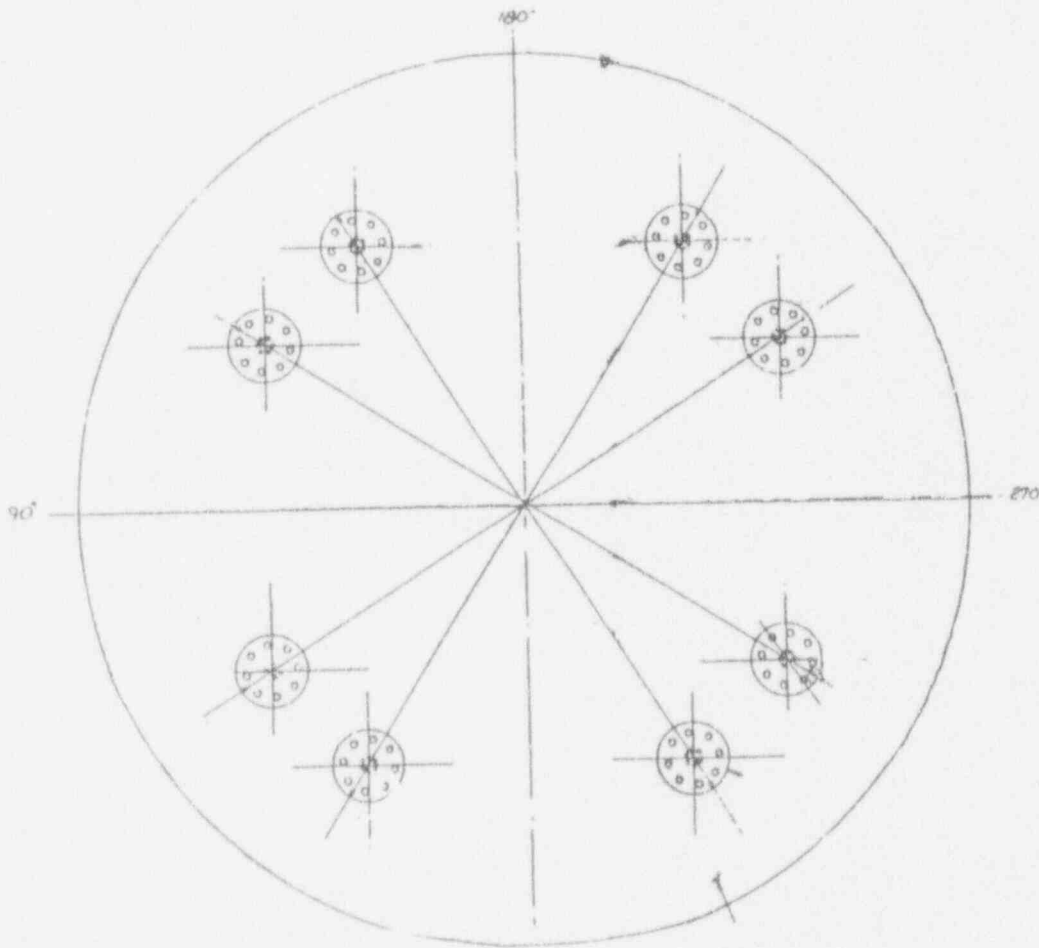
FIGURE 1

On February 21, 1994 during a refueling shutdown inspection of the Unit 1 reactor vessel head area, we discovered higher than anticipated corrosion of three nuts on one of the Incore Instrumentation (ICI) flanges. One nut had failed and two adjacent nuts were significantly corroded but had not failed. The corrosion was caused by reactor coolant leakage past the ICI detector joint assembly, leading to a build-up of concentrated boric acid on flange components.

PLAN VIEW INDICATING LOCATION AND ORIENTATION
OF ICI FLANGES ON PRESSURE VESSEL CLOSURE HEAD

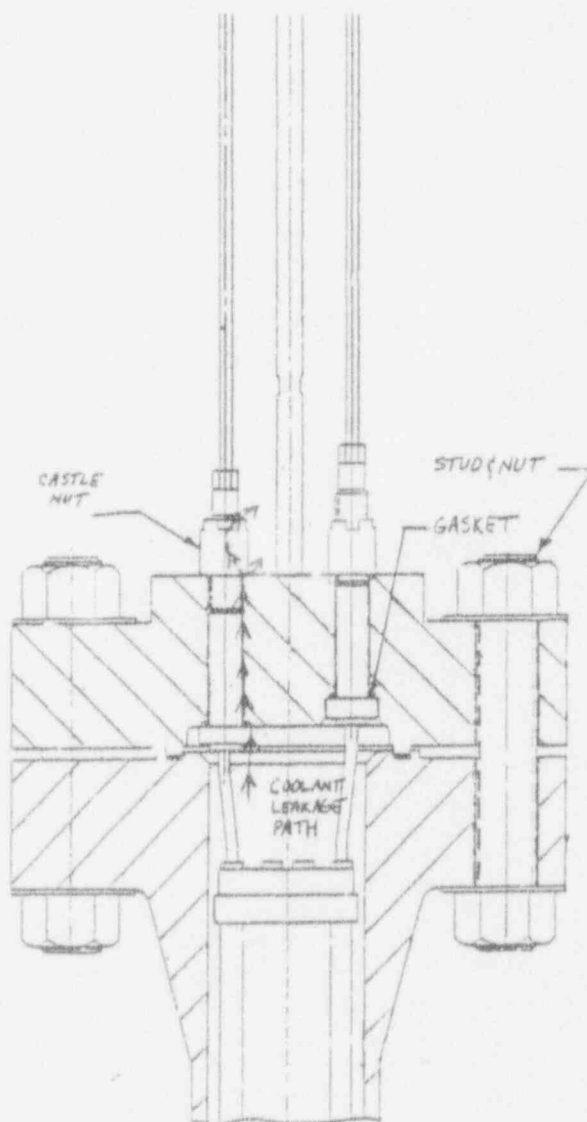
FIGURE 2

The apparent cause of the event was an increased presence of wet boric acid rather than dry boric acid on a few of the affected ICI flange stud nuts. In deciding in 1993 to defer repairs, we assumed that the high temperature of the vessel head components would result in rapid evaporation of moisture from the leaking coolant, leaving predominantly dry boric acid. This was consistent with the observed results of leakage on Unit 2. We therefore used an expected corrosion rate of 1.6 mils per month to support the evaluations discussed above. A root cause analysis to determine the reasons for the increased presence of wet boric acid is in progress. A supplement to this Licensee Event Report (LER) will be submitted when this analysis is complete.

Each of the eight ICI flange assemblies consists of an upper and lower half secured together with eight 13 inch long 1-3/4 inch diameter studs secured by a 1-3/4 inch heavy hex nut (see Figures). The nuts are made of ASTM A 194 Grade 2H carbon steel and the studs are made of ASTM A 193 Grade B7 carbon steel. In this specific case, three adjacent studs were degraded: one was failed, and two were significantly corroded. An engineering analysis performed by the reactor vendor conservatively demonstrated that three adjacent studs would have to be completely failed and a fourth severely degraded in order to result in a partial failure accompanied by slight rotation of the joint. The analysis further concluded that if a loss of three adjacent studs and consequent joint rotation were to occur, it would most likely occur such that gross leakage would be apparent for some time prior to catastrophic failure and thus alert operators of the condition in time to take mitigating action. In the unlikely event of catastrophic joint failure, the effects would be bounded by the Calvert Cliffs loss-of-coolant accident analyses.

ICI FLANGE ASSEMBLY

Corrective action for the ICI flange leakage problem was to implement the modification discussed above. The modification was implemented on Unit 2 in 1993 and thus far we have observed no evidence of further leakage on that unit. In December, 1993, we performed a mock-up test that validated the new design. The modification was implemented on Unit 1 during the present outage. We are conducting a root cause analysis to determine the cause of the increased presence of wet boric acid and to ascertain lessons to be incorporated into our engineering decision process with respect to boric acid leakage. The results of this analysis will be reported in a supplement to this LER.
