MONTICELLO NUCLEAR GENERATING PLANT
Docket No. 50-263 License No. DPR-22

Crack on Jet Pump Riser Brace Due to Fatigue

LICENSEE EVENT REPORT (LER)

89-21

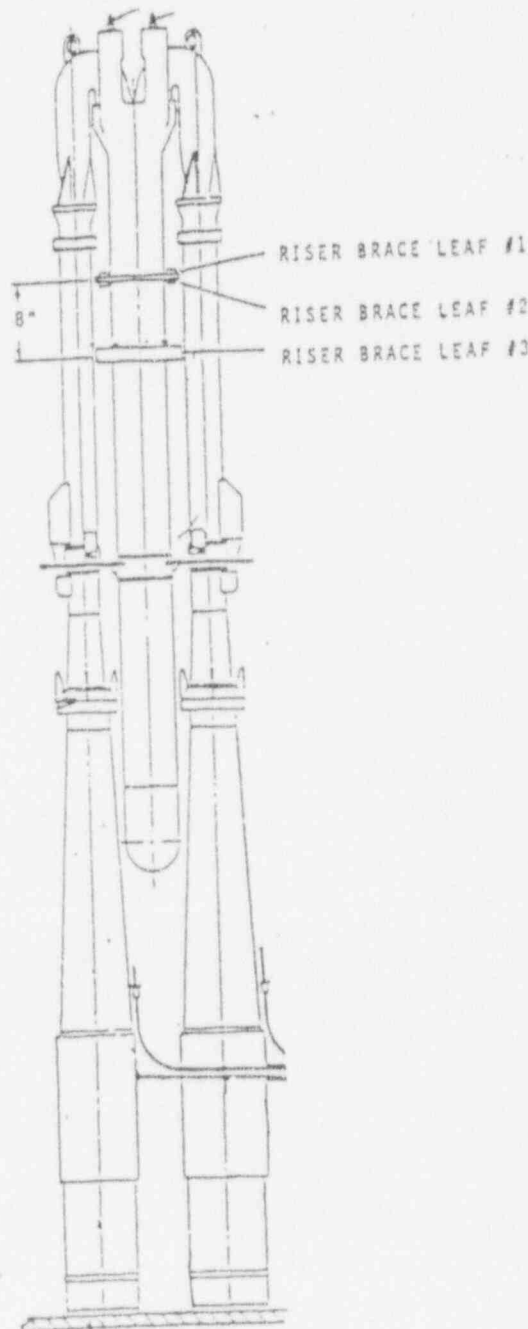
Figure 1. Jet Pump Assembly

The lower riser brace leaf (Leaf #3 in Figure 1) has a calculated natural frequency of 358 Hz, which is well removed from resonant conditions. Therefore resonance is not expected to occur at the lower brace. Evaluation of normal and accident jet pump loading indicates that stresses with only the lower brace in place are within acceptable limits. This shows that the loss of the entire upper brace would not affect the operability of the risers or the associated jet pumps.

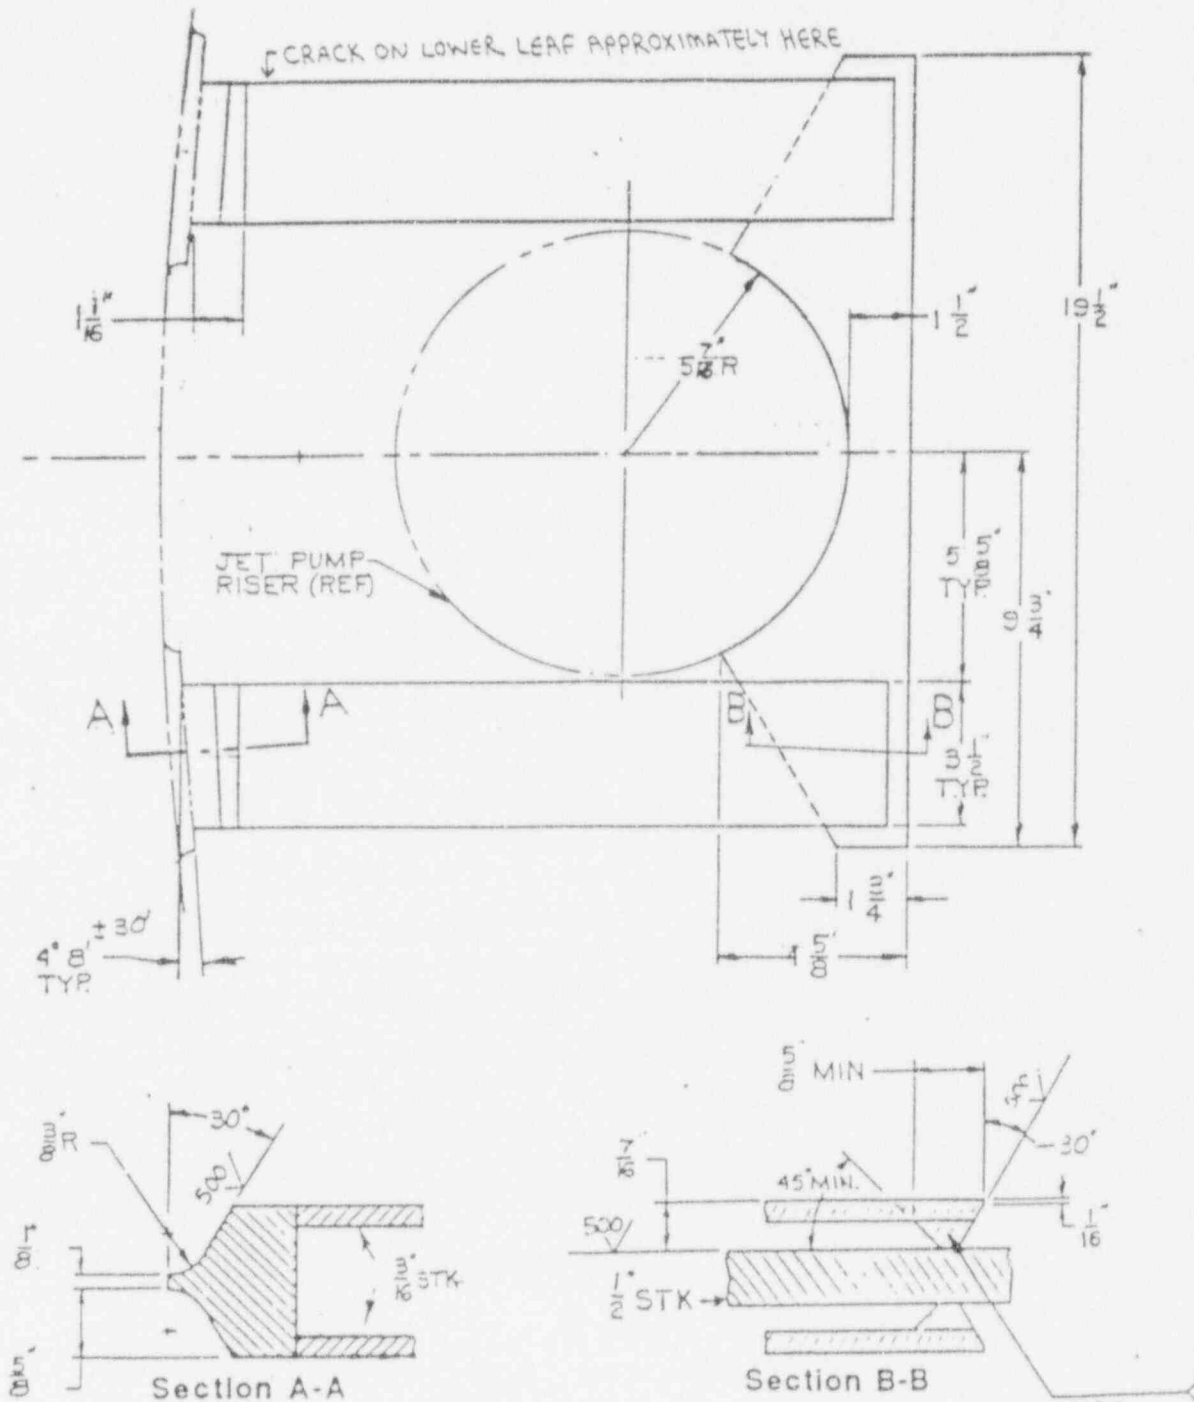
Figure 2. Upper Jet Pump Riser Brace

The crack is located on the lower leaf on the right side (facing out from the vessel centerline) of the upper support brace on the riser for jet pumps #7 and #8. The crack indication runs about 3/4 of the way across the top of the leaf about 1/2" from the point where it is welded to the vessel wall.

The risers are supported by an upper brace which consists of two leaves on each side of the riser and a lower brace which consists of one thicker leaf. All remaining leaves on this riser and the 9 other risers in the vessel were examined during the 1989 refueling outage with no other indications found. Subsequent re-examinations during the 1991 and 1993 refueling outages revealed no additional cracking of these components of the subject jet pump or any other jet pump.

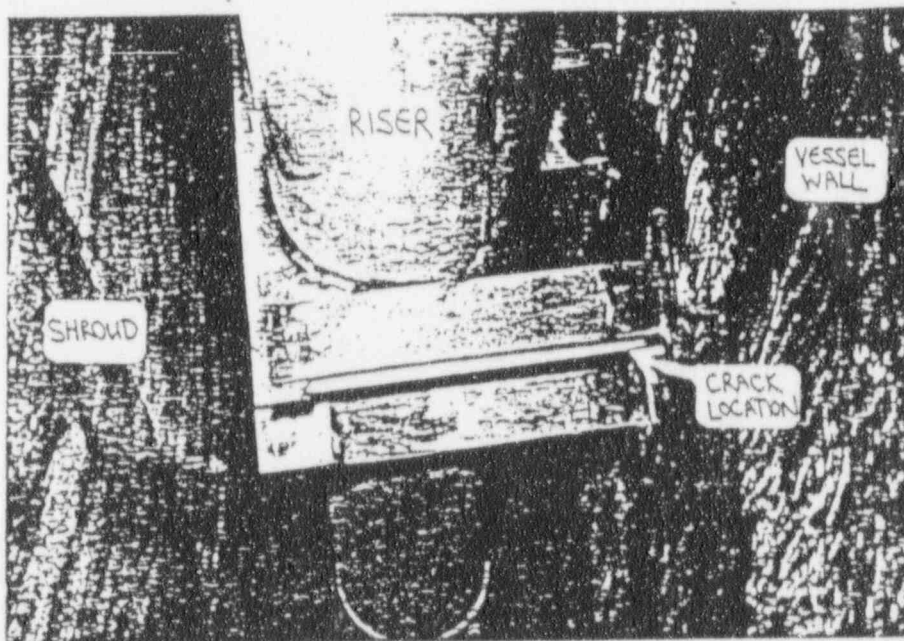
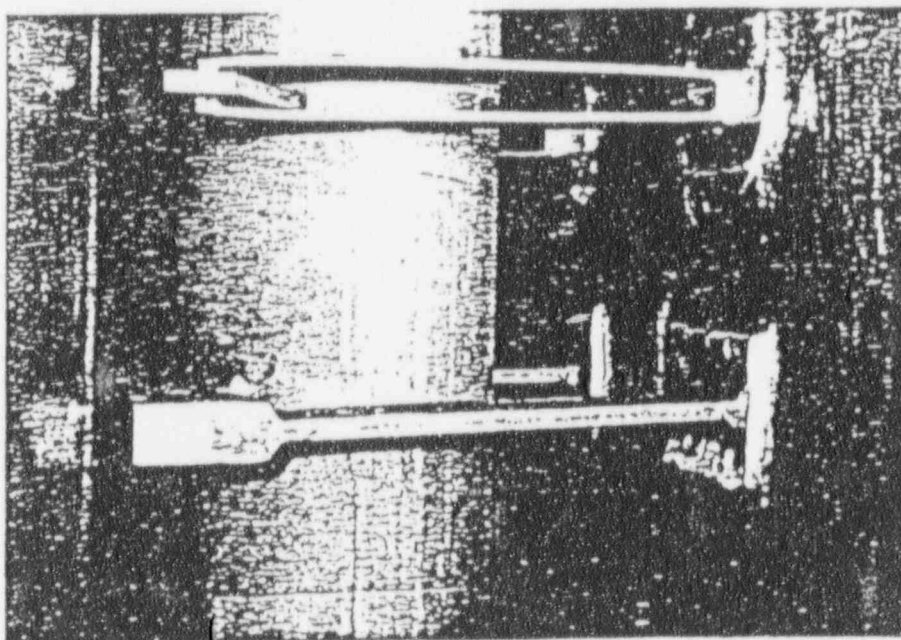
Figure 3. Construction Photos of Riser Braces

Visual inspections indicate that the cracked lower leaf has some cross-sectional reduction (thinning) which may have been caused by grinding performed during weld fit-up. This thinning is unique to this riser brace leaf and appears to have reduced the cross-sectional area by about 30%. It also appears that there is some lack of fusion in the weld at the point on the leaf where the crack initiated. These factors, thinning, work hardening from grinding and lack of weld fusion, may have contributed to the cracking of this riser leaf by making it more susceptible to any of the possible crack initiating mechanisms (i.e. resonance, IGSCC, ductile tearing).

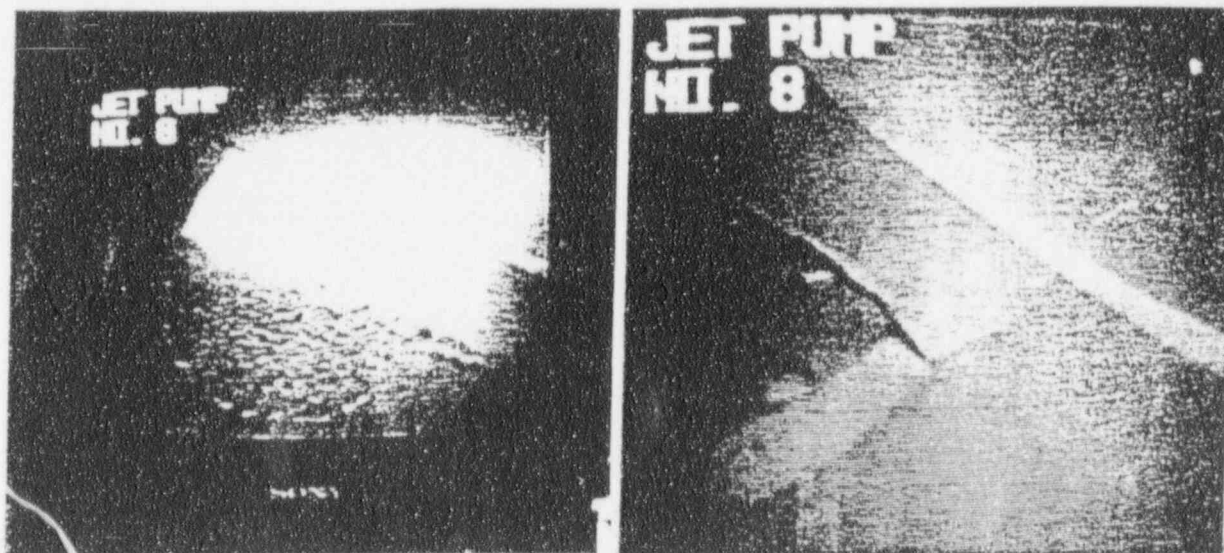
Figure 4. Top View of Cracked Leaf

A study was originally performed in 1989 to determine the cause of the cracking. The results of that study indicated that the most likely cause of this crack was high cycle fatigue. The natural frequency of the riser brace in its uncracked state coincided with the vane passing frequency of the reactor recirculation pumps (AD) at a speed in the range of 92% to 98% (127 Hz to 135 Hz). The subsequent experimental program carried out at the General Electric facilities in San Jose, California confirmed cycle fatigue as the most plausible cause of the observed cracking. The resonant frequency of the riser brace was determined by this program to be 116.4 Hz based on nominal dimensions of the riser brace leaves and that the actual riser brace frequency varies as a strong function of the riser brace leaf as-built dimensions (thickness and length) and axial loading of the brace. Based on just the allowed thickness tolerance of the riser brace leaf, the most important resonant frequency could actually lie anywhere within a wide range of 108.5 to 152.20 Hz (78% to 109% recirculation pump speed).

The as-clad weld surface of the vessel has an additional weld pad buildup at these locations and riser braces are then welded to the pad. The crack is entirely within the base-metal of the brace, follows the toe of the weld and has no indications of branching. This is indicative of fatigue cracking and not IGSCC. Crack propagation into the weld metal by fatigue is highly unlikely because of geometry and the nature of the stress loading. Propagation into the weld metal by IGSCC is unlikely because of the greater weld metal resistance to IGSCC.

Considering that the recirculation pump speed cannot practically be limited to avoid resonant frequencies, and the conclusions of the test program, the limitation on recirculation pump speed has been removed.

These riser brace leaves will continue to be inspected during refueling outages in accordance with the Monticello Inservice Inspection Program.

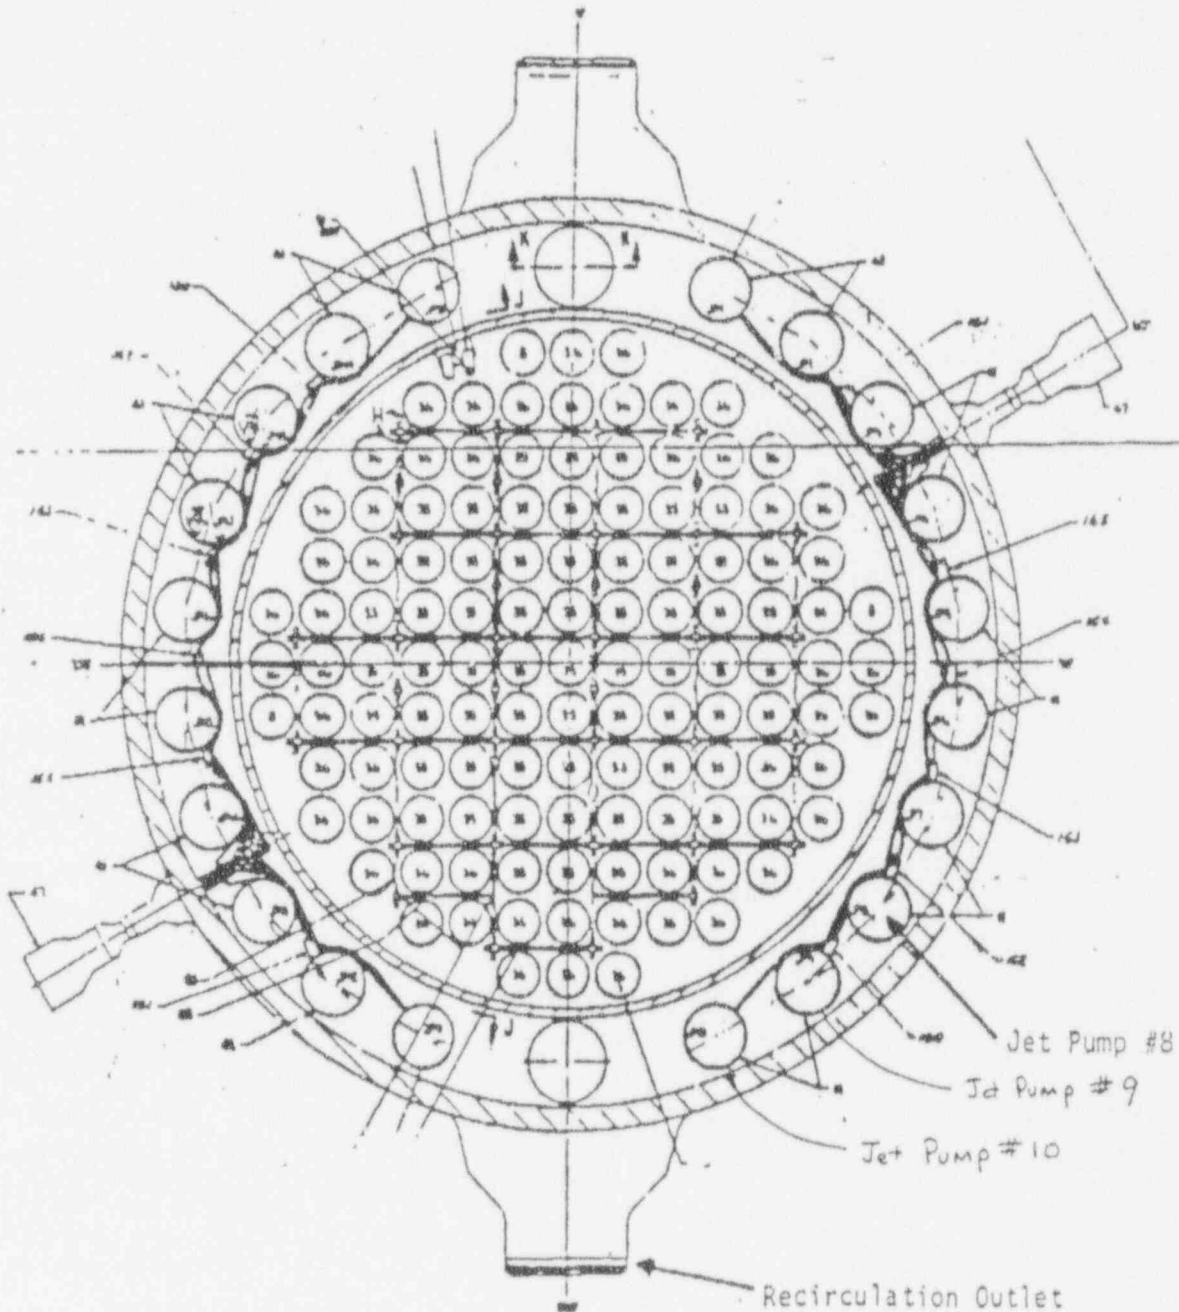
that the riser brace leaf is shielded from the recirculation inlet nozzle by jet pumps #8, #9 and #10 (See Figure 6) making it unlikely that it could be entrained by the recirculation suction flow during its fall to the bottom of the shroud annulus region. As the part is not expected to migrate to the core region via the recirculation loop flow, there is a negligible potential for fuel bundle flow blockage and subsequent fuel damage. For the same reason, there is virtually no potential for interference with control rod drive operation. However, if the jet pump riser brace directly above the recirculation loop suction nozzle is assumed to fail, the riser brace leaf may be carried into the recirculation piping due to suction flow. The following paragraphs describe the potential consequences of a loose part migrating to other portions of the recirculation system and reactor vessel.
