**Florida  
Power**  
CORPORATION  
Crystal River Unit 3  
Docket No. 60-302

Subject: Licensee Event Report (LER) 93-008-01

FACILITY NAME (1) CRYSTAL RIVER UNIT 3 (CR-3)										DOCKET NUMBER (2) 0 5 0 0 0 3 0 2				PAGE (3) 1 OF 0 7										
TITLE (4) Due to a Lack of Engineering Review, Motor Operated Valves With Brakes Could Fail to Perform Their Safety Function Under Degraded Voltage Conditions																								
EVENT DATE (5)			LER NUMBER (6)				REPORT DATE (7)			OTHER FACILITIES INVOLVED (8)														
MONTH	DAY	YEAR	YEAR	SEQUENTIAL NUMBER	REVISION NUMBER	MONTH	DAY	YEAR	FACILITY NAMES N/A			DOCKET NUMBER(S) 0 5 0 0 0												
0	7	0	6	9	3	9	3	0	0	8	0	1	0	5	1	2	9	4	N/A	0	5	0	0	0
OPERATING MODE (9)		THIS REPORT IS SUBMITTED PURSUANT TO THE REQUIREMENTS OF 10 CFR §: (CHECK ONE OR MORE OF THE FOLLOWING) (11)																						
1		20.402(b)				20.405(c)				50.73(a)(2)(iv)				73.71(b)										
POWER LEVEL (10)		20.405(a)(1)(i)				50.36(c)(1)				50.73(a)(2)(v)				73.71(c)										
1		20.405(a)(1)(ii)				50.36(c)(2)				50.73(a)(2)(vii)				OTHER (Specify in Abstract below and in Text, NRC Form 366A)

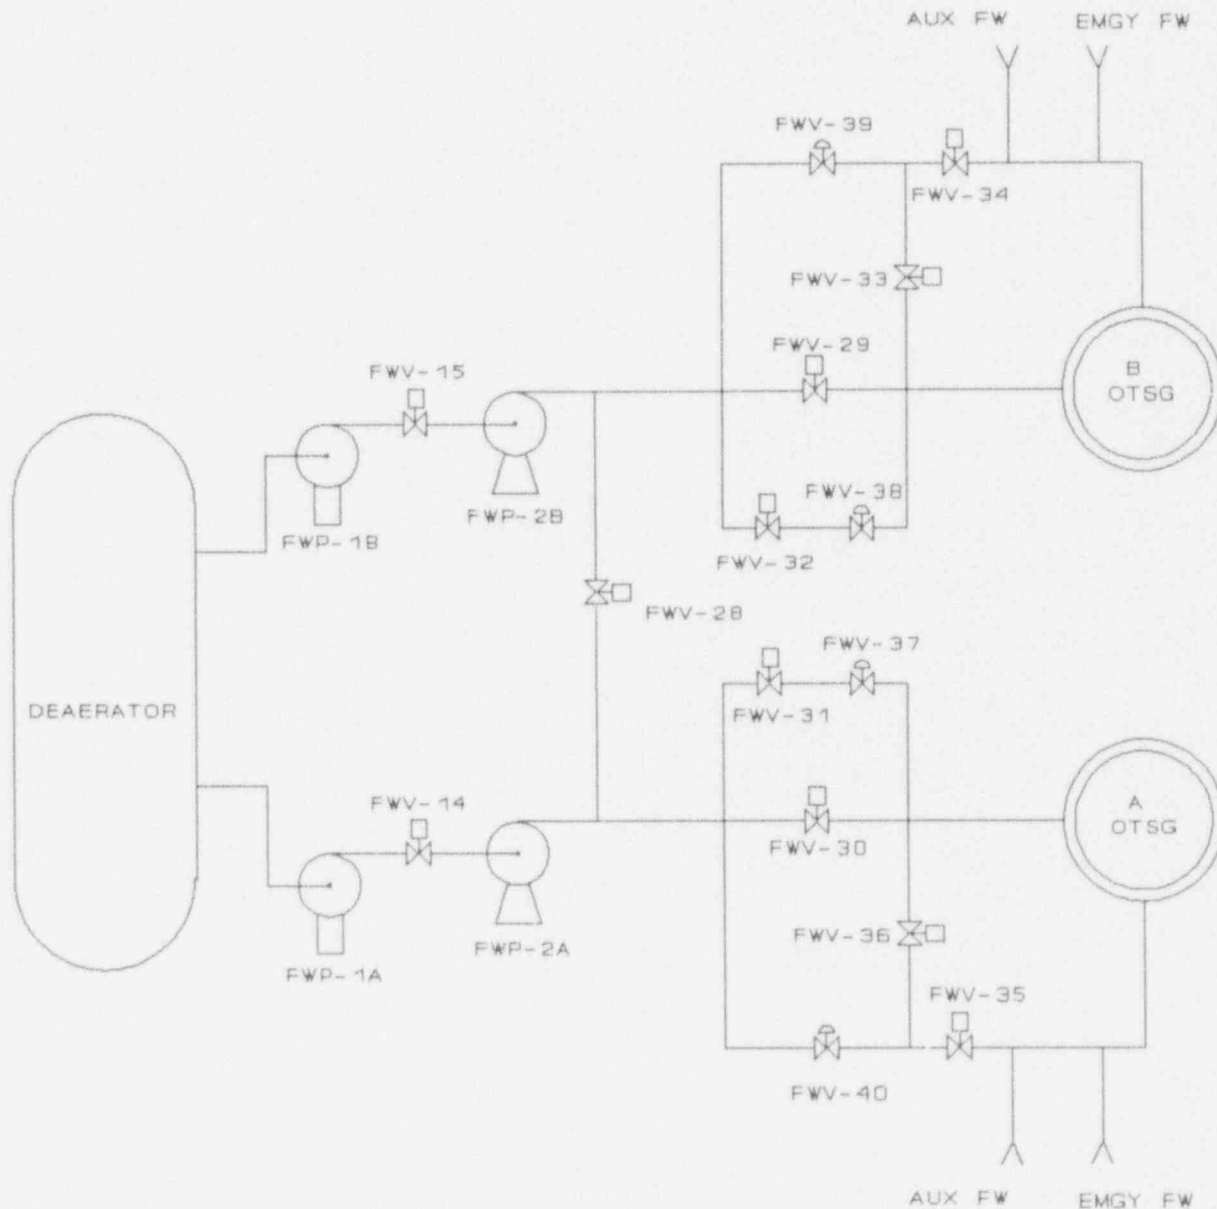
## SIMPLIFIED MAIN FEEDWATER FLOW DIAGRAM

Since Revision 0 of the motor starting calculations did not model FWV-28 (see Attachment - Simplified Main Feedwater Flow Diagram), an estimate of voltage available at the motor terminals was made by comparison with a similar valve addressed in Revision 0 of the calculations. The estimate of 345 VAC was adequate to assure proper operation of FWV-28, including brakes. Presently unverified motor starting calculations now model FWV-28 utilizing the Revision 1 criteria. These calculations indicate that only 307 VAC would be available at the motor terminals during accident conditions coincident with degraded grid voltage. Although the 307 VAC at the motor terminals still allows the valve operator to exceed minimum required thrust values, the MOV brake release requires 345 VAC. The inability of the MOV brake to release would prevent the motor from operating and performing its intended safety function of closing on main feedwater isolation.

The inability of the FWV-28 brake to release will prevent the motor from operating and performing its intended safety function. The safety function of FWV-28 is to provide feedwater system isolation in conjunction with the feedwater block valves during events which result in significant depressurization of one or both Once Through Steam Generators (OTSG) [SG]. Upon reaching 600 psig pressure in an affected OTSG the main feedwater isolation circuitry sends an isolation signal to that train's feedwater pump, suction valve, block valves, and crosstie valve FWV-28. Assuming that only one feedwater pump is in operation, and that the running pump is on the opposite train as the affected OTSG, the main feedwater isolation circuitry will send a suction valve and block valve closure signal to the train associated with the affected OTSG, a trip signal to the non-running pump and a closure signal to FWV-28. A modification to the main feedwater isolation logic circuitry will, when appropriate conditions are met, provide an isolation signal to both feedwater trains, and a trip signal to both main feedwater pumps. This action will eliminate the need to assign a safety function to FWV-28.

MUV-58 and MUV-73 have had their motor brakes removed. Applicable drawings have been revised to more accurately reflect the motor brake option. The lack of a separate engineering review for these valve operator subcomponents is considered an isolated event due to the manner in which they were wired as part of the motor. Engineering personnel have been advised of this occurrence to increase the awareness for vendor supplied subcomponents when performing operability reviews or preparing design packages. A modification to the main feedwater isolation logic will be installed during Refuel 9, which will eliminate the need for assigning the safety function of main feedwater crosstie valve FWV-28. Additionally, the calculations (E-91-0018 Revision 1) will be verified prior to the end of July 1994.
