Pennsylvania Power & Light Company

November 5, 1981

SUSQUEHANNA STEAM ELECTRIC STATION  
INTERIM REPORT OF A DEFICIENCY INVOLVING  
ISOLATION MOTOR GENERATOR SETS  
ERs 100450/100508 FILE 821-10  
PLA-950

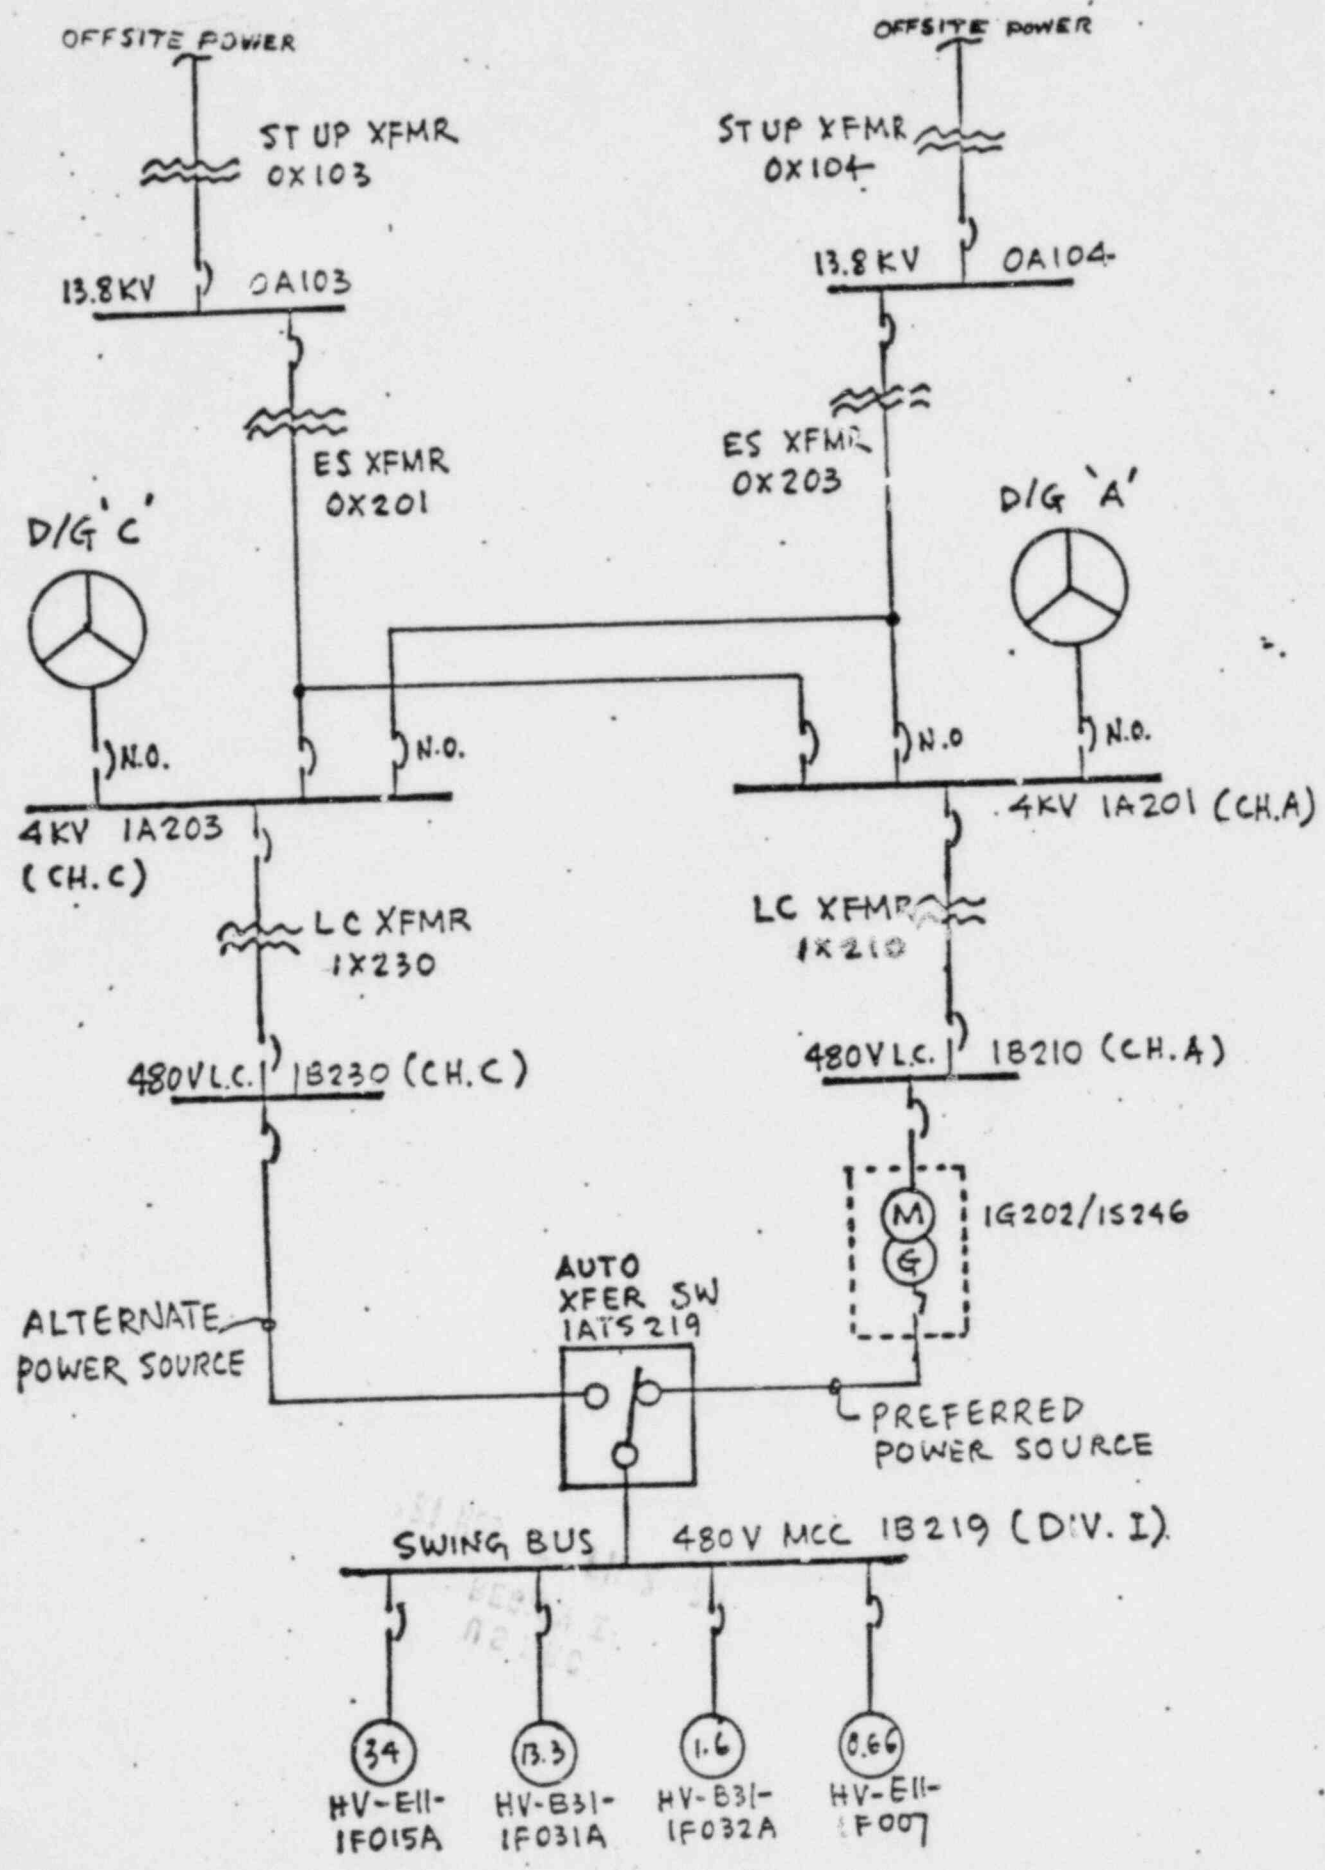
FIG. 1 M/G SET & SWING BUS

Under a LOCA condition accompanied by a loss of offsite power (LOOP), the 480 volt motor-generator (MG) sets used to provide electrical isolation for the Low Pressure Coolant Injection System (LPCI) motor operated valves could be tripped and locked out by underfrequency relaying before the diesel generators are capable of restoring power to maintain operation of these MG sets.

Referring to Figure 1 (last page of this report), it can be seen that, if:

- offsite power is lost,
- an MG set trips and locks out,
- diesel generator 'C' fails,

power will be unavailable at the 480 volt swing bus.

The present design of the relay scheme for protecting the LPCI swing bus MG sets could trip the preferred source of power to the bus. If the diesel generator which provides the alternate power source fails to start, the swing bus would remain de-energized. The valves powered from that bus would be inoperable. Since one CS pump would be lost as a result of the diesel failure to start, one CS loop would be unavailable. Therefore, the minimum ECCS criteria could not be met in the accident postulated and adequate core cooling could not be assured.

PP&L has concluded that the LPCI MG set underfrequency trip relay scheme could lead to an inability to meet minimum ECCS criteria and is therefore a significant design deficiency. The deficiency could have adversely affected safe plant operation and is therefore reportable under 10 CFR 50.55(e).

The possibility of increasing the time delay on the 480V isolation MG set under-frequency relays is being investigated. The proposed delay would prevent tripping the subject MG sets before the MG sets have re-accelerated.
