PNPS Core Spray Sparger Inspection Results

1981 CORE SPRAY SPARGER INSPECTION

BOSTON EDISON COMPANY
FILCRIM NUCLEAR POWER STATION
SUMMARY OF CORE SPRAY SPARGER INDICATIONS
AS NOTED DURING VISUAL EXAMINATION

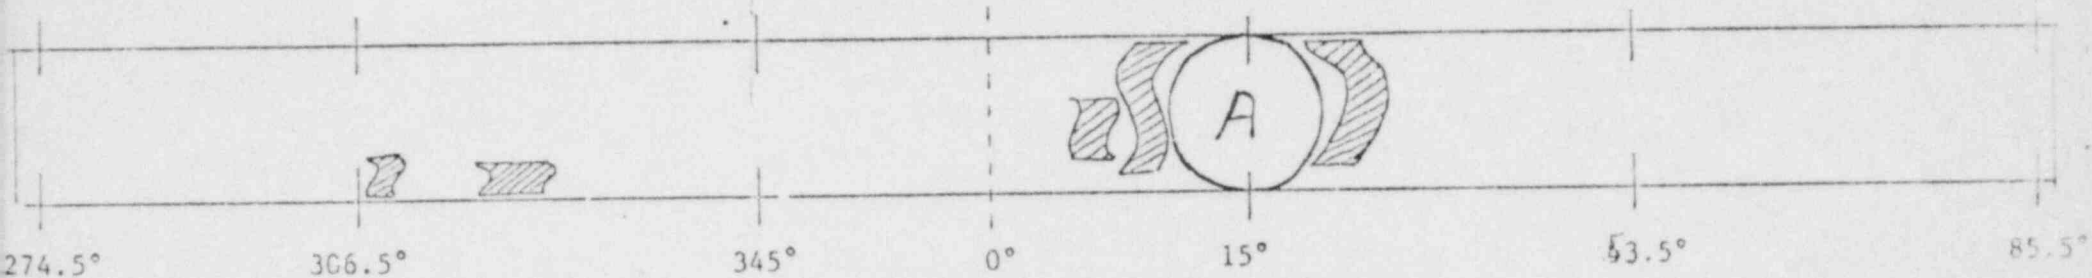
Indications were viewed in the cross hatched areas. These were resolved as not significant.
See R.P. Shimkus' report dated 9 Oct, 1981.

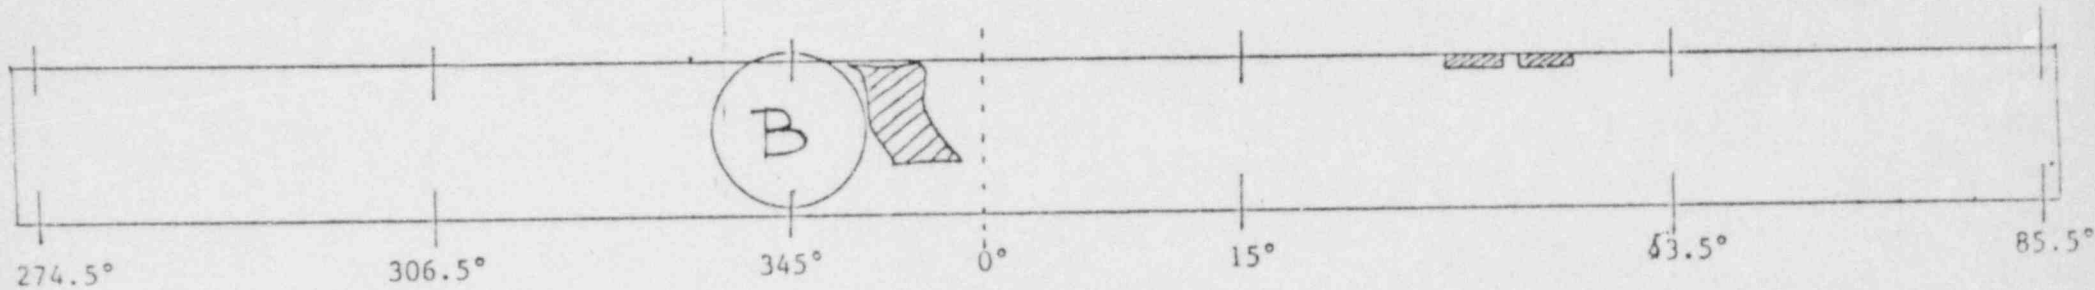
Indications on the 0° side of the junction box determined to be cracks. The area is judged to have stabilized and no further area degradation is expected. What were once thought to be crack-like indications in the heat affected zones adjacent to the weldolats for nozzles 40 & 41 B were resolved as shadows. See R.P. Shimkno' report dated 9 Oct., 1981.

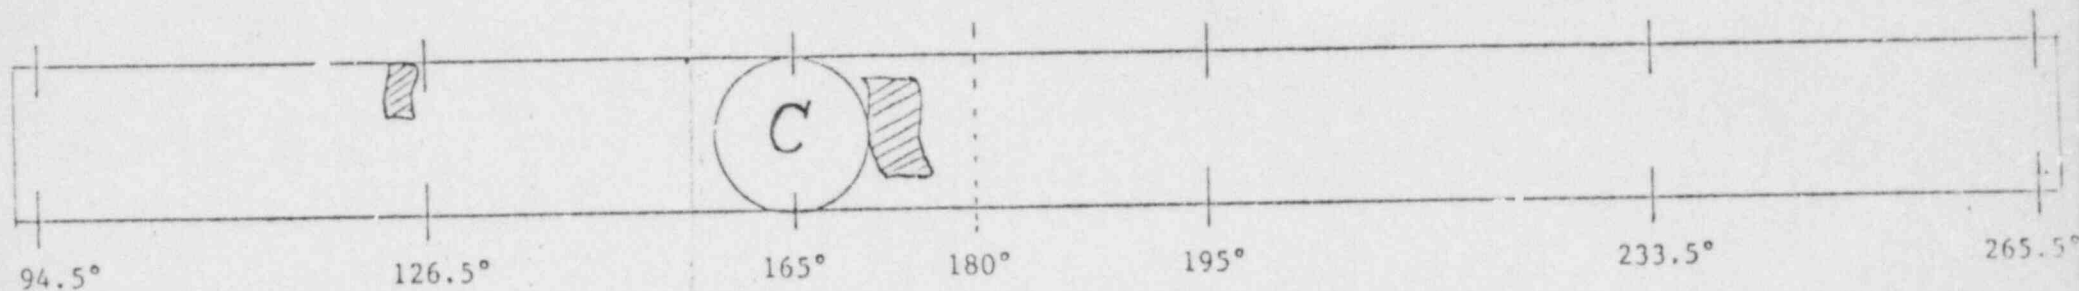
Indications were found in the cross-hatched areas. All were resolved as not significant. See R.P. Shimkus' report dated 9 Oct, 1981

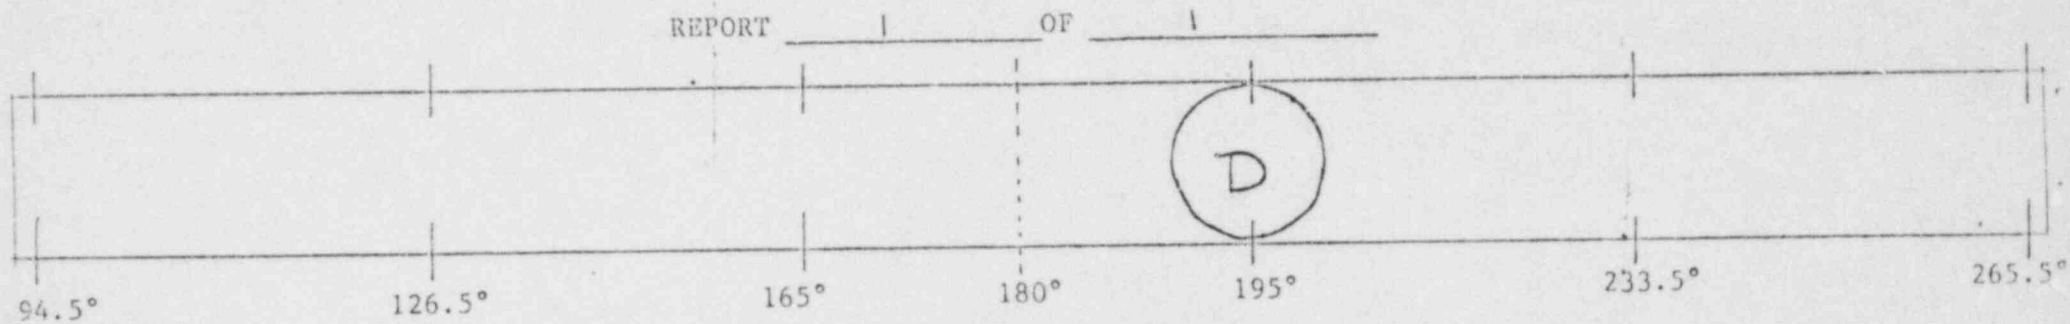
No significant indications. See R.P. Shimkus' report dated 9 Oct, 1981
