Subject: 10CFR21 Revised Report

Subject: 10CFR21 -- Report of Defect Related to
River Bend Nuclear Power Station,
St. Francisville, LA; & Nuclear Projects
WNP #1 & 4, Hanford Works, Richland, WA

10CFR21 -- REPORT OF DEFECT RELATED TO
RIVER BEND NUCLEAR POWER STATION,
ST. FRANCISVILLE, LA; & NUCLEAR PROJECTS
WNP #1 & 4, HANFORD WORKS, RICHLAND, WA

Revised November 24, 1981

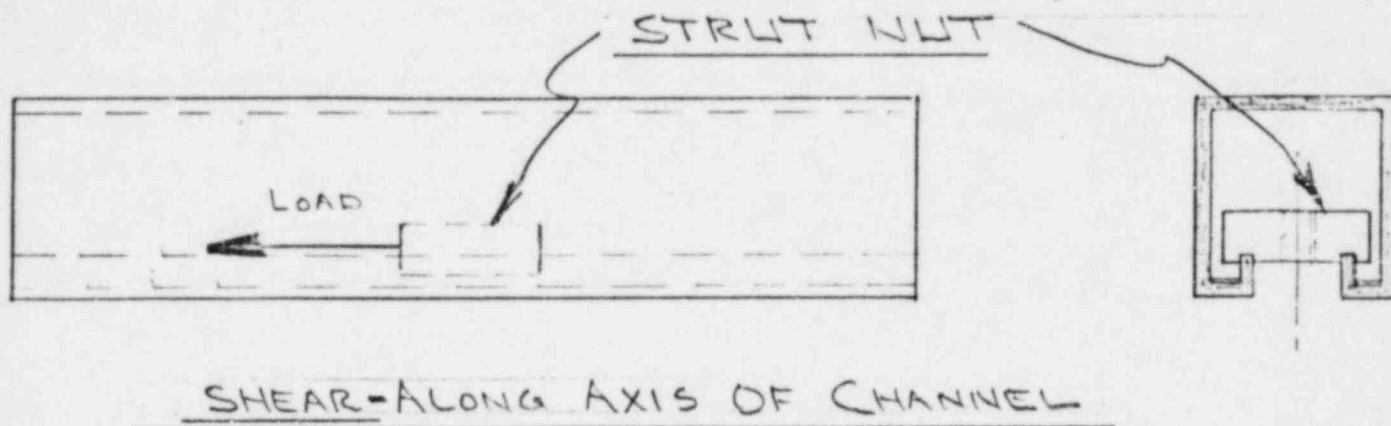
SKETCH 1A

Shallow depth of strut nut serrations, part number PS-9227-1/2RS

Potential reduced load carrying capacity for slip values in shear loading (slip along axis of channel) Ref. Attachment 1-A.

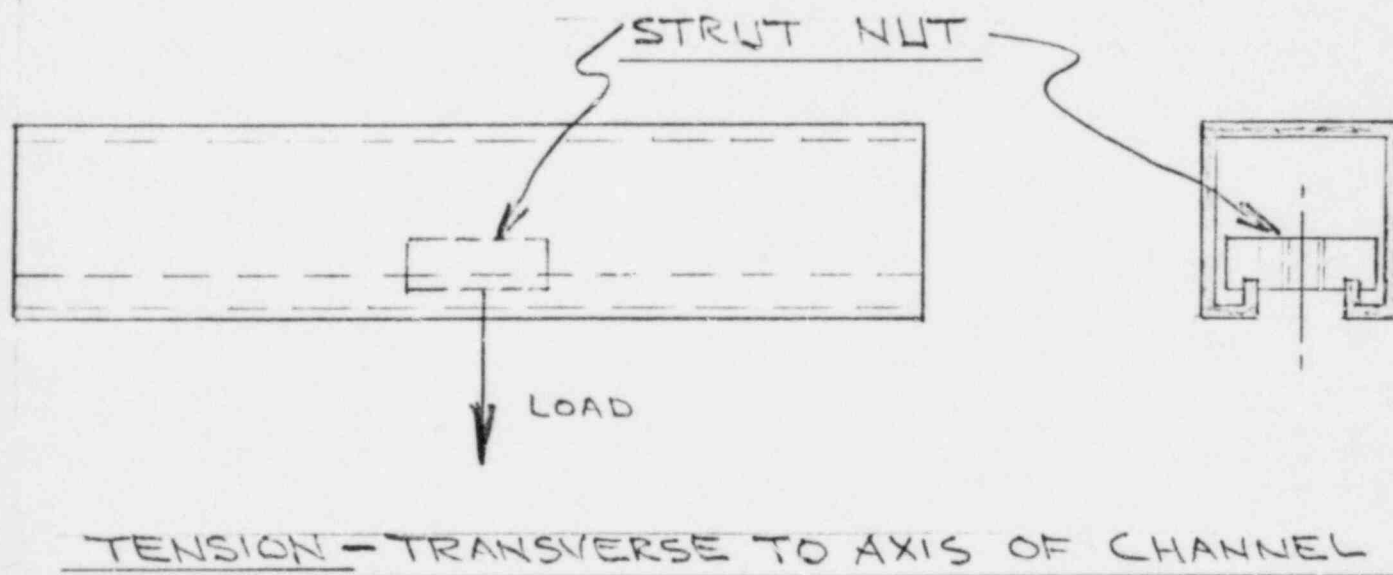
SKETCH 1B

Note: This noncompliance is not applicable to strut nut pullout tension values (perpendicular to axis of channel) Ref. Attachment 1-B.
