LICENSEE EVENT REPORT (LER)

FACILITY NAME (1)
Calvert Cliffs, Unit 1

TITLE (4)
Non-Seismic Solenoid Valves and Solenoid Valve Power Supplies on Class 1 Systems
Results in a Condition Outside the Plant's Design BasisEVENT DATE (5)
MONTH DAY YEAR
1 1 1 3 8 9 8 9
LER NUMBER (6)
YEAR SEQUENTIAL NUMBER REVISION NUMBER
0 2 0 0 1 0
REPORT DATE (7)
MONTH DAY YEAR
4 0 5 9 0
OTHER FACILITIES INVOLVED (8)
FACILITY NAMES DOCKET NUMBER(S)
Calvert Cliffs, Unit 2 0 5 0 0 0 3 1 8
0 5 0 0 0OPERATING MODE (9)
5
POWER LEVEL (10)
0 0 0
THIS REPORT IS SUBMITTED PURSUANT TO THE REQUIREMENTS OF 10 CFR 5. (Check one or more of the following) (11)

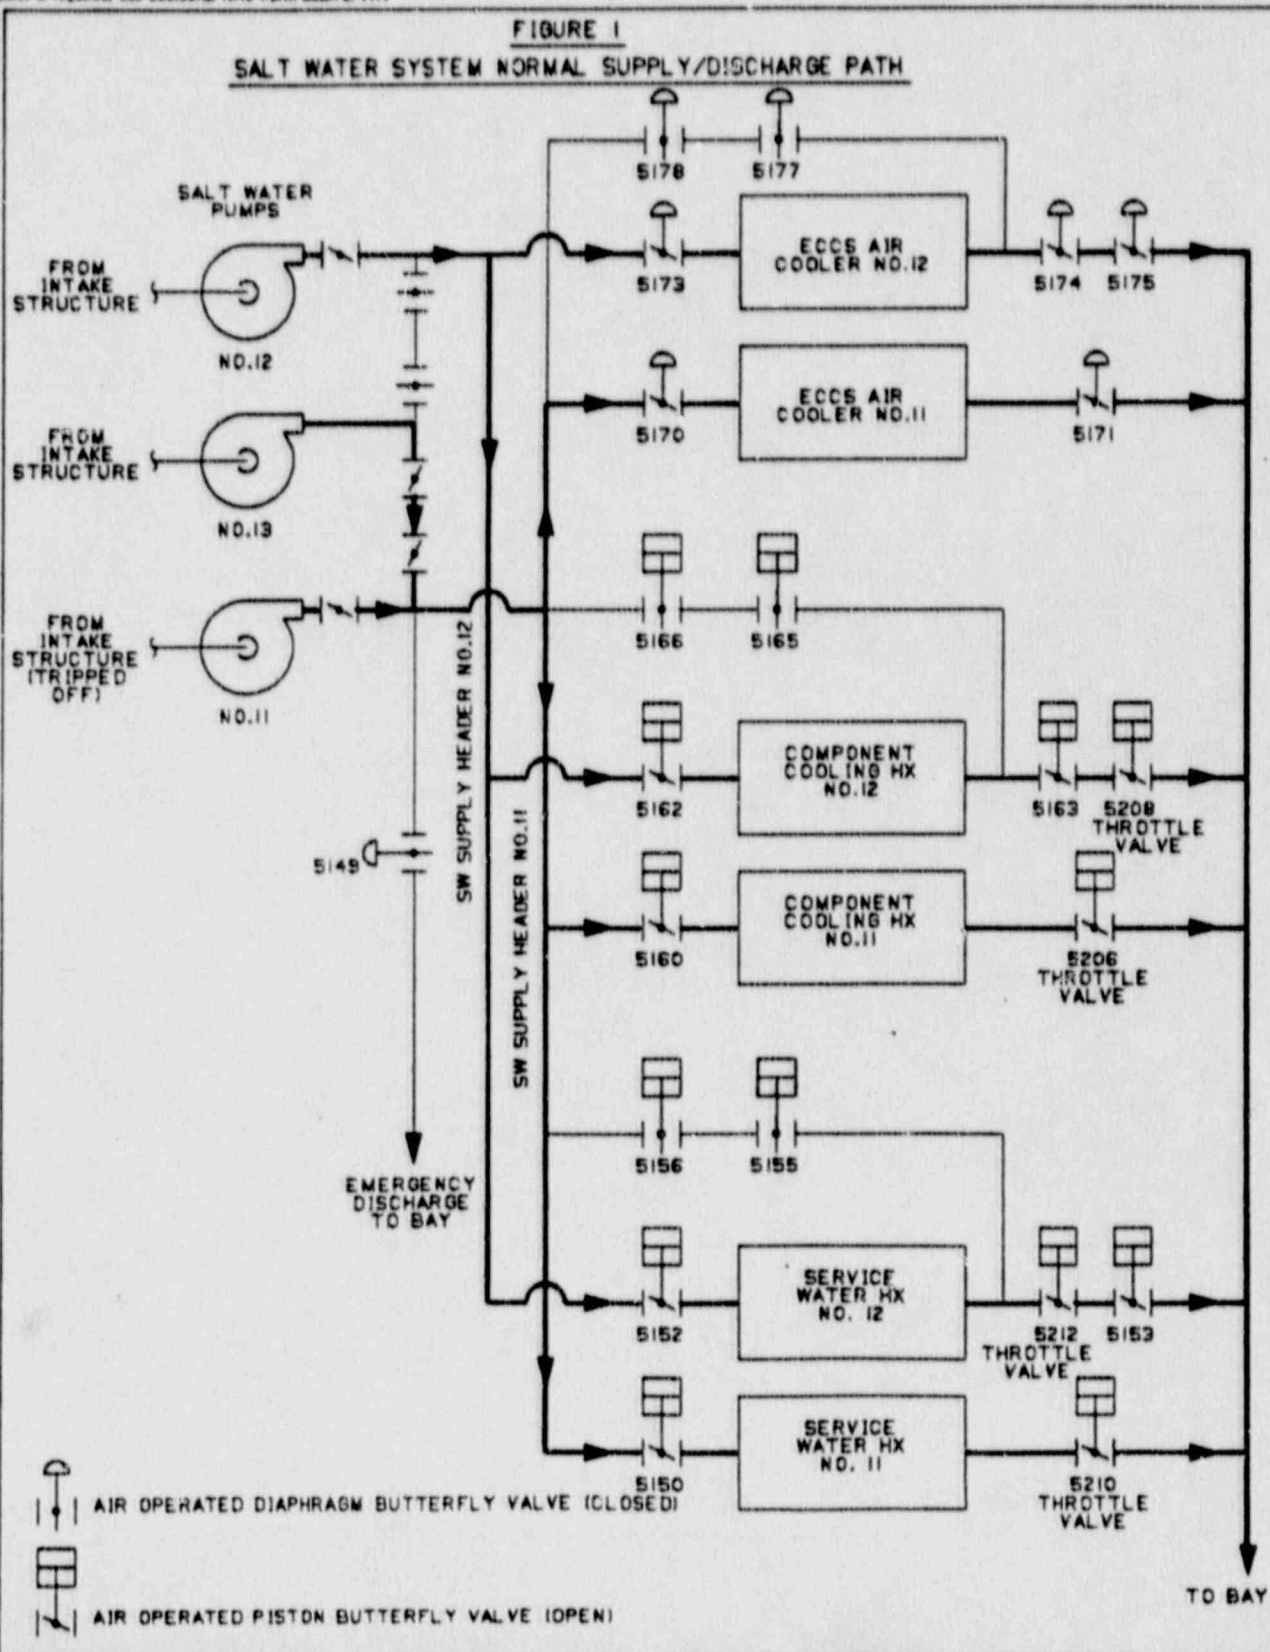
The Saltwater System is designed to provide cooling water for the Service Water and Component Cooling Water heat exchangers, and ECCS Pump Room Coolers. The Component Cooling and Service Water Systems are designed to remove heat from the plants' various auxiliary systems during normal and shutdown conditions and remove heat during a LOCA. Figure 1 shows the normal Saltwater System flow path.

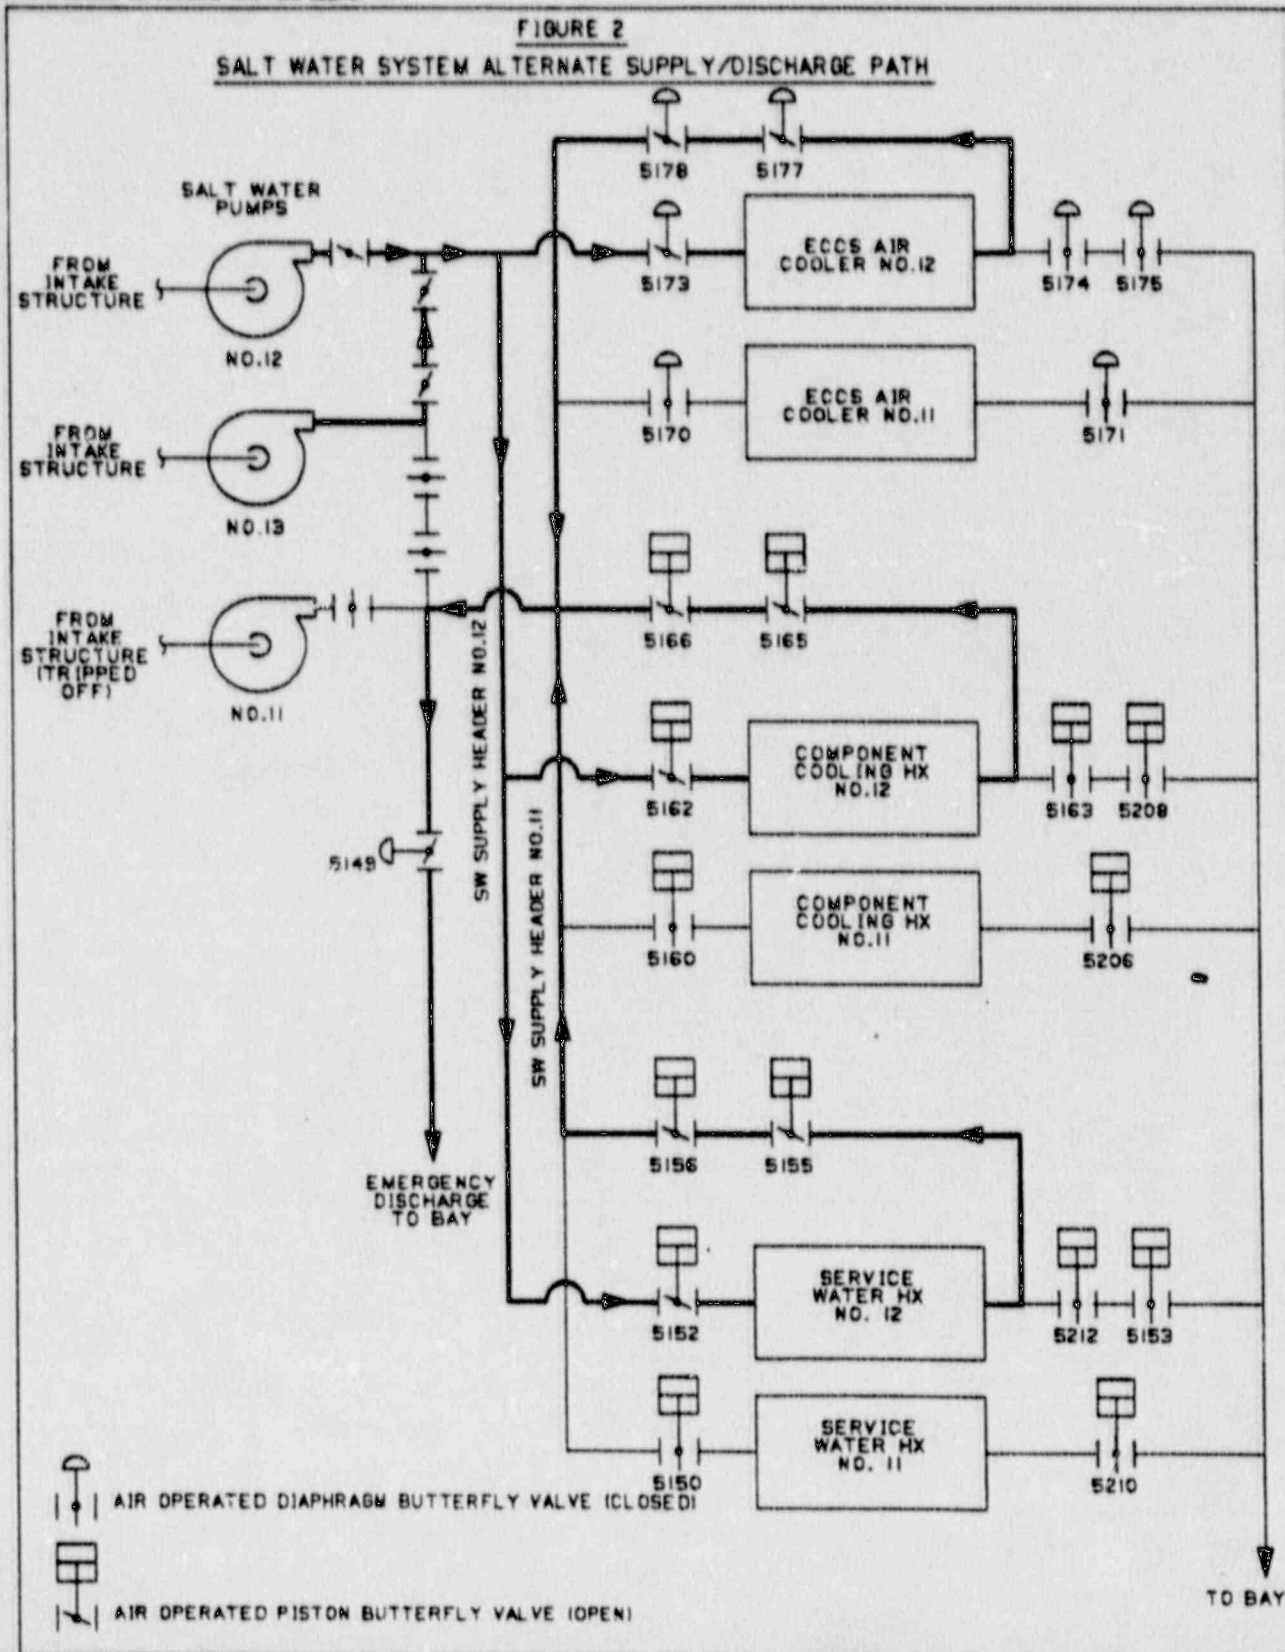
During the recirculation mode after a LOCI, should a piping rupture occur in the common discharge header of the Saltwater System, the alternate (overboard) Saltwater System flow path to the Chesapeake Bay would be employed. Figure 2 shows the alternate Saltwater System flow path. The control valves (CVs) used to position this lineup are air-operated with accumulators supplied by the normal (NSR) Instrument Air System. Most of the CVs would have to be repositioned from their failed position to achieve the alternate discharge path lineup. Some of
