SUBJECT: Arkansas Nuclear One - Unit 1  
Docket No. 50-313  
License No. DPR-51  
Licensee Event Report No. 50-313/89-007-01

## LICENSEE EVENT REPORT (LER)

DOCKET NUMBER (2) 1051010101  
PAGE (3) 3131 OF 1014TITLE (4) Inadequate Design Change Process Results in Failure to Identify a High Pressure Injection  
System Line Break Scenario Which Could Cause the System to be Incapable of Supplying  
Adequate Core Cooling

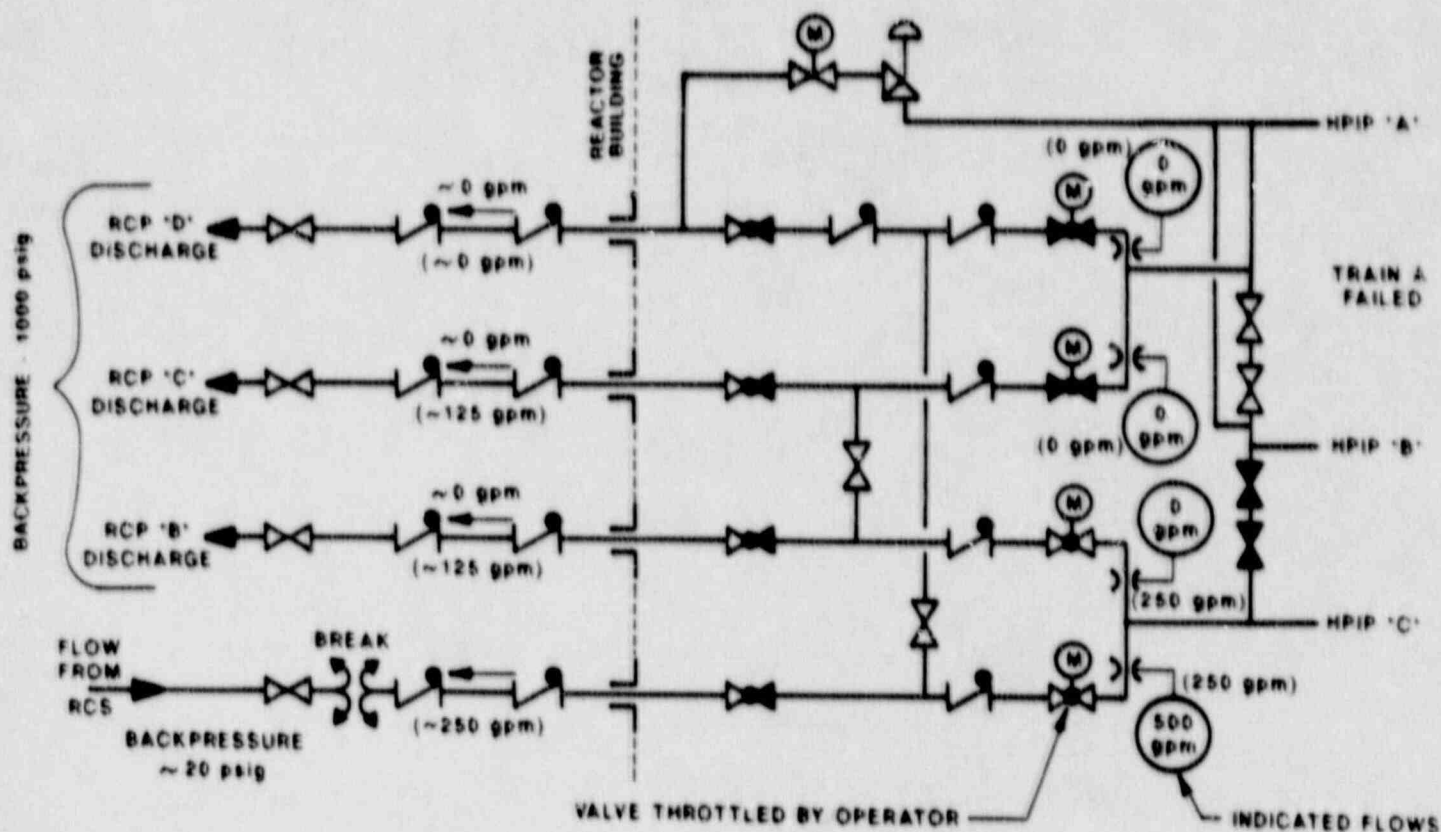
As a result of a January 1989 transient, reported in LER 50-313/89-002-00, a review of the plant's Emergency Core Cooling System (ECCS) analysis was conducted which included a reevaluation of the qualification and functional capability of the High Pressure Injection (HPI) System [BJ]. During this review it was discovered that a postulated break of a HPI line could result in a small break Loss of Coolant Accident (LOCA) which was not enveloped by the plant's existing design basis. The hypothetical break location is upstream of the HPI/Reactor Coolant System (RCS) [AB] cold leg connection and downstream of the first RCS/HPI system boundary check valve. (See Figure 1 for the general system layout).

During performance of the ECCS review, it was determined that a potential break of any one of the HPI lines upstream of the RCS cold leg connection and downstream of the first RCS/HPI system boundary check valve was not enveloped by prior analysis and could, assuming a worst case single failure (i.e., an emergency diesel generator failure rendering a HPI pump inoperable), result in significant HPI flow exiting the break with little flow reaching the core. This would occur because back pressure on the broken line would essentially be Containment Building pressure while back pressure on the other lines would be RCS pressure. This condition would continue until a Control Room Operator took action to throttle the excessive HPI flows as stipulated in the existing Emergency Operating Procedure (EOP). After flow balancing was achieved (analyzed to occur ten minutes following a break due to the action of the Operator), approximately 50 percent of the flow from the one running HPI pump would reach the core with the remaining flow exiting the break.

An investigation of the impact of this postulated break on current ECCS evaluations determined that the break did not appear to be enveloped by previously postulated breaks. For breaks which had been considered in the ECCS analysis, approximately 50 percent of HPI flow was assumed to initially reach the core and approximately 70 percent of HPI flow was assumed to reach the core following Control Room Operator action to throttle excessive HPI flow (analyzed to occur ten minutes following a break due to the action of the Operator). Based on the differences in the HPI flows for the postulated break versus the analyzed breaks, it was determined that the HPI system might not be capable of supplying adequate core cooling should the break occur during high power operation.

High Pressure Injection System Line Break

A design change was implemented during outage 1M89 (December, 1989) which installed break flow limiting cavitating venturis in each of the four HPI lines upstream of the two check valves which isolate this piping from the RCS. However, during post-modification testing of the venturis, excessive vibration was experienced in the piping downstream of the venturis which necessitated their removal. The venturis were replaced with welded spool pieces which restored the system to its original configuration with the exception of a minor piping reroute on the 'D' HPI line.

Evaluations are presently in progress which are considering two possible permanent corrective actions which will allow resumption of full power operation. The first consideration involves reinstalling the cavitating venturis with a modified piping support configuration. The second consideration involves the installation of motor operated valves in each of the HPI lines as well as additional flow instrumentation which would allow the operators to more readily identify and compensate for a pipe break in the location discussed in this report. After determination of the permanent corrective action, a Design Change will be developed and implemented during refueling outage 1R9, which is scheduled to begin in October, 1990.
