April 19, 1990  
Fort St. Vrain  
Unit No. 1  
P-90103

SUBJECT: Licensee Event Report 89-015-01, Final Report

## LICENSEE EVENT REPORT (LER)

FACILITY NAME (1) Fort St. Vrain, Unit No. 1										DOCKET NUMBER (2) 0 5 0 0 0 2 6 1 7										PAGE (3) 1 OF 1		
TITLE (4) REGION 19 CONTROL ROD DRIVE FAILED TO FULLY INSERT ON SCRAM SIGNAL																						
EVENT DATE (5)			LER NUMBER (6)				REPORT DATE (7)			OTHER FACILITIES INVOLVED (8)												
MONTH	DAY	YEAR	YEAR	SEQUENTIAL NUMBER	REVISION NUMBER	MONTH	DAY	YEAR	FACILITY NAMES N/A					DOCKET NUMBER(S) 0 5 0 0 0								
0 8	1 8	8 9	8 9	0 1 5	0 1	0 4	1 9	9 0						0 5 0 0 0								
OPERATING MODE (9) N		THIS REPORT IS SUBMITTED PURSUANT TO THE REQUIREMENTS OF 10 CFR 5: (Check one or more of the following) (11)																				
POWER LEVEL (10) 0 7 9		20.402(b)				20.406(e)				50.73(a)(2)(iv)				73.71(b)

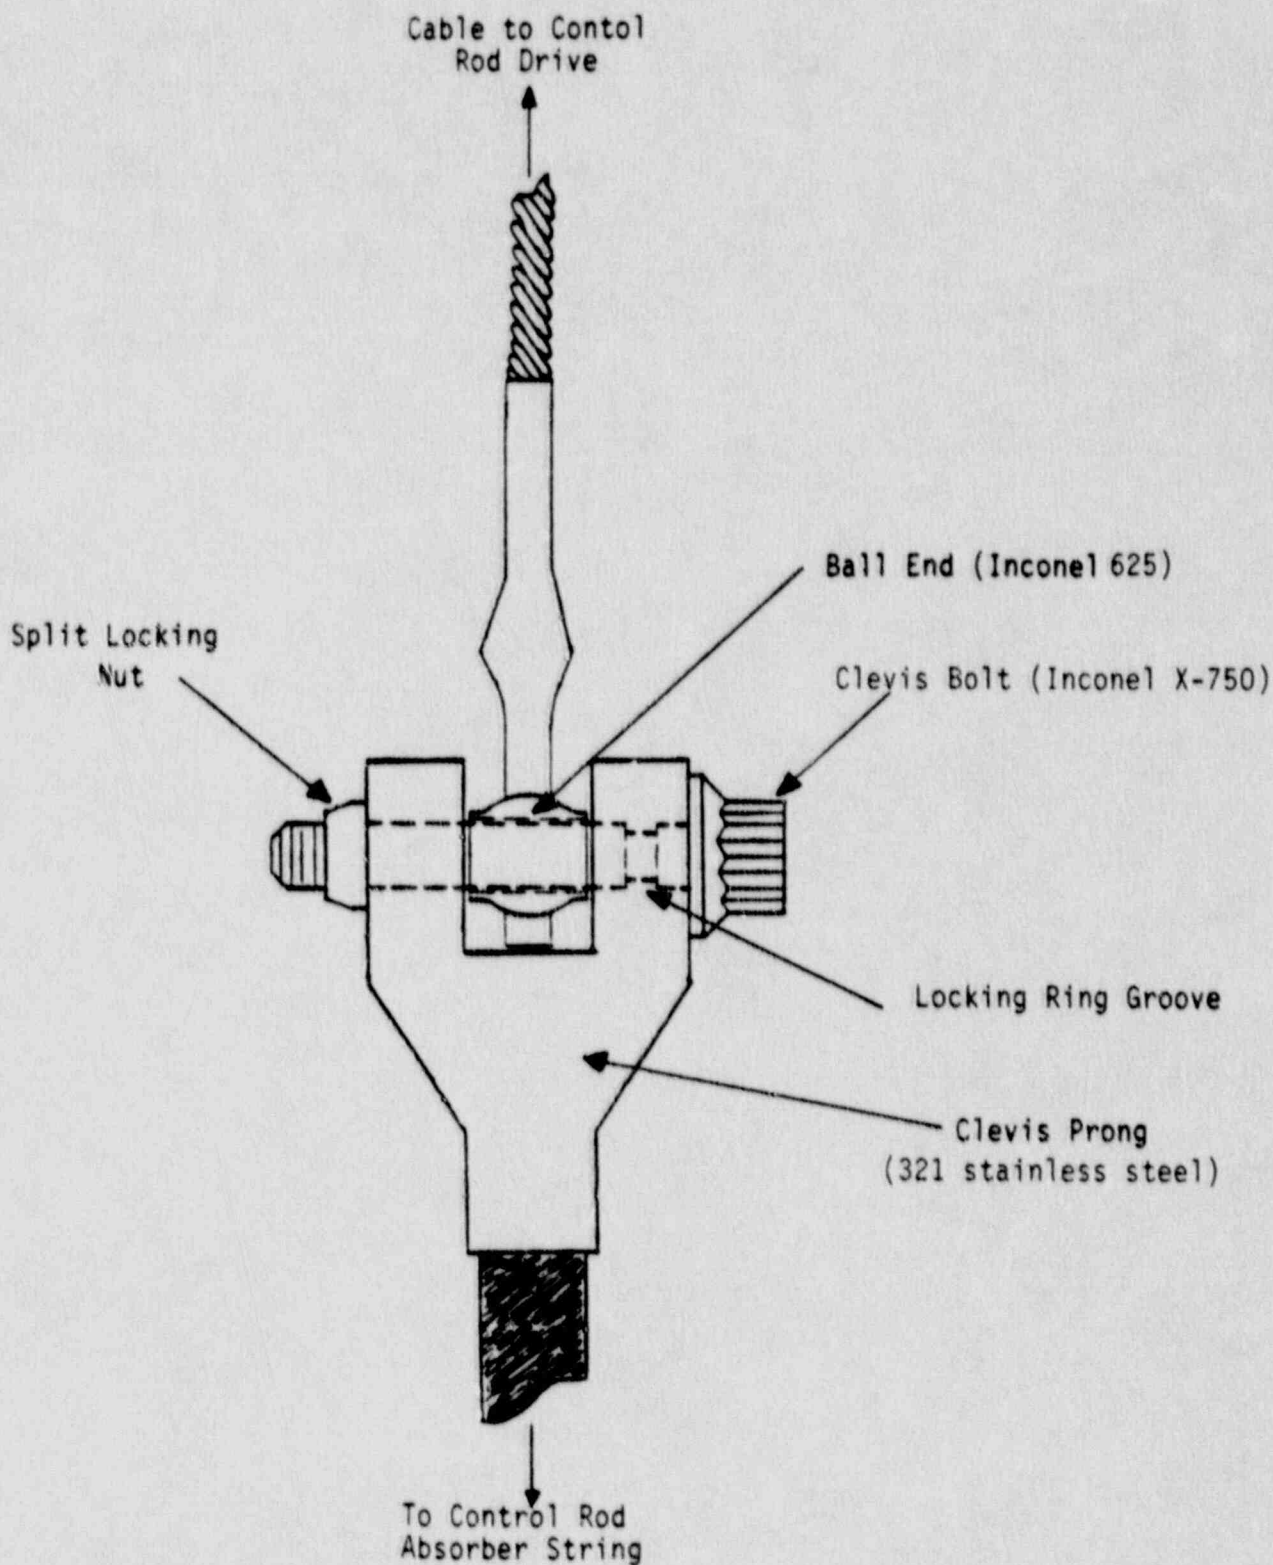
FIGURE 1.

The effects of pre-loading the clevis bolts were also analyzed. The part of the bolt most susceptible to tensile failure is the locking ring groove (see Figure 1) cut into the bolt shank. This corresponds to the location of the fracture observed in both failed clevis bolts. The torquing of the clevis bolts does not entirely account for the failures observed, since the heads would have sheared when the load was initially applied. Residual tensile and shear stresses from the initial torquing would remain within the bolt and combine with other stresses which could eventually have caused the failures observed.

During the CRD refurbishment program in 1985, approximately 18 control rod pairs (including the region 19 rod pair) were refurbished with Inconel X-750 clevis bolts. The remaining rods were left with the original A186 high strength alloy steel clevis bolts due to material availability. The clevis prong itself is made of 321 stainless steel while the support ball end is made of Inconel 625 (see Figure 1).

| The thermal expansion effects of the entire clevis assembly were analyzed. It has been determined that if the gap between the clevis prong wall and the ball end bearing (see Figure 1) were completely closed by preloading during refurbishment, the differential expansion between the stainless steel clevis prong and the Inconel X-750 clevis bolt during normal reactor core thermal cycling would cause significant tensile stresses to develop within the clevis bolt. The tensile stress caused by differential expansion would most adversely affect the bolt cross-section where the locking ring groove is machined. The magnitude of the thermally induced stress in itself is not sufficient to cause tensile failure independent of other mechanisms. However, thermal differential expansion stresses, unlike other thermal expansion stresses, are not self-equilibrating, and as such, they add to the tensile stress state in the bolt, and are at a maximum at the location of the fractures observed.
