# NORTHEAST UTILITIES

Reference: Facility Operating License No. NPF-49  
Docket No. 50-423  
Licensee Event Report 90-010-00

## LICENSEE EVENT REPORT (LER)

FACILITY NAME (1) Millstone Nuclear Power Station Unit 3										DOCKET NUMBER (2) 0 5 0 0 0 4 2 3				PAGE (3) 1 OF 0 4					
TITLE (4) Auxiliary Building Ventilation Filters Inoperable Due to Equipment Failure																			
EVENT DATE (5)			LER NUMBER (6)				REPORT DATE (7)			OTHER FACILITIES INVOLVED (8)									
MONTH	DAY	YEAR	YEAR	SEQUENTIAL NUMBER	REVISION NUMBER	MONTH	DAY	YEAR	FACILITY NAMES										
0	3	1	9	9	0	9	0	0	1	0	0	0	4	1	8	9	0	0 5 0 0 0 0	
OPERATING MODE (9)		THIS REPORT IS BEING SUBMITTED PURSUANT TO THE REQUIREMENTS OF 10 CFR § (Check one or more of the following) (11)																	
1		20.402(b)				20.402(c)				50.73(a)(2)(iv)				73.71(b)					
POWER LEVEL (10)		20.405(a)(1)(i)				50.36(c)(1)				X 50.73(a)(2)(v)				73.71(c)					
1		20.405(a)(1)(ii)				50.36(c)(2)				50.73(a)(2)(vii)				OTHER (Specify in Abstract below and in Text, NRC Form 366A)

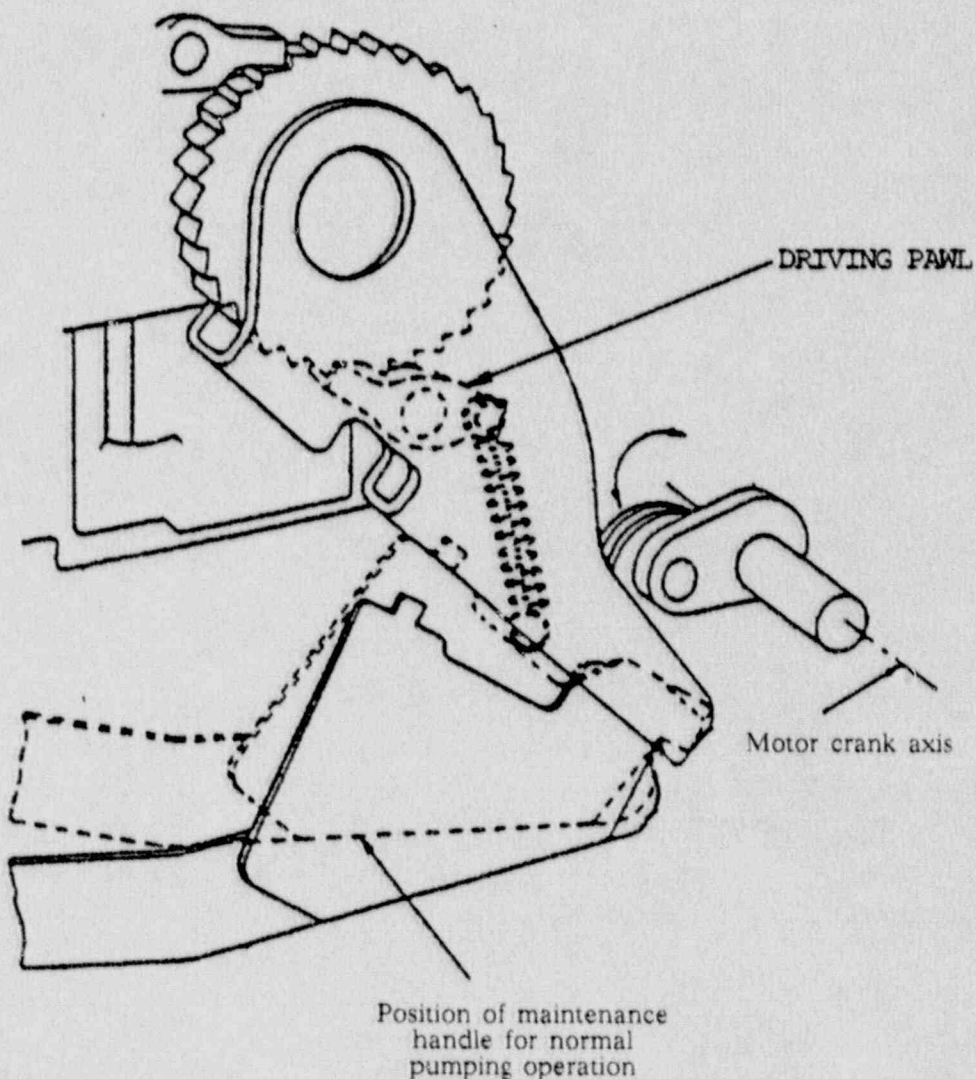
CHARGING MOTOR DRIVING PAWL AND SPRING ASSEMBLY

The root cause of the event was fatigue failure of the driving pawl spring associated with the 3HVR\*FLT1A circuit breaker charging motor. The spring failed at a severe 90 degree bend near the hook.

The charging motor moves a driving pawl, which in turn drives a ratchet wheel and causes the closing spring to charge, or be placed under tension. The spring is used to return the driving pawl to a position from which it can drive the ratchet wheel. The charging motor stops via a limit switch which is driven off of the ratchet wheel.

When 3HVR\*FLT1B was shut down, the spring on the driving pawl failed. With the spring broken, the charging motor continued to operate but could not turn the ratchet wheel. As a result the limit switch stop could not be actuated and the charging motor operated continuously until failure.

As immediate corrective action, work on the filter inspection of 3HVR\*FLT1A was stopped and the unit was restored to operable status. The unit was placed back in service and Technical Specification 3.0.3 was exited at 0920 hours on March 19, 1990. The failure of the motor driving pawl spring is considered an isolated incident. Therefore, no further corrective action is planned.
