Detroit
Edison

Subject: Response to NRC Notice of Violation 89-033-01

Detroit Edison Response to Notice of Violation 89-033-01

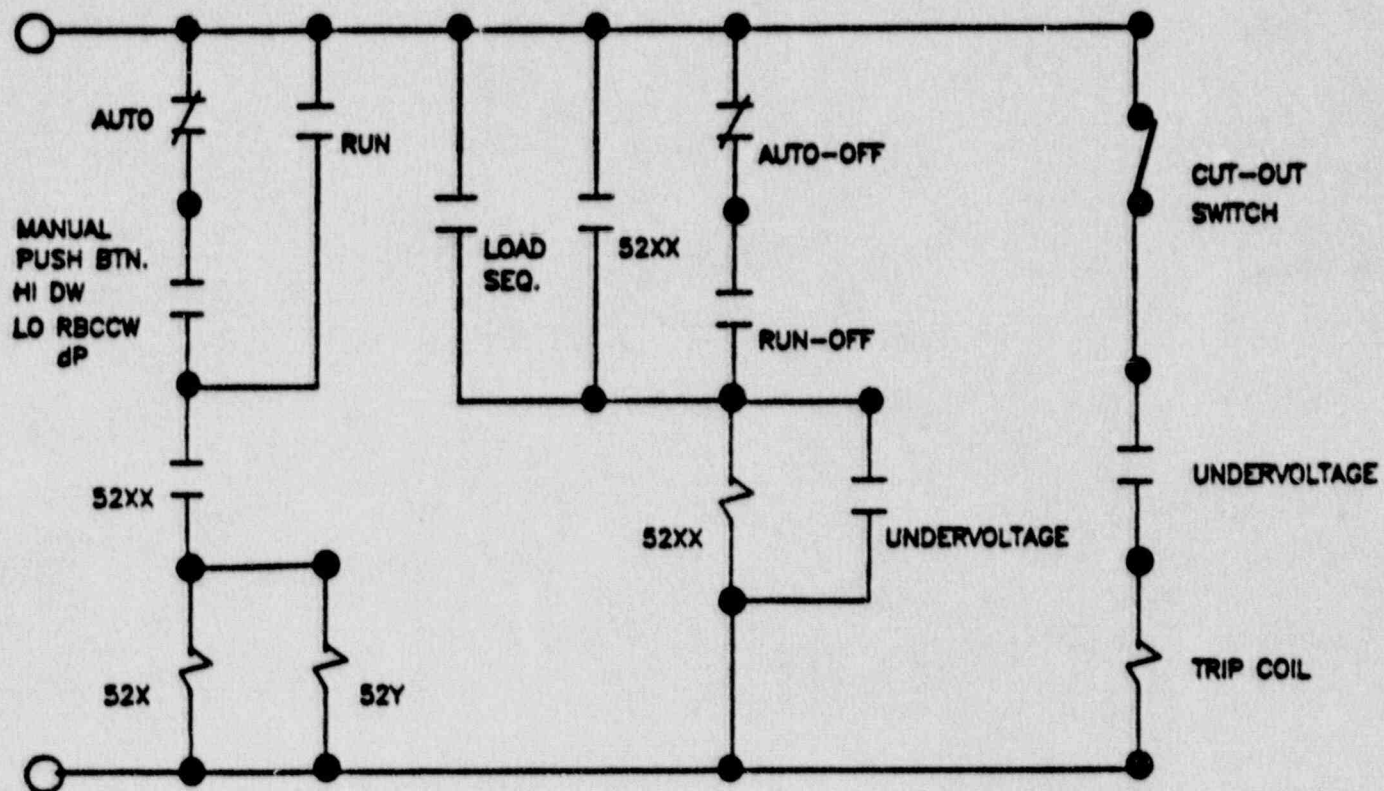
EECW/EESW PUMP START LOGIC CIRCUIT

Surveillance procedures 24.305.01 and 24.305.02, Division I and II 480VAC Engineered Safety Features Bus Load Shedding Verification Tests, had been performed the previous day. Investigation into the cause of the EECW/EESW pump trips determined that when specific steps of procedure 24.305.02 were performed to preclude tripping of the Division II EECW pump during the load shedding surveillance, they also defeated selected automatic start features of the EECW pump. This occurred when the "52XX" relays were de-energized during these steps by operating undervoltage relay 4NT94. Similar relay logic exists in the Division I EECW pump auto-start logic circuit and for the Divisions I and II EESW pumps (see the attached simplified figure for the EECW/EESW Pump Start Logic Circuit which shows the 52XX relays). This condition existed for approximately 30 hours following completion of the load shedding surveillance test and before discovery during the EECW pump and valve operability test.

Upon discovery of this condition, Deviation Event Report (DER) 89-1371 was written and a thorough investigation into the root cause was conducted. The immediate cause attributed to this violation was the inadequate surveillance procedures used to perform the 480 Volt Load Shedding Verification Tests described above. The procedures were inadequate in that their performance resulted in de-energizing the 52XX relays and there were no steps provided to reset these relays. This resulted in the loss of the auto-start capability for the EECW/EESW pumps on selected actuation signals (i.e., High Drywell Pressure and Reactor Building Closed Cooling Water (RWCCW) Low Differential Pressure). Thus, the EECW and EESW pumps were technically inoperable per the Fermi 2 Technical Specifications, sections 3.7.1.2 and 3.7.1.3, respectively.

Surveillance procedures 24.305.01 and 24.305.02 were revised to ensure that the 52XX relays will be reset for the EECW and EESW pumps. With this action, compliance with Tech. Spec. 6.8.1.d was established for this testing.
