SEQUOYAH NUCLEAR PLANT (SQN) UNITS 1 AND 2 - DOCKET NOS. 50-327 AND 50-328 -
FACILITY OPERATING LICENSES DPR-77 AND 79 - SPECIAL REPORT 90-06 - FIRE
PROTECTION PLAN

ENCLOSURE
14-Day Follow-Up Report
Special Report 90-06

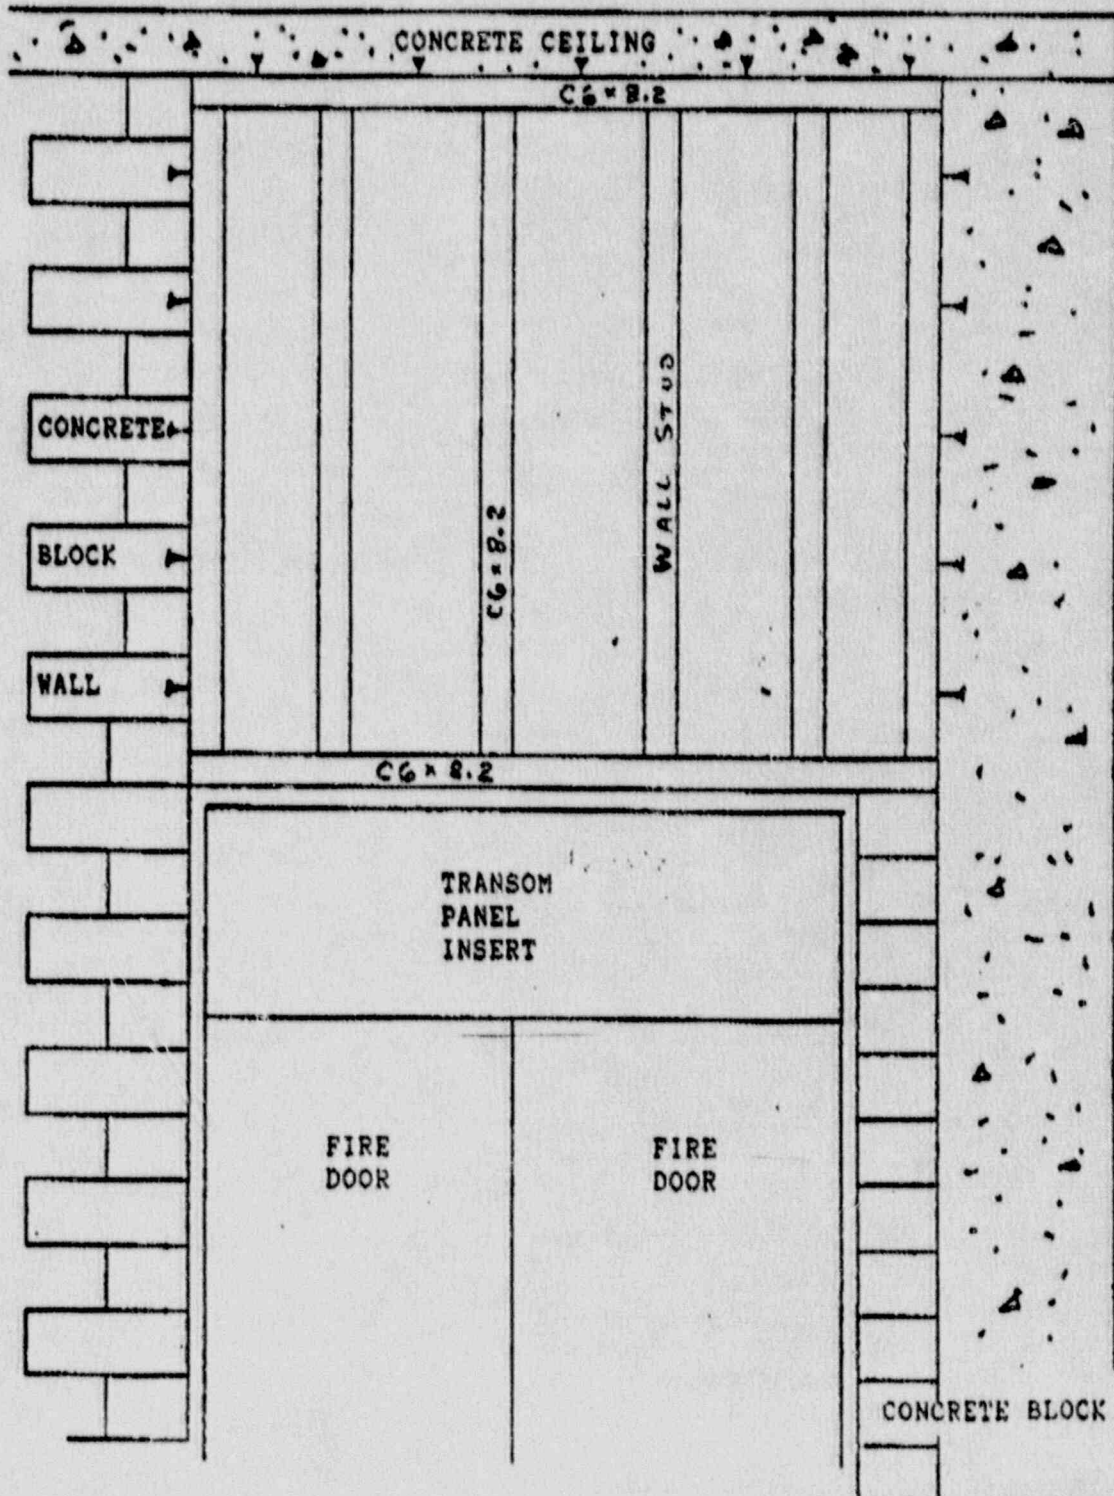
SKETCH
(NOT TO SCALE)

The noncompliance with Unit 2 License Condition 2.C.13.a was identified as a potential problem on April 10, 1990, and was confirmed on April 11, 1990. Unit 2 License Condition 2.C.13.a requires TVA to maintain and implement all provisions of the approved fire protection plan which, in part, committed to a 1.5-hour rated fire wall between each unit's auxiliary instrument room and the corridor outside the computer room on control building Elevation 685. These walls together provide fire separation between the auxiliary instrument room for each respective unit. While preparing a design change to route new phone lines through the subject wall, a technical problem was discovered with the original design and installation of the walls, which are above the transom panel of Fire Doors C22 and C24.

Each wall consists of four 5/8-inch, fire-rated gypsum wallboards, two attached to each side of metal wall studs. The 1.5-hour fire rating of each wall is based upon the similarity of its design to an Underwriters Laboratory fire-tested wall configuration fire-rated at 1.5 hours or longer. The fire-tested wall configuration consisted of four 5/8-inch, fire-rated gypsum wallboards, two attached to each side of metal wall studs. The wall studs in the tested configuration were made of galvanized sheet metal and were bolted to upper and lower runners with a free space at the stud ends to allow thermal expansion of the metal wall studs during a fire. In the subject walls at SQN, the wall studs are made of heavier-gauge steel channels that are welded to the upper and lower runners. There was no provision made in the original design for thermal expansion of the wall studs during a fire.

When this condition was identified as a potential problem, calculations were made to determine if the wall-stud thermal expansion would be accommodated by deflection and deformation of the sheet-metal door transom (between the top of the fire doors and the bottom of the fire wall) in such a way to preserve the fire integrity of the overall wall and door structure. The calculations showed this result would be expected except for one wall stud. This wall stud is located above a concrete block wall that extends from the floor to the top of the door transom as shown on the attached sketch. (This configuration is not the same as shown on plant drawings, which indicate the concrete block wall extends from floor to ceiling.) The calculation concluded that the thermal expansion of this one wall stud might cause that wall stud to bow during a fire, which could result in deflection that could degrade the structure as a fire-rated barrier.

The root cause of this condition has been attributed to a design deficiency in the original wall design in that allowance was not made for thermal expansion of the wall studs during a fire. A contributing cause of the condition is that the as-built configuration of the concrete block wall is different than shown on plant drawings.

The affected areas have been included in the surveillance of hourly, roving fire watch patrols as of 1055 Eastern daylight time on April 10, 1990. A design change has been issued consisting of adding two additional half-inch, fire-rated gypsum wallboards to each side of both walls. This addition would lower the expected wall stud temperature during a fire and consequently reduce the wall-stud thermal expansion to an acceptable value. This design change will be implemented by July 12, 1990. The hourly, roving fire watch patrol coverage will be maintained until the design change is implemented. In addition, the design and construction of other gypsum fire walls will be reviewed to determine whether similar problems exist in any other plant locations. This review will be completed by June 1, 1990. A drawing deviation has been issued to revise the affected plant drawing to reflect the as-built configuration of the concrete block wall.
