Subject: McGuire Nuclear Station Unit 2
Docket No. 50-370
Licensee Event Report 370/90-04

FACILITY NAME (1) McGuire Nuclear Station, Unit 2										DOCKET NUMBER (2) 0 5 0 0 0 3 7 0 1 OF 1 3										PAGE (3) 1 OF 1 3																																
TITLE (4) Power Mismatch Exceeded Technical Specification Limits Because Of A Design Deficiency																																																				
EVENT DATE (5)									LER NUMBER (6)									REPORT DATE (7)									OTHER FACILITIES INVOLVED (8)																									
MONTH			DAY			YEAR			YEAR			SEQUENTIAL NUMBER			REVISION NUMBER			MONTH			DAY			YEAR			FACILITY NAMES N/A													DOCKET NUMBER(S) 0 5 0 0 0												
0 3			2 1			9 0			9 0			0 0			4 0			0 0			0 4			2 0			9 0			0 5 0 0 0																						
OPERATING MODE (9) 1										THIS REPORT IS SUBMITTED PURSUANT TO THE REQUIREMENTS OF 10 CFR 8. (Check one or more of the following) (11)																																										
POWER LEVEL (10) 1 0 0										20.402(b)										20.406(e)										50.73(a)(2)(iv)										73.71(b)

McGuire Nuclear Station

Unit 2 Runback of 2/13/90

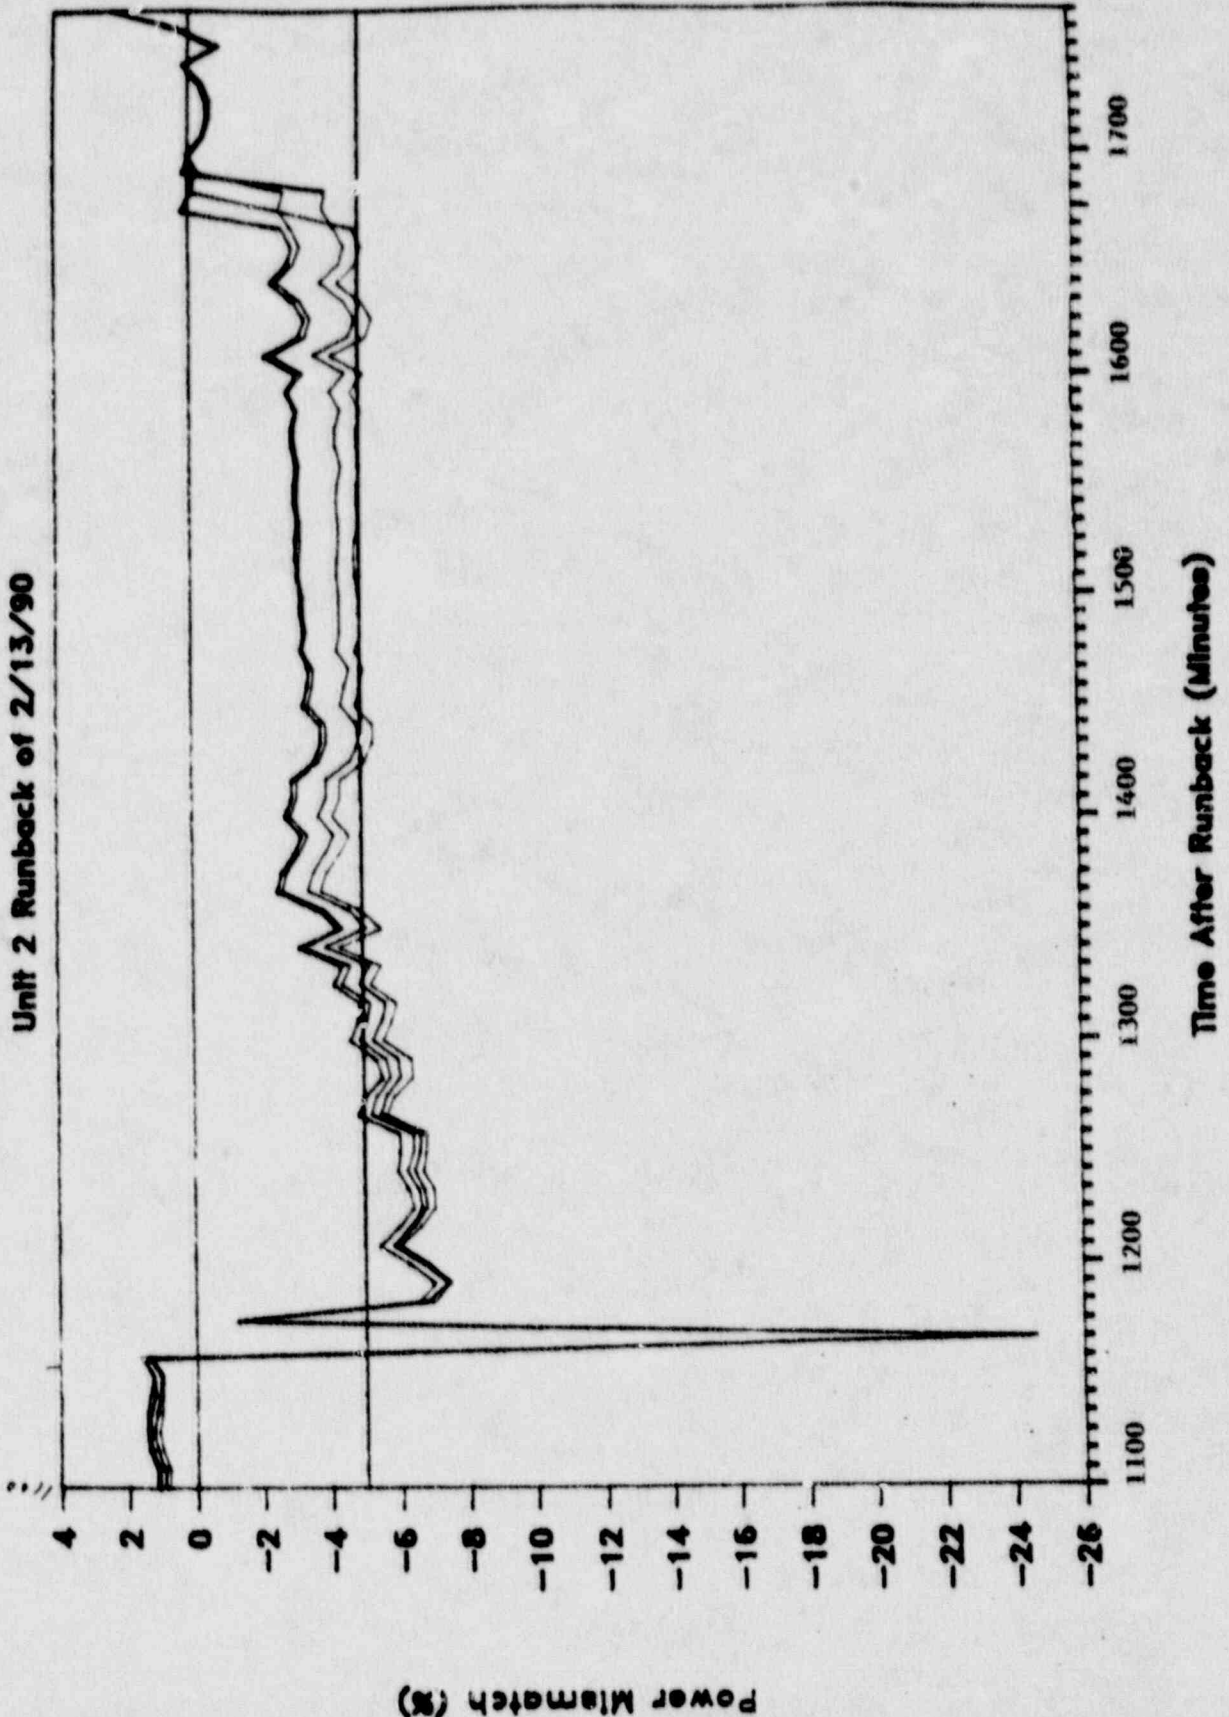
Power Mismatch values addressed in this paragraph and the graph on page 10 of 13 were obtained from the Operator Aid Computer (OAC) all points data base by Performance personnel after the event occurred. This information is not available to Operations personnel. Between 1150 and 1310, during rod withdrawal, the Power Mismatch oscillated between -7.5 percent and -5.0 percent for all four channels; however, the trend was toward -5.0 percent. At certain times during this period, some channels were recorded with a value of -4.0 percent. By 1335, all four channels had returned to within the +5.0 percent difference band. From 1415 to 1635, the Power Mismatch for one channel, Channel 42, oscillated from -4 percent to -5.3 percent. This was recorded for 12 five minute intervals. At 1750, all four channels spiked to +5.2 percent, but then returned to -3.8 percent which was the value prior to the spike. (See Table on page 11 of 13.)

The -24 percent Power Mismatch spike for all four excore detectors has been explained by Performance Reactor Group personnel as a lag in secondary heat balance calculations as compared to actual calorimetric power. This is because of the 200 Mw/minute runback rate for the Main Turbine. The secondary heat balance calculations are updated every minute.

- Subsequent:
- 1) MNS management requested Design Engineering to perform a design study to investigate and recommend alternatives to the transient power mismatch limit of ± 5 percent as currently interpreted by Design Engineering.
 - 2) Operations Employee Training and Qualification Coordinator issued required reading package 90-009-LS to all Licensed Operators and Operations staff personnel covering the TS interpretation on excore detectors and the graph shown on page 10 of 13 for this event.
