**Florida
Power**
CORPORATION

Subject: Crystal River Unit 3
Docket No. 50-302
Operating License No. DPR-72
Licensee Event Report No. 89-039-01

FACILITY NAME (1) CRYSTAL RIVER UNIT 3										DOCKET NUMBER (2) 0 5 0 0 0 3 0 2										PAGE (3) 1 OF 11																		
TITLE (4) Personnel Error Results in Operation Outside the 10 CFR 50 Appendix R Separation Design Basis																																						
EVENT DATE (5)						LER NUMBER (6)						REPORT DATE (7)						OTHER FACILITIES INVOLVED (8)																				
MONTH			DAY			YEAR			YEAR			SEQUENTIAL NUMBER			REVISION NUMBER			MONTH			DAY			YEAR			FACILITY NAMES						DOCKET NUMBER(S)					
																											N/A						0 5 0 0 0					
0 3 2 9			9 0			8 9			0 3 9			0 1 0			4 3 0 9			0			N/A						0 5 0 0 0											
OPERATING MODE (9) 5						THIS REPORT IS SUBMITTED PURSUANT TO THE REQUIREMENTS OF 10 CFR 5: (Check one or more of the following) (11)																																
POWER LEVEL (10) 0 0 0						20.402(b)						20.406(c)						60.73(a)(2)(iv)						73.71(b)

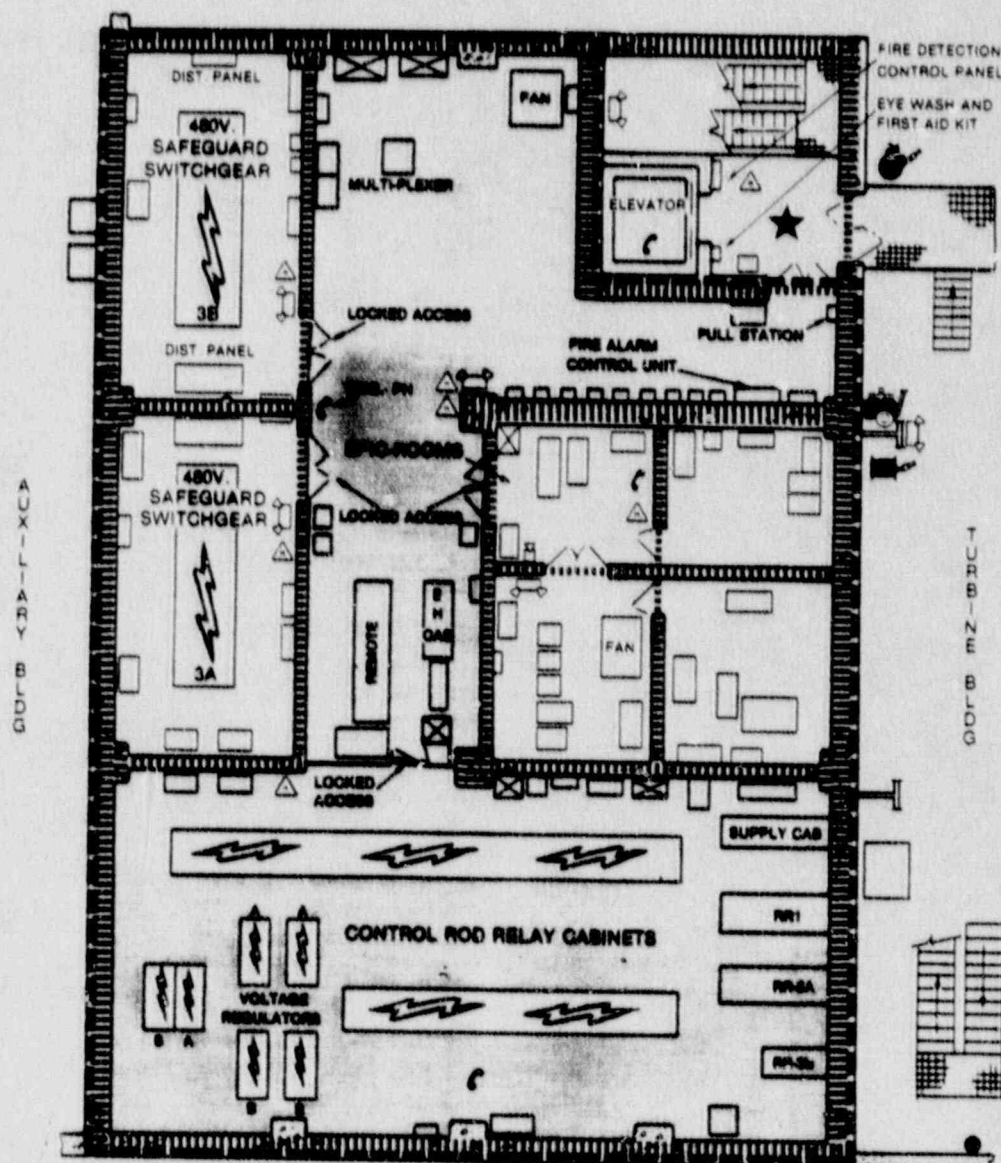
FIGURE 2

Each of the listed components (SWP-1A[CC,P], SWP-1B [CC,P] and RWP-2B [KG,P]) utilizes contacts from relays located in the CRD/Relay Room in their breaker closing control circuits. There are several fire areas on the 124' elevation of the control complex, shown on Figure 2. Each of the switchgear rooms and each of the Emergency Feedwater Initiation and Control (EFIC) [BA] rooms constitute a separate fire area. The remaining area, the corridors and CRD/Relay Room, shown shaded on Figure 2, constitute the seventh area. The Fire Study assumes that a fire in this shaded area would disable all equipment in that area. The relay circuits are presently listed as "Fail Safe" and thus not impact the pump operability. However, the current review revealed that certain hot shorts in these circuits could blow the fuse in the breaker closing control circuit rendering the pumps inoperable from the Main Control Room.

In the event of a concurrent loss of offsite power, RWP-2B [KG,P] and SWP-1B [CC,P] are considered the only reliable pumps because there is a potential for losing the "A" EDG [EK,DG] due to fire damage to relays and circuits.

Control of equipment required to shut down the plant might not be available from the main control room for a fire in the shaded area of Figure 2. This does not put the plant into an unrecoverable condition because the pumps could be started locally from the 4160 volt ESB switchgear.

ITEM 1
SWP-1A
SWP-1B
RWP-2B
EDG 'A'

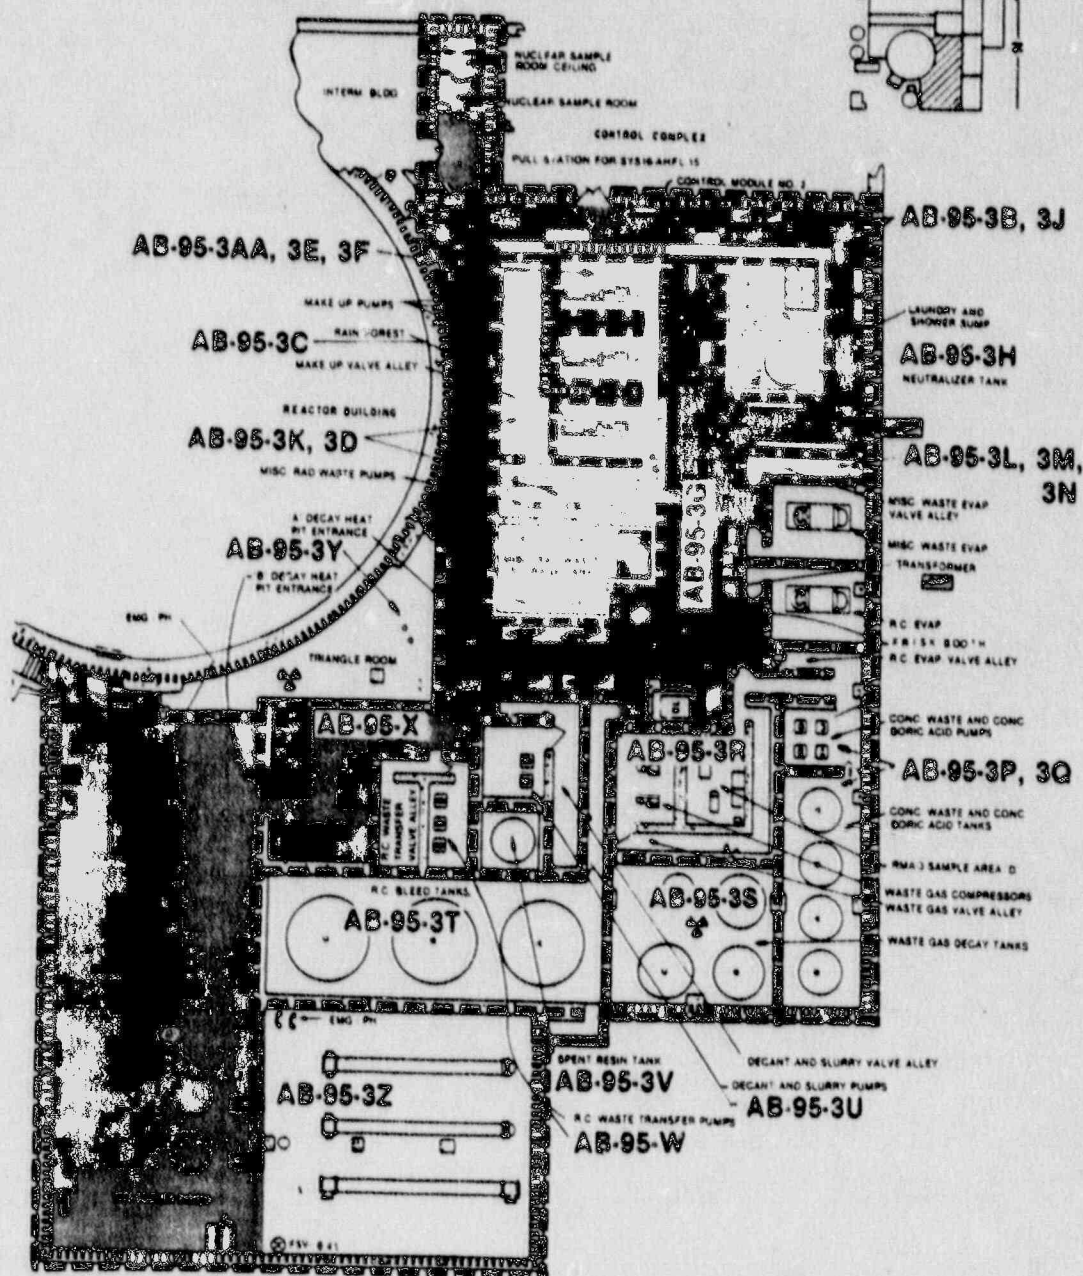
FIGURE 3

Figure 3 shows the Auxiliary Building 95' elevation. Most of this elevation is treated as a single fire area. This area includes the seawater room that contains both the A and B trains of the Emergency Nuclear Services Closed Cycle Cooling Water Pumps (SW pumps [CC,P]) and the Nuclear Services Seawater Pumps (RW pumps [KG,P]). It was assumed that one train would be operable, opposite the end of the room that the fire was in. This was acceptable because a fire on the 95' elevation of the Auxiliary Building would not affect the Emergency Diesel Generators (EDG's). The current review found a circuit for the power feed to ES MCC 3B1, which powers the fuel oil transfer pump for the "B" EDG, being routed through the seawater room. The fire could also disable the "B" train battery charger, making the DC powered backup fuel oil transfer pump unreliable.

This creates a situation where it is possible to postulate the loss of the "A" SW and RW pumps and the "B" EDG, a condition where it is not completely assured that at least one train of safe shutdown equipment is available in a common fire area.

Compensatory operator actions can prevent this situation from degenerating to an unrecoverable condition. The amount of fuel in the day tank for the "B" EDG allows enough time for the operators to cross-tie the ES 4160 volt busses. This evolution involves stripping all non-safe shutdown loads from the busses. This would allow the "B" SW and RW pumps to be powered by the "A" EDG.

ITEM 2
EDG 3B

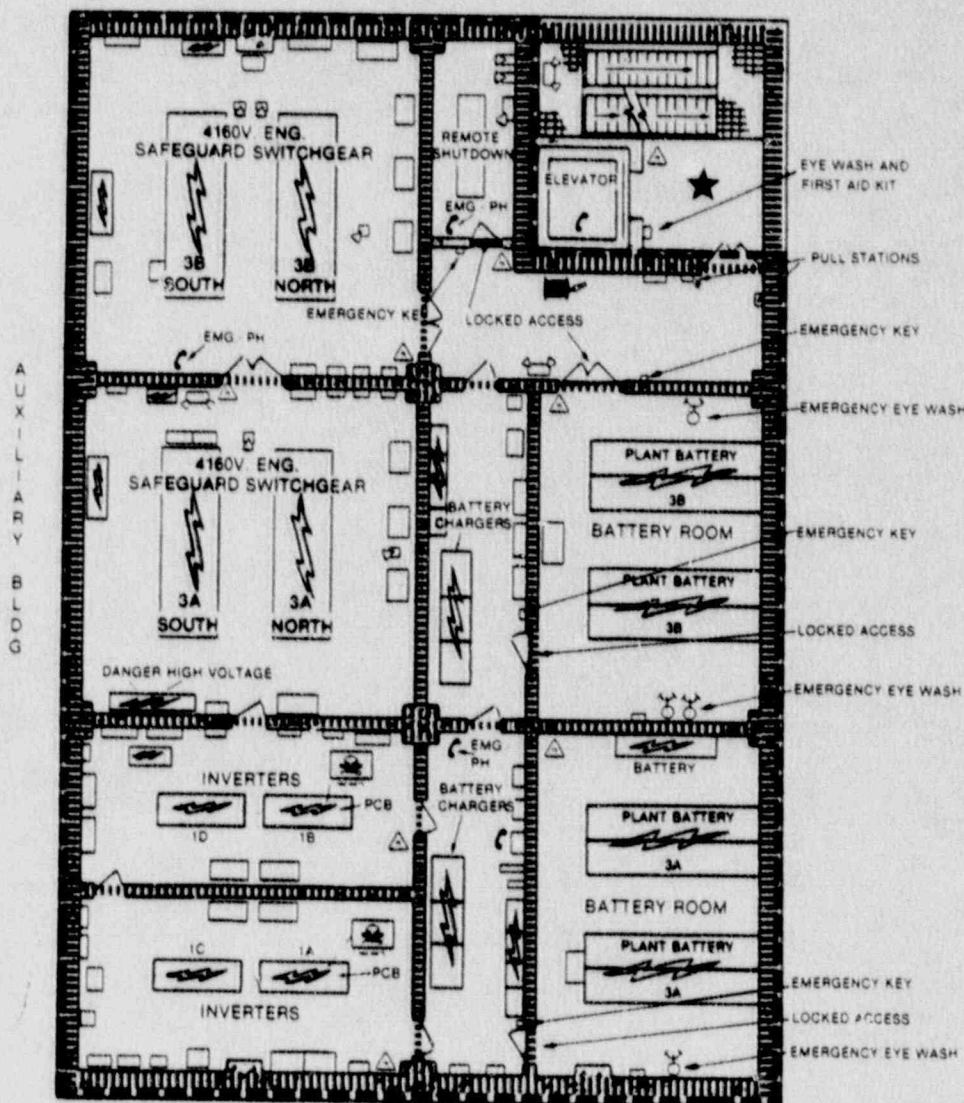
FIGURE 4

The circuits for the Train 1 indicators, RC-1-LT1, RC-4A-TE1 and SP-6A-PT1, are routed through the 4160 volt and 480 volt "B" ES switchgear rooms. See Figures 4 and 2 for layout showing the ES switchgear rooms. Since the indicators listed are Train 1 and the fire is in the "B" ES switchgear rooms, the Train 2 indicators must be assumed lost due to loss of all "B" power. Thus, both redundant trains of indication are lost.
