Subject: McGuire Nuclear Station Unit 2
Docket No. 50-370
Licensee Event Report 370/90-01-01

LICENSEE EVENT REPORT (LER)

On January 23, 1990, Design Engineering personnel discovered while performing a field survey, that solenoid valve 2IASV5160, Lower Air Lock Control Valve, mounted on the Personnel Air Lock (PAL) bulkhead, was within 1/2 inch of the stationary Bypass Leakage Enclosure (BLE). Valve 2IASV5160 would be pinched between the PAL bulkhead and the BLE under a worst case Loss Of Coolant (LOCA) Design Basis Accident condition. On January 26, 1990, the lower PAL outside door was declared inoperable under Technical Specification (TS) 3.6.1.3 because of the potential inoperability of solenoid valve 2IASV5160. On February 1, 1990, the valve was relocated to a column within the annulus area near the PAL. On February 12, 1990, solenoid valve 2IASV5160 was retroactively determined inoperable under TS 3.6.2 as a containment isolation valve versus originally determined lower PAL outside door inoperability under TS 3.6.1.3. This event is assigned a cause of Unanticipated Interaction of Components because of field routing. The new valve bracket and replacement solenoid valve were re

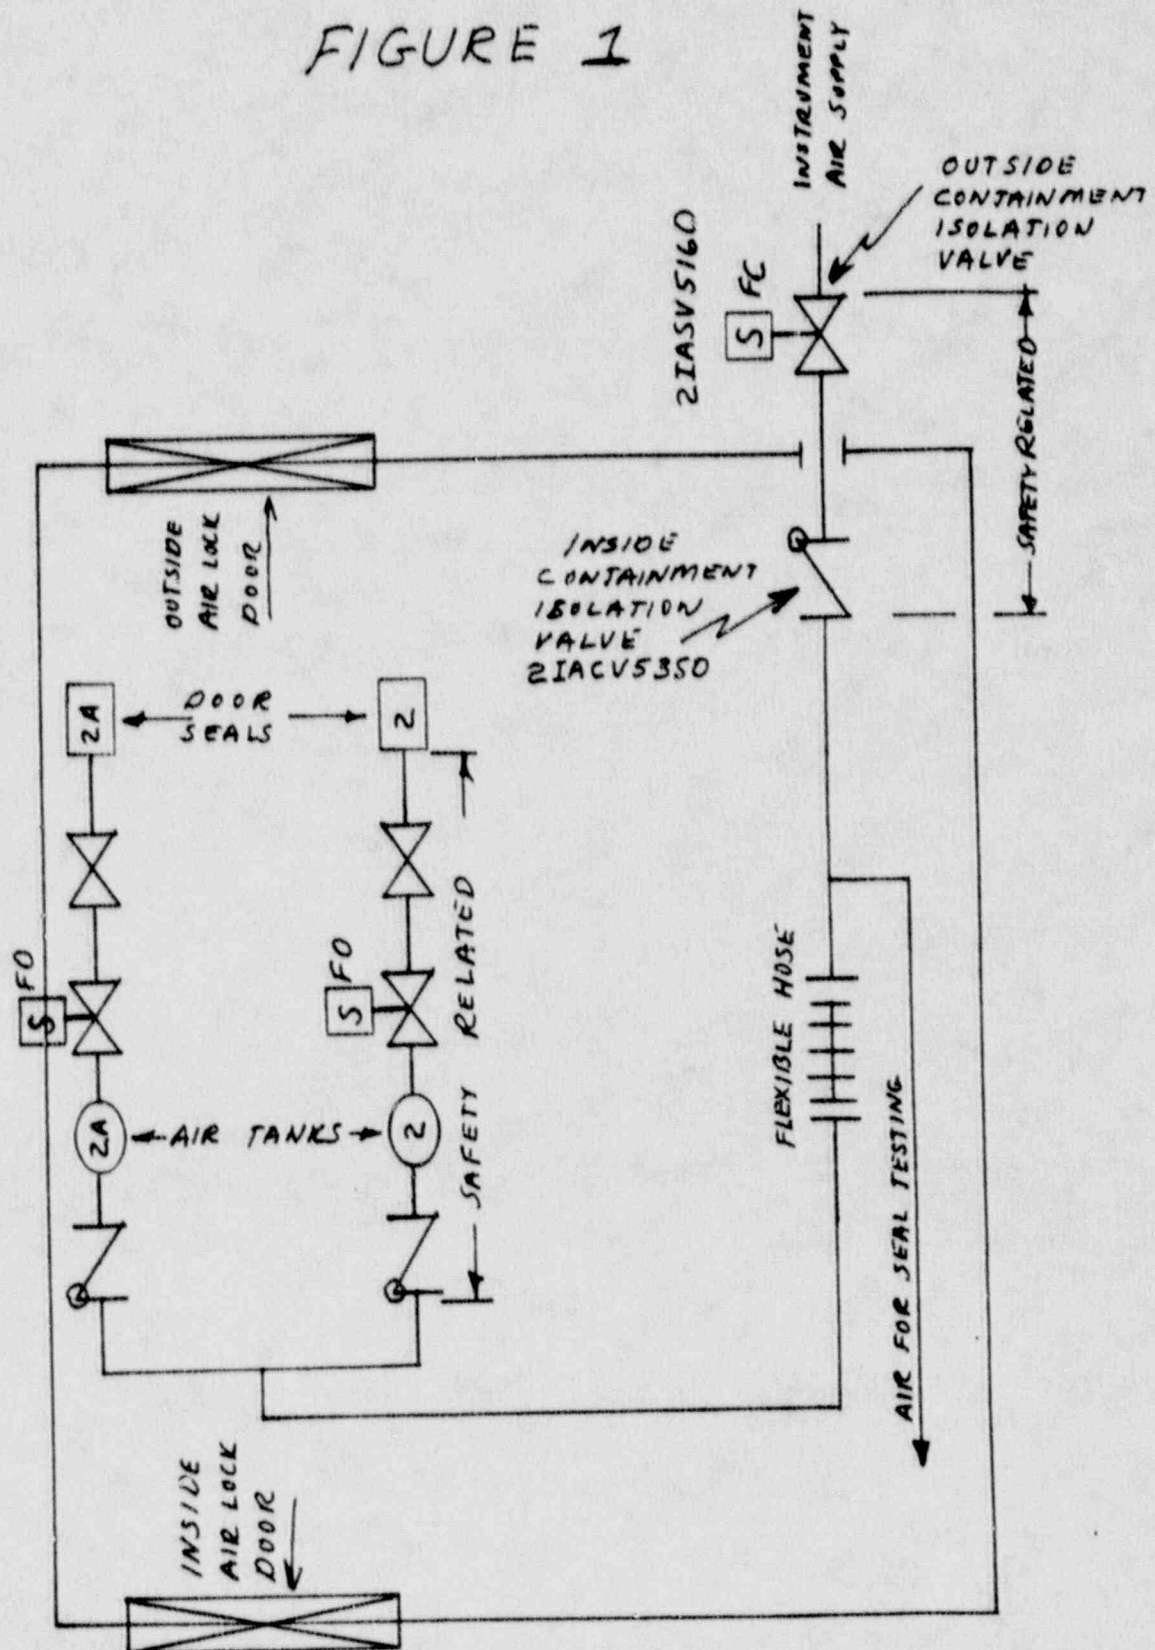
FIGURE 1

Solenoid valve 2IASV5160, Lower Personnel Air Lock Control, functions as an outside containment isolation valve, Figure 1 page 8. Valve 2IASV5160 was mounted on the Auxiliary Building [EIIS:Nf] side of the personnel air lock (PAL) barrel bulkhead. Displacement of the air lock bulkhead under postulated LOCA and seismic conditions are calculated in accordance with MCS 1108.00-00-0002, Specification For The Response Spectra And Seismic Displacements For Category 1 Structures, Revision 5. These displacements are 1.36 inches radially outward, 0.39 inches vertically and 0.21 inches laterally.

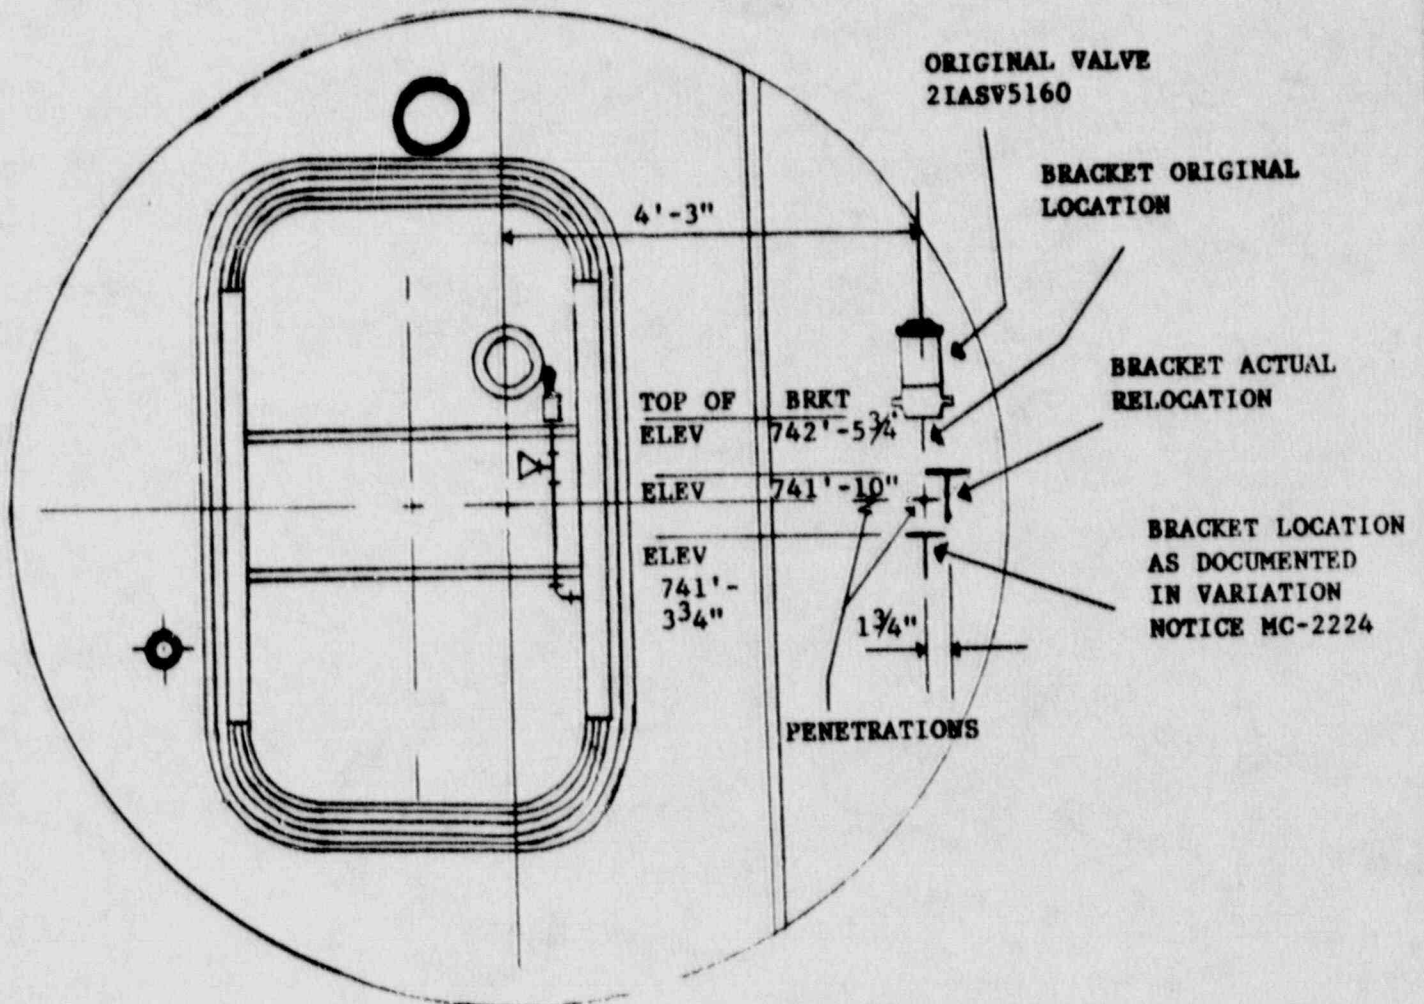
FIGURE 2
VALVE MOUNTING BRACKET
LOCATION DEPICTION

A second cause of Erroneous Documentation was assigned because variation notice MC-2224 did not reflect the actual location of the relocated valve bracket. Design Engineering personnel determined that the new location of the valve bracket/solenoid valve was acceptable based on the incorrect location information documented in the variation notice. The variation notice reflected the use of an extended bracket and a new elevation of approximately 730 feet 0 inches. The variation notice did not reflect any lateral relocation from the drawing specified 4 foot 3 inches PAL barrel center line to valve bracket center line. Design Engineer B took exception to the new bracket elevation since it represented a drop of over 12 feet. CMD personnel clarified the drop to be approximately 1 foot 2 inches versus 12 feet. Field surveys performed by Design Engineer B and CMD personnel on February 23 and 26, 1990, verified the actual bracket location. The new bracket was located approximately 1 3/4 inches laterally toward the outside of

the PAL barrel. Also, the bracket elevation was approximately 741 feet 10 inches versus approximately 741 feet 4 inches. Figure 2 Page 9 depicts graphic orientation of the different bracket locations. It could not be determined during this investigation how the incorrect location data was derived.

- Immediate: The inside PAL door was secured in the closed position to provide an additional flow path barrier from the Containment Building.
- Subsequent: Solenoid valve 2IASV5160 was relocated to an Auxiliary Building column under variation notice MEVN-2185. This was implemented by 2/1/90.
- Planned:
- 1) CMD-North Engineering and Craft personnel involved with the field relocation of valve 2IASV5160 will be instructed to ensure that all variations from original design are communicated and documented accurately.
 - 2) Project Services personnel will ensure that proper engineering analysis is performed, including Design Engineering review, and relocation coordinates are clearly documented when filed relocation of components is necessary.
 - 3) The Safety Review Group will perform an investigation to determine if any generic problems exist with the field routing practice.
