PLANT HATCH - UNIT 1
NRC DOCKET 50-321
OPERATING LICENSE DPR-57
STATUS OF IGSCC WELD EXAMINATIONS AND
PROPOSED WELD OVERLAY DESIGN

PLANT HATCH - UNIT 1
NRC DOCKET 50-321
OPERATING LICENSE DPR-57
LIMITED SCOPE EXPANSION OF
IGSCC WELD EXAMINATIONS

PLANT HATCH - UNIT 1
NRC DOCKET 50-321
OPERATING LICENSE DPR-57
PROPOSED WELD OVERLAY DESIGNS

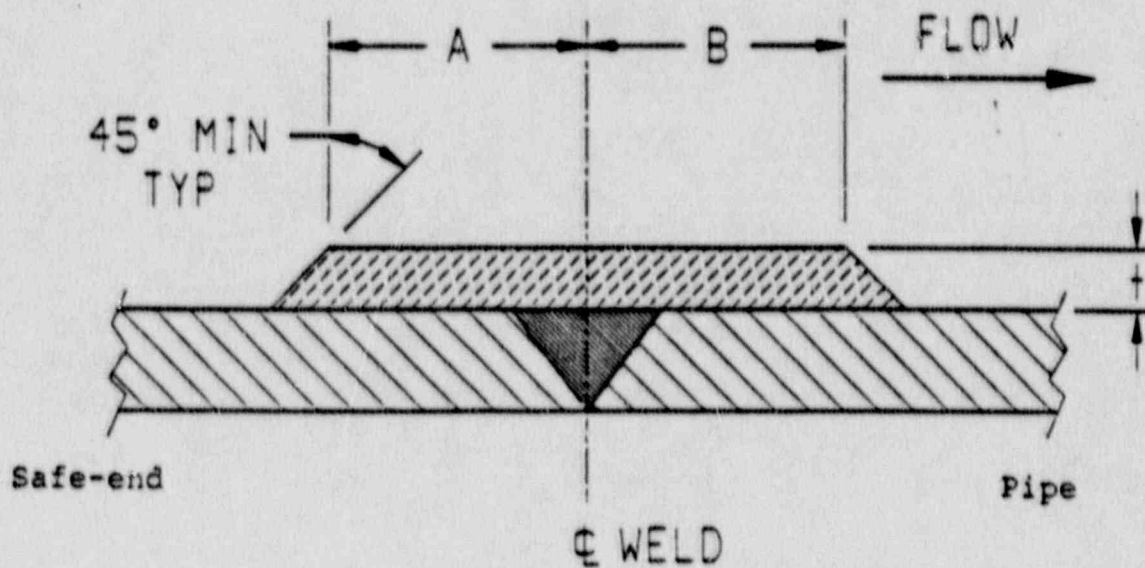
WELD NUMBER	FLAW CHARACTERIZATION	DESIGN DIMENSIONS			COMMENTS
		+	A	B	
1B31-1RC-28A-2	1) Circ 0.8" Long x 25% a/t 2) Circ 5.5" Long x 37% a/t 3) Circ 4" Long x 15% a/t 4) Circ 1 1/4" Long x 19% a/t	0.46"	3.20"	3.20"

PREPARED BY: <u><i>Laurel</i></u>		DATE: <u>3/30/90</u>	DESCRIPTION: Standard Weld Overlay Repair Design for Weld 1B31-1RC-28A-2 (per NUREG-0313, Revision 2)	
CHECKED BY: <u><i>Mike May</i></u>		DATE: <u>3/30/90</u>		
JOB NO: GPCO-18Q	PLANT / UNIT: Georgia Power Plant Hatch Unit 1		STRUCTURAL INTEGRITY ASSOCIATES INC.	
FILE NO: GPCO-18Q-301	DWG NO: GPCO-18Q-001			
			REV <u>1</u>	SHT 1 OF 2

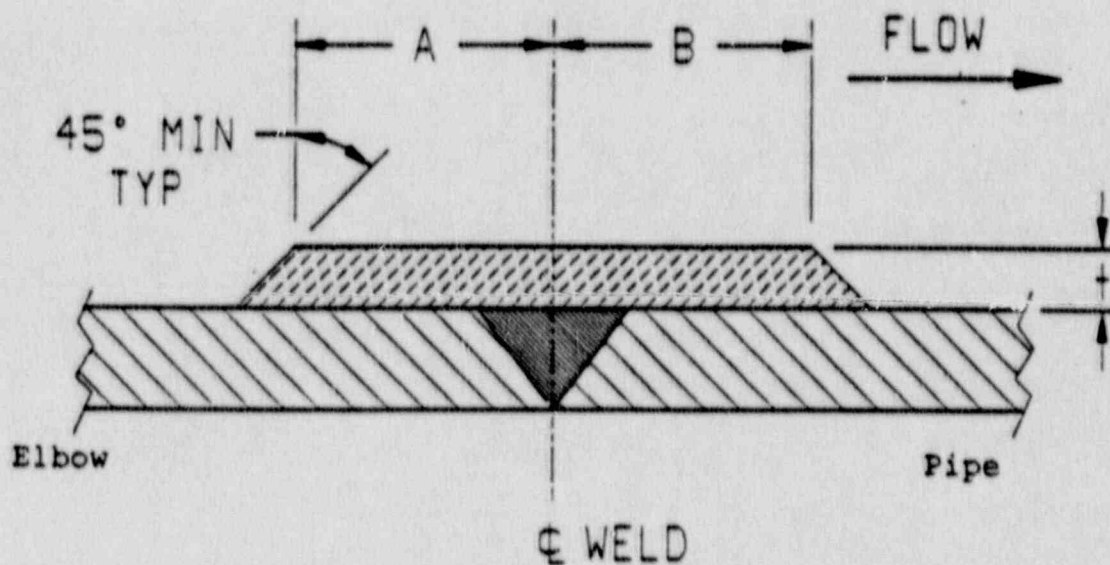
WELD NUMBER	FLAW CHARACTERIZATION	DESIGN DIMENSIONS			COMMENTS
		t	A	B	
1B31-1RC-28A-4	8 Axial Flaws Plus 1) Circ 6.85" Long x 19% a/t 2) Circ 5" Long x 17% a/t 3) Circ 6" Long x 23% a/t 4) Circ 3 1/4" Long x 54% a/t	0.45"	3.20"	3.20"

PREPARED BY: <i>[Signature]</i>	DATE 3/30/90	DESCRIPTION: Standard Weld Overlay Repair Design for Weld 1B31-1RC-28A-4 (per NUREG-0313, Revision 2)
CHECKED BY: <i>[Signature]</i>	DATE 3/30/90

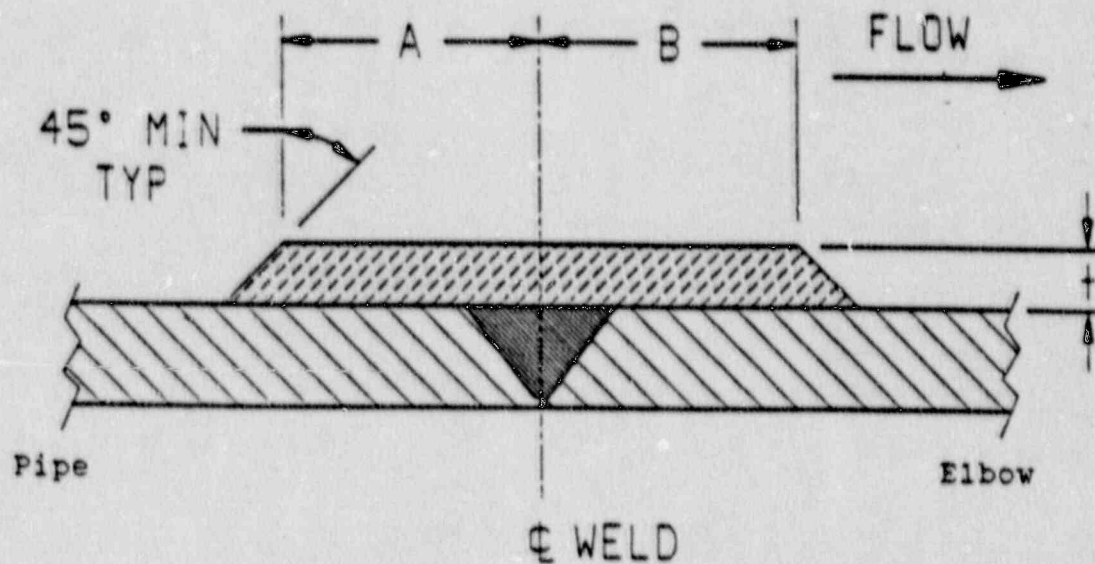
WELD NUMBER	FLAW CHARACTERIZATION	DESIGN DIMENSIONS			COMMENTS
		+	A	B	
1B31-1RC-28A-6	3 Axial Flaws plus 1) Circ. 1.75" long x 10% a/t 2) Circ. 2.2" long x 17% a/t 3) Circ. 1.2" long x 9% a/t 4) Circ. 4.7" long x 12% a/t	0.44"	3.10"	3.10"

PREPARED BY: 	DATE: 3/30/90	DESCRIPTION: Standard Weld Overlay Repair Design for Weld 1B31-1RC-28A-6 (per NUREG-0313, Revision 2)
CHECKED BY: 	DATE: 3/30/90

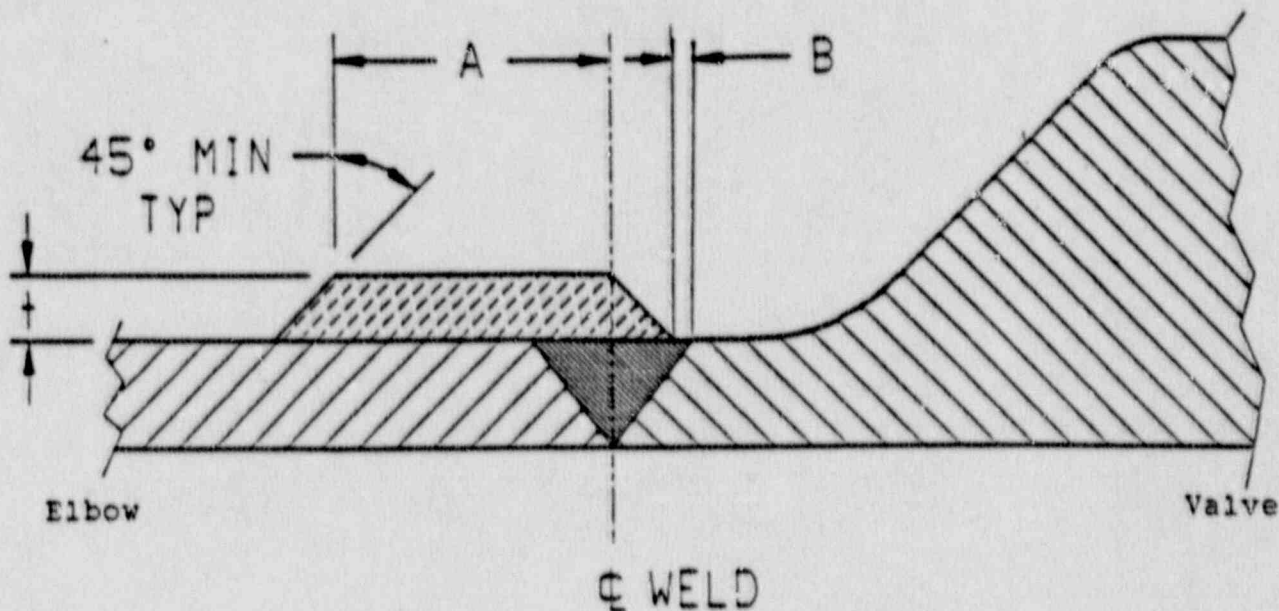
WELD NUMBER	FLAW CHARACTERIZATION	DESIGN DIMENSIONS			COMMENTS
		t	A	B	
1B31-1RC-28B-8	7 Axial Flaws plus 1) Circ. 0.6" long x 25% a/t	0.44"	3.50"	≥0.125"

PREPARED BY: <i>L. H. Hsieh</i>	DATE 3/30/90	DESCRIPTION: Standard Weld Overlay Repair Design for Weld 1B31-1RC-28B-8 (per NUREG-0313, Revision 2)
CHECKED BY: <i>Mike Hsieh</i>	DATE 3/30/90

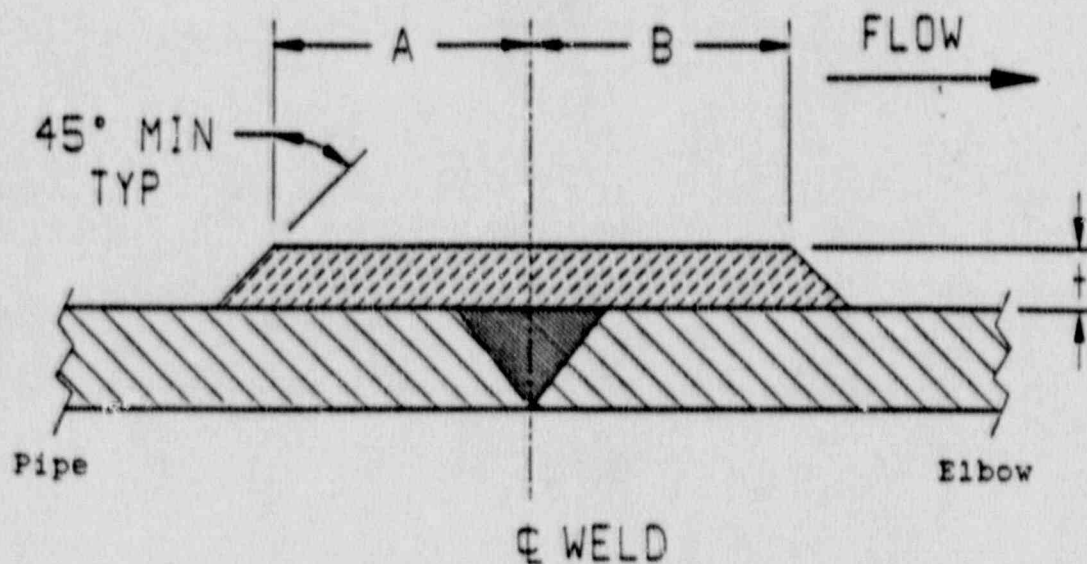
WELD NUMBER	FLAW CHARACTERIZATION	DESIGN DIMENSIONS			COMMENTS
		t	A	B	
1B31-1RC-28B-10	2 Axial Flaws plus 1) Circ 2.5" long x 33% a/t 2) Circ 1" long x 33% a/t 3) Circ 17" long x 21% a/t	0.44"	3.10"	3.10"

PREPARED BY: <u><i>Jackie</i></u> DATE: <u>3/30/90</u>		DESCRIPTION: Standard Weld Overlay Repair Design for Weld 1B31-1RC-28B-10 (per NUREG-0313, Revision 2)	
CHECKED BY: <u><i>Phil King</i></u> DATE: <u>3/30/90</u>			
JOB NO: GPCO-18Q	PLANT / UNIT: Georgia Power Plant Hatch Unit 1

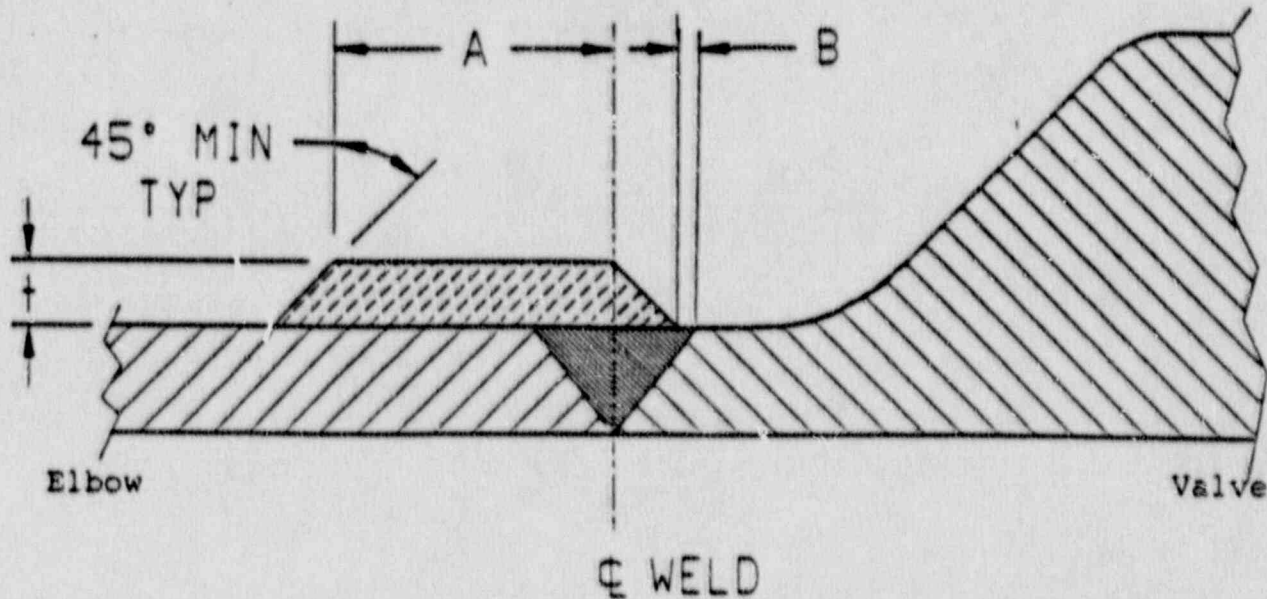
WELD NUMBER	FLAW CHARACTERIZATION	DESIGN DIMENSIONS			COMMENTS
		t	A	B	
1B31-1RC-28A-7		0.49"	3.50"	≥0.125"

Standard Weld Overlay Repair Design
for Weld 1B31-1RC-28A-7
(per NUREG-0313, Revision 2)

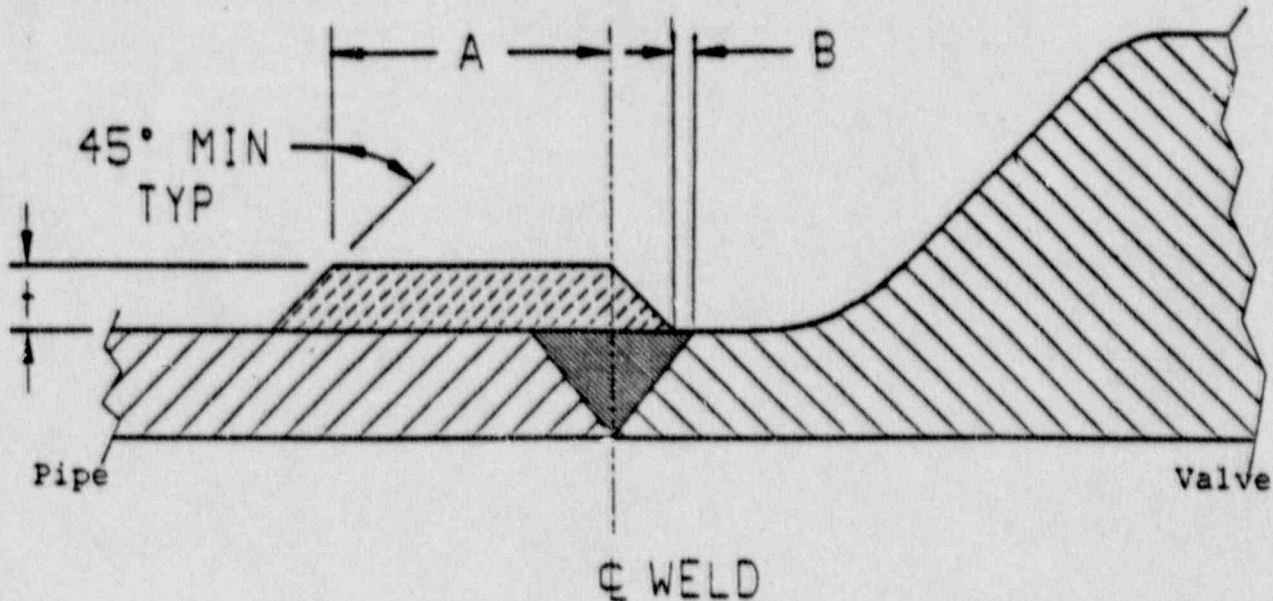
WELD NUMBER	FLAW CHARACTERIZATION	DESIGN DIMENSIONS			COMMENTS
		t	A	E	
1B31-1RC-28A-8		0.43"	3.50"	≥0.125"

Standard Weld Overlay Repair Design
for Weld 1B31-1RC-28A-8
(per NUREG-0313, Revision 2)

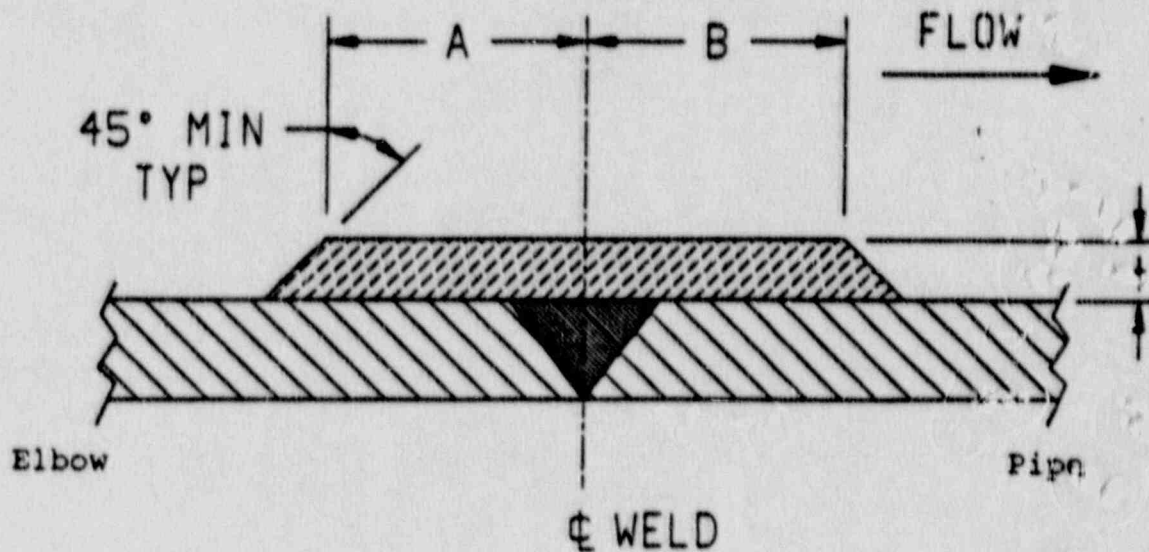
Weld 28A-14 (Elbow to Pipe) was inspected in 1990 with nine new axial indications being detected. Six axial indications (15-37% through-wall) were detected using the 45° shear wave. Three axial indications (26-34% through-wall) were detected with the 60° refracted longitudinal wave, but were not seen with the 45° shear wave. Comparison of the 1988 and 1990 45° shear wave data shows that there were no recordable indications during the 1988 examinations in the area of interest.

WELD NUMBER	FLAW CHARACTERIZATION	DESIGN DIMENSIONS			COMMENTS
		t	A	B	
1B31-1RC-28A-14		0.52"	3.35"	3.35"

PREPARED BY: <u><i>L. R. R. R.</i></u>		DATE: <u>4/16/90</u>		DESCRIPTION: Standard Weld Overlay Repair Design for Weld 1B31-1RC-28A-14 (per NUREG-0313, Revision 2)	
CHECKED BY: <u><i>J. F. G. G.</i></u>		DATE: <u>4-16-90</u>			
JOB NO: GPCO-18Q		PLANT / UNIT: Georgia Power Plant Hatch Unit 1

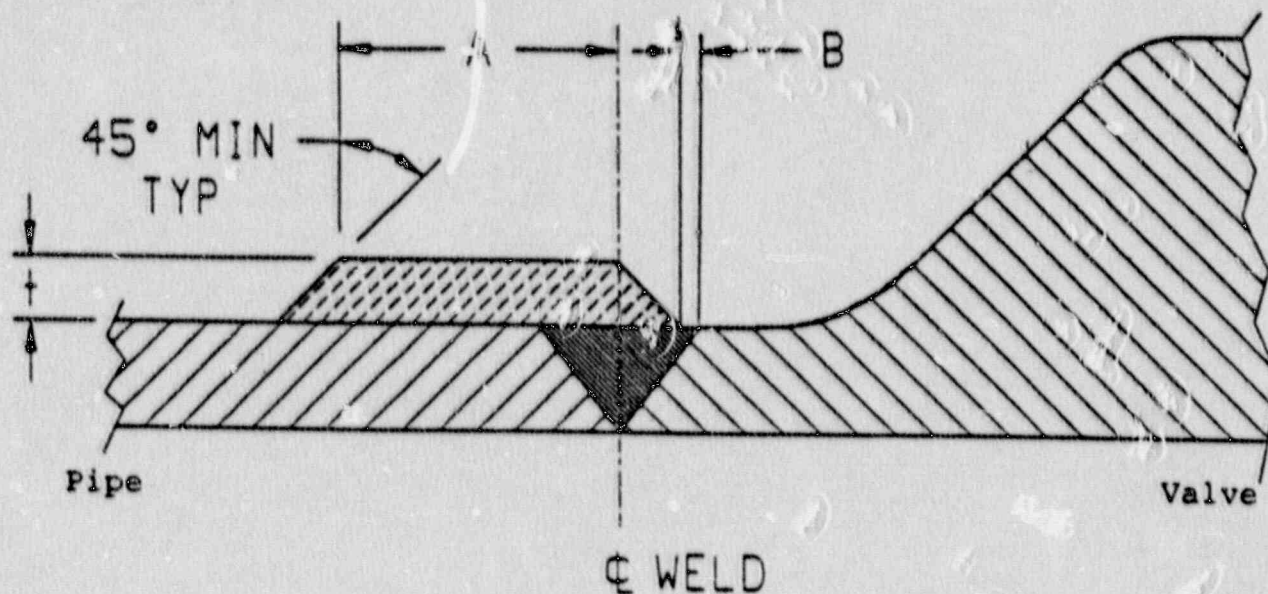
Weld 28B-9 (Valve to Pipe) was inspected in 1990 with three new circumferential indications being detected with the 45° shear wave and confirmed with the 60° refracted longitudinal. These indications are 4" long by 37% through-wall, 2" long by 13% through-wall, and 6" long by 25% through-wall. Through-wall measurements given are maximum for the indication and not for the entire length. Comparison of the 1988 and 1990 45° shear wave data shows that there were heavy root geometry type signals present during the 1988 examinations.

WELD NUMBER	FLAW CHARACTERIZATION	DESIGN DIMENSIONS			COMMENTS
		t	A	B	
1B31-1RC-28B-9		0.44"	3.5"	20.125"

PREPARED BY: <i>h. h. h.</i>	DATE <i>4/16/90</i>	DESCRIPTION: Standard Weld Overlay Repair Design for Weld 1B31-1RC-28B-9 (per NUREG-0313, Revision 2)
CHECKED BY: <i>J. F. G. G.</i>	DATE <i>4-16-90</i>

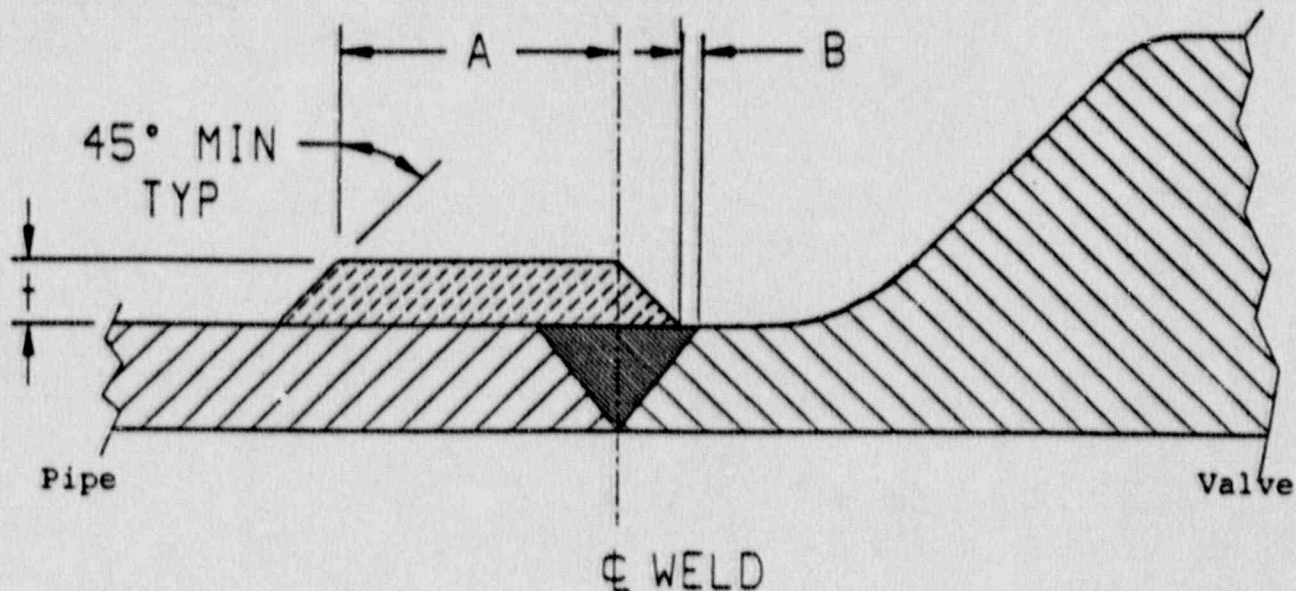
WELD NUMBER	FLAW CHARACTERIZATION	DESIGN DIMENSIONS			COMMENTS
		+	A	B	
1B31-1RC-28B-13		0.52"	3.5"	≥0.125"

PREPARED BY: <u>hastie</u> DATE: <u>4/16/90</u>		DESCRIPTION: Standard Weld Overlay Repair Design for Weld 1B31-1RC-28B-13 (per NUREG-0313, Revision 2)	
CHECKED BY: <u>J.F. Copeland</u> DATE: <u>4-16-90</u>			
JOB NO: GPCO-18Q	PLANT / UNIT: Georgia Power Plant Hatch Unit 1

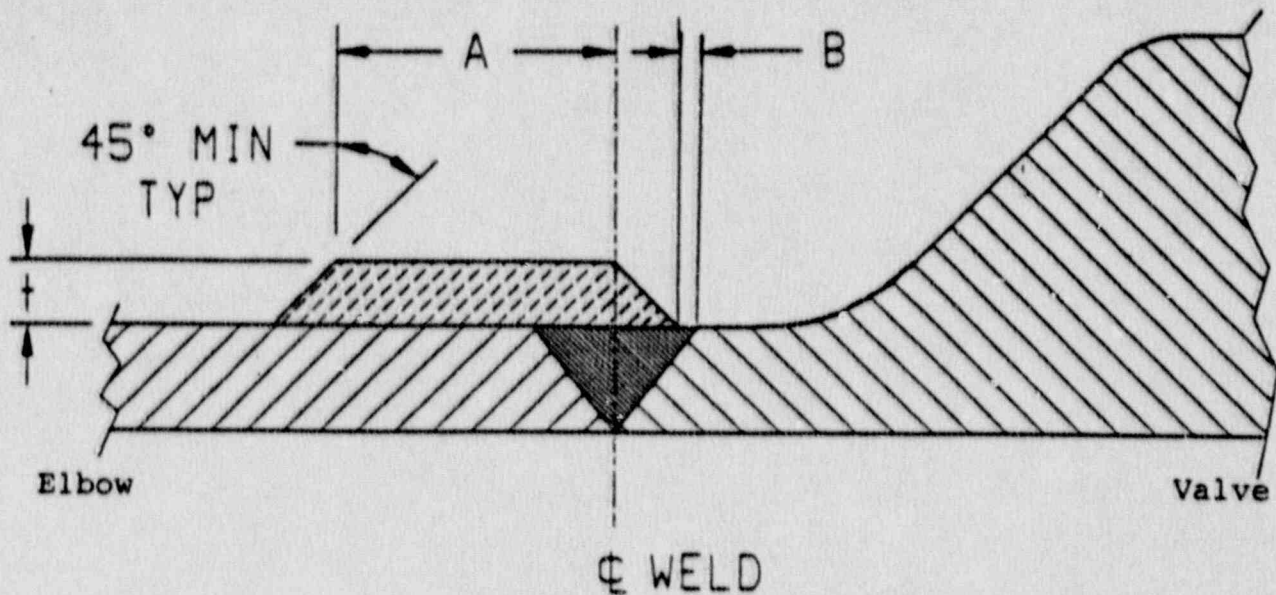
WELD NUMBER	FLAW CHARACTERIZATION	DESIGN DIMENSIONS			COMMENTS
		+	A	B	
1B31-1RC-28B-14		0.52"	3.5"	≥0.125"

Standard Weld Overlay Repair Design
for Weld 1B31-1RC-28B-14
(per NUREG-0313, Revision 2)

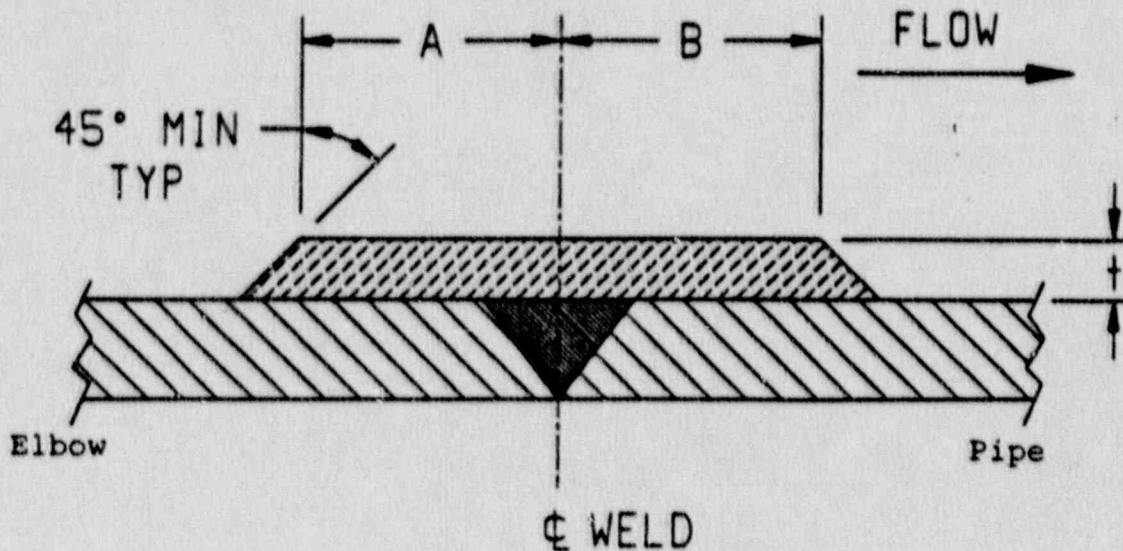
Table 2 presents the flaw characterizations for the seven 28" Category C welds which will be overlayed. Note that weld 28B-15 shows considerably more cracking than the other welds in the table. This weld was not examined last outage but was examined two outages ago in 1987. Weld 28B-15 had indications of heavy root geometry when inspected in 1984, 1985/86 (pre- and post- IHSI) and in 1987. As part of the process to evaluate the IGSCC indications found this outage, the previous 1987 data was again reviewed. This detailed review of the 1987 data indicated a possible change in indications as compared to previous (1984, 1985) exams. It appears that these indications could have been evaluated as "IGSCC-like" indications during the 1987 inspections but were not because of the pre-existing heavy root conditions. In light of this information, the examination histories for all Category C welds not examined this outage were reviewed. The results of this evaluation showed no other suspicious indications that warrant further examination.

WELD NUMBER	FLAW CHARACTERIZATION	DESIGN DIMENSIONS			COMMENTS
		t	A	B	
1B31-1RC-28B-15		0.52"	3.35"	3.35"

PREPARED BY: <u><i>Hardie</i></u>		DATE: <u>4/16/90</u>		DESCRIPTION: Standard Weld Overlay Repair Design for Weld 1B31-1RC-28B-15 (per NUREG-0313, Revision 2)	
CHECKED BY: <u><i>J.F. Copeland</i></u>		DATE: <u>4-16-90</u>			
JOB NO: GPCO-18Q		PLANT / UNIT: Georgia Power Plant Hatch Unit 1
