The attached LER 90-11, Revision 0, is being sent to you as required under 10 CFR 50.73.

FACILITY NAME (1) Calvert Cliffs, Unit 1										DOCKET NUMBER (2) 0 5 0 0 0 3 1 7 1				PAGE (3) 1 OF 06			
TITLE (4) Power Operated Relief Valve Inoperability Due to Open Overload Contact																	
EVENT DATE (5)			LER NUMBER (6)				REPORT DATE (7)			OTHER FACILITIES INVOLVED (8)							
MONTH	DAY	YEAR	YEAR	SEQUENTIAL NUMBER	REVISION NUMBER	MONTH	DAY	YEAR	FACILITY NAMES				DOCKET NUMBER(S)				
03	3	09	09	01	1	00	04	3	09	0	5	0	0	0			
OPERATING MODE (9) 5		THIS REPORT IS SUBMITTED PURSUANT TO THE REQUIREMENTS OF 10 CFR 5. (Check one or more of the following) (11)															
POWER LEVEL (10) 01010		20.402(b)				20.408(e)				50.73(a)(2)(iv)				73.71(b)

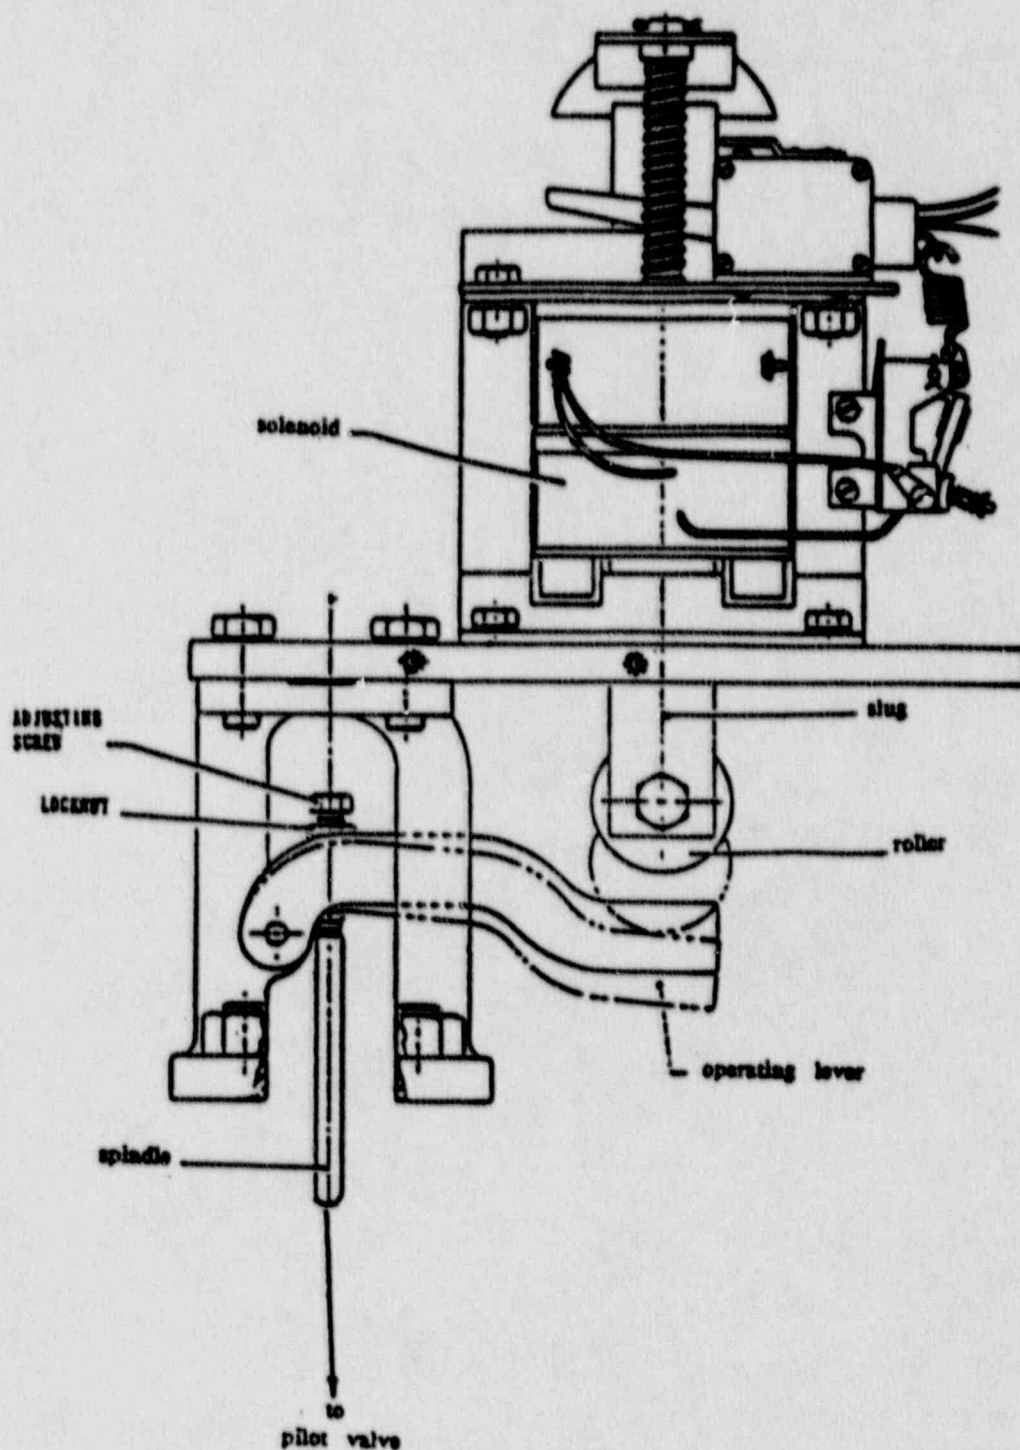
Figure 1 is a simplified drawing of the ERV-402 assembly. Upon receipt of an actuation signal, the solenoid (EIIS AB-SOL) forces down the slug which depresses the operating lever. A roller at the end of the slug reduces the frictional forces between the slug and the operating lever, allowing easier movement of the latter. The operating lever forces down the spindle, opening a pilot valve (EIIS AB-LOV) which bleeds off steam from the main valve. The resulting pressure differential causes the main valve to open. An adjusting nut on top of the spindle allows for calibration and adjustment of the assembly.

Upon further investigation, the roller at the end of the slug was found to be frozen in place. With the roller removed, the slug was found to travel an extra 1/4 inch. The current was measured at 1.4 amperes. The roller was replaced with one that moved freely and the pilot valve was slightly readjusted. The current remained at 1.4 amperes, within design, and the valve functioned properly. No chatter was observed in the solenoid.

The immediate cause of this condition was the inability of the slug to extend its full length which prevented it from reaching magnetic center. This caused the chatter in the solenoid and required excess current to be drawn to operate the valve. Movement of the slug was inhibited by the stuck roller which applied additional friction force increasing the current necessary to open the valve and may have caused a moment between the slug and the lever arm preventing free movement of the slug. The slug had been positioned high during its last readjustment but was within the tolerance specified by the manufacturer. The combination of the high positioning of the slug and the stuck roller prevented the slug from reaching magnetic center.

The available evidence indicates that the roller had been stuck since the initial installation of the valve. The bearing on which the roller was mounted was too short to prevent the roller from being clamped in place when the bolt running through the bearing was tightened. The vendor information provided did not include any guidance on the significance of a freely moving roller. No examination of the roller or solenoid was performed to verify that full travel of the slug was not interfered with. There was no procedural requirement to examine the solenoid or roller and repair identified problems. This insufficient monitoring and followup of physical problems with the PORVs was the root cause of this condition.

1. A procedure will be initiated to require that all PORVs are inspected periodically to prevent problems from developing which may inhibit operability of the valve. This procedure will also require that the current to the solenoid be checked.

2. The procedure for overhauling the PORVs, RCS-25, will be revised to require that, while the pilot valve setting is being adjusted, full extension of the slug is visually verified.
