SUBJECT: Licensee Event Report 93-001-00, Final Report

LICENSEE EVENT REPORT (LER)

Fort St. Vrain Unit No. 1

Overflow of Radioactive Liquid Effluent Line

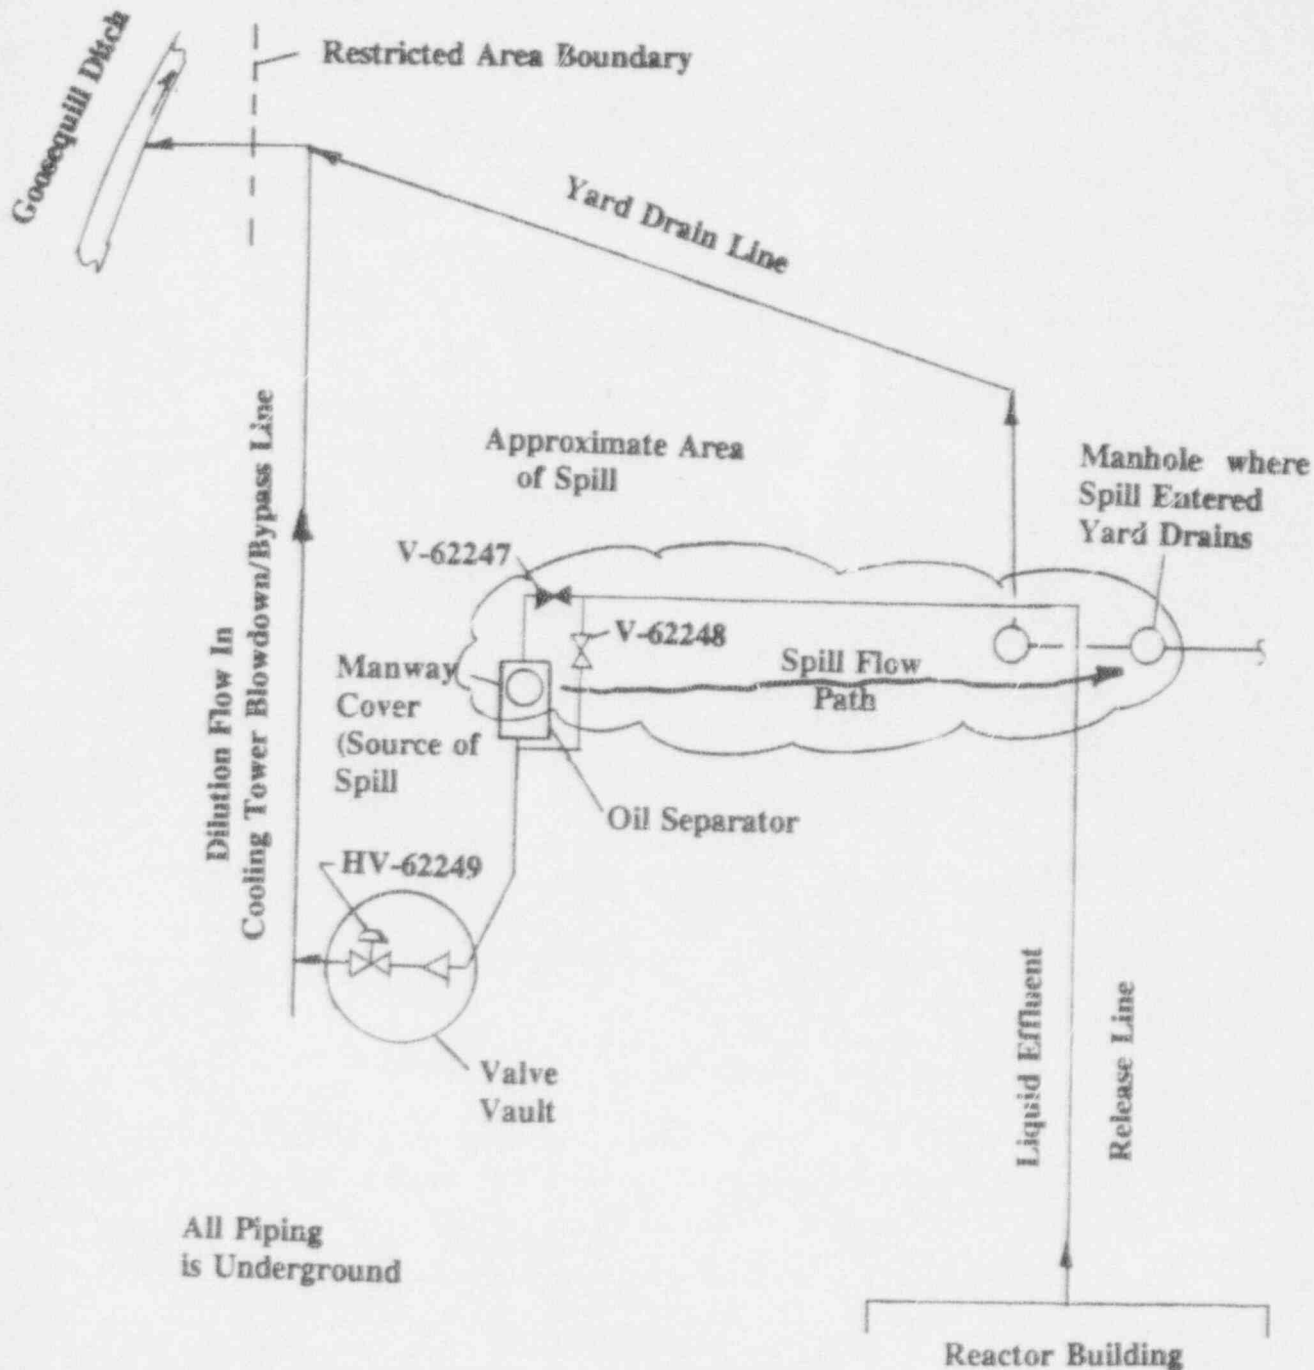
FIGURE SHOWING SPILL
FROM OIL SEPARATOR TO
YARD DRAINS

Radioactive liquid effluent is released through underground piping that includes an oil separator and a remotely operated isolation valve, as shown on the attached figure. The oil separator serves mainly to remove oils from discharges from the reactor building sump. During batch releases from the radioactive liquid waste system, the oil separator is normally isolated by closing V-62247 and opening the bypass line through V-62248. Radioactive liquid effluent then enters the yard drain system where it mixes with and is diluted by water from on-site storage ponds. This dilution flow is referred to as cooling tower blowdown or bypass flow, and is provided by the circulating water makeup pumps at a flowrate that typically provides dilution of at least a factor of 110.

At approximately 0120 hours on January 27, 1993, an FSV Equipment Operator discovered that the oil separator in the radioactive liquid effluent release line had overflowed and water had spilled onto the ground, in an area within the FSV restricted area. Water flowed out of the underground oil separator through a vented manway cover, and flowed east for a total distance of about 110 feet. Along the way this water could have entered an alternate portion of the yard drain system through a vented manhole cover. It then would have flowed approximately 400 feet through this alternate underground yard drain before being diluted by cooling tower blowdown flow, which was being discharged through the normal connecting drain line. From that point, it flowed through the normal release path out of the restricted area, into the Goosequill Ditch, and eventually offsite.

The cause of the oil separator overflow is believed to have been an ice plug that blocked the downstream release line and caused the release to back up into the oil separator. The release line downstream of the oil separator is a 6-inch line that reduces to a 3-inch line just before entering the yard drain system at the cooling tower blowdown/ bypass line. This 3-inch section includes a remote operated isolation valve (HV-62249), located about 8 feet underground in a concrete vault/manway, about 40 feet downstream of the oil separator.

The cause or location of the blockage was not evident, especially since this has never happened before at Fort St. Vrain. Engineering and maintenance personnel suspected that the blockage was located at the isolation valve (HV-62249), because it is located in the smallest part of the line. During an inspection of the valve, ice was observed around its position indicating limit switches, and an ice plug in the line was suspected, even though the line is 8 feet underground and was thought to be sufficiently protected.

The area had experienced sub-freezing weather for an extended period before the spill, and the location of the valve in the vault/manway could have exposed it to these low temperatures. Also, HV-62249 is normally closed after a liquid effluent release and the line slopes down from the oil separator to the valve, potentially trapping a volume of water on the upstream side of the closed valve. A portable heater was lowered into the valve vault, and by the next morning the release line was flowing freely. Based on this, PSC considers that an ice plug in the 3-inch section of the release line downstream of the oil separator is the most likely cause of the blockage described above. PSC also considers it likely that this blockage existed, to at least a partial extent, before radioactive liquid waste release number 1575 was initiated, and that some of this release was probably made through the manway into the yard drain system.

The immediate corrective action was to dam the manholes into the yard drain system to prevent any further drainage. Also, the ice plug was thawed by use of a heater and a free release path was restored.

The 3-inch valve (HV-62249) and piping in the valve vault area have been heat-traced to prevent future freezing. This is the most likely place for ice to form, since the remainder of this release line is a 6-inch line that is buried 8 feet underground.
