Joseph M. Farley Nuclear Plant - Unit 1  
Steam Generator Tube Analysis Results

SUMMARY OF EXAMINATION CONDUCTED ON FARLEY UNIT 1  
STEAM GENERATOR TUBING

Two hot leg steam generator tube segments from Farley Unit 1 (Tubes R14-C80 from S/G B and R19-C41 from S/G A) were examined in January-February, 1993 at the Westinghouse Science and Technology Center. The examination was conducted to provide supporting data for the development of alternative plugging criteria specific to support plate crevice corrosion at Farley Unit 1. The tubes were selected to obtain two of the highest bobbin voltages (>3 volts) found in the 1992 eddy current inspection and to obtain differences in RPC response features. One indication had well defined multiple axial indications while the other had a more volumetric RPC response typical of closely spaced axial indications. The tubesheet top (TST) and support plate (SP) regions were nondestructively examined. Subsequently, elevated temperature leak testing and room temperature burst testing were conducted on SP2 of Tube R14-C80 and SP1 of Tube R19-C41, the locations with the largest voltage NDE indications. The burst tested specimens were then destructively

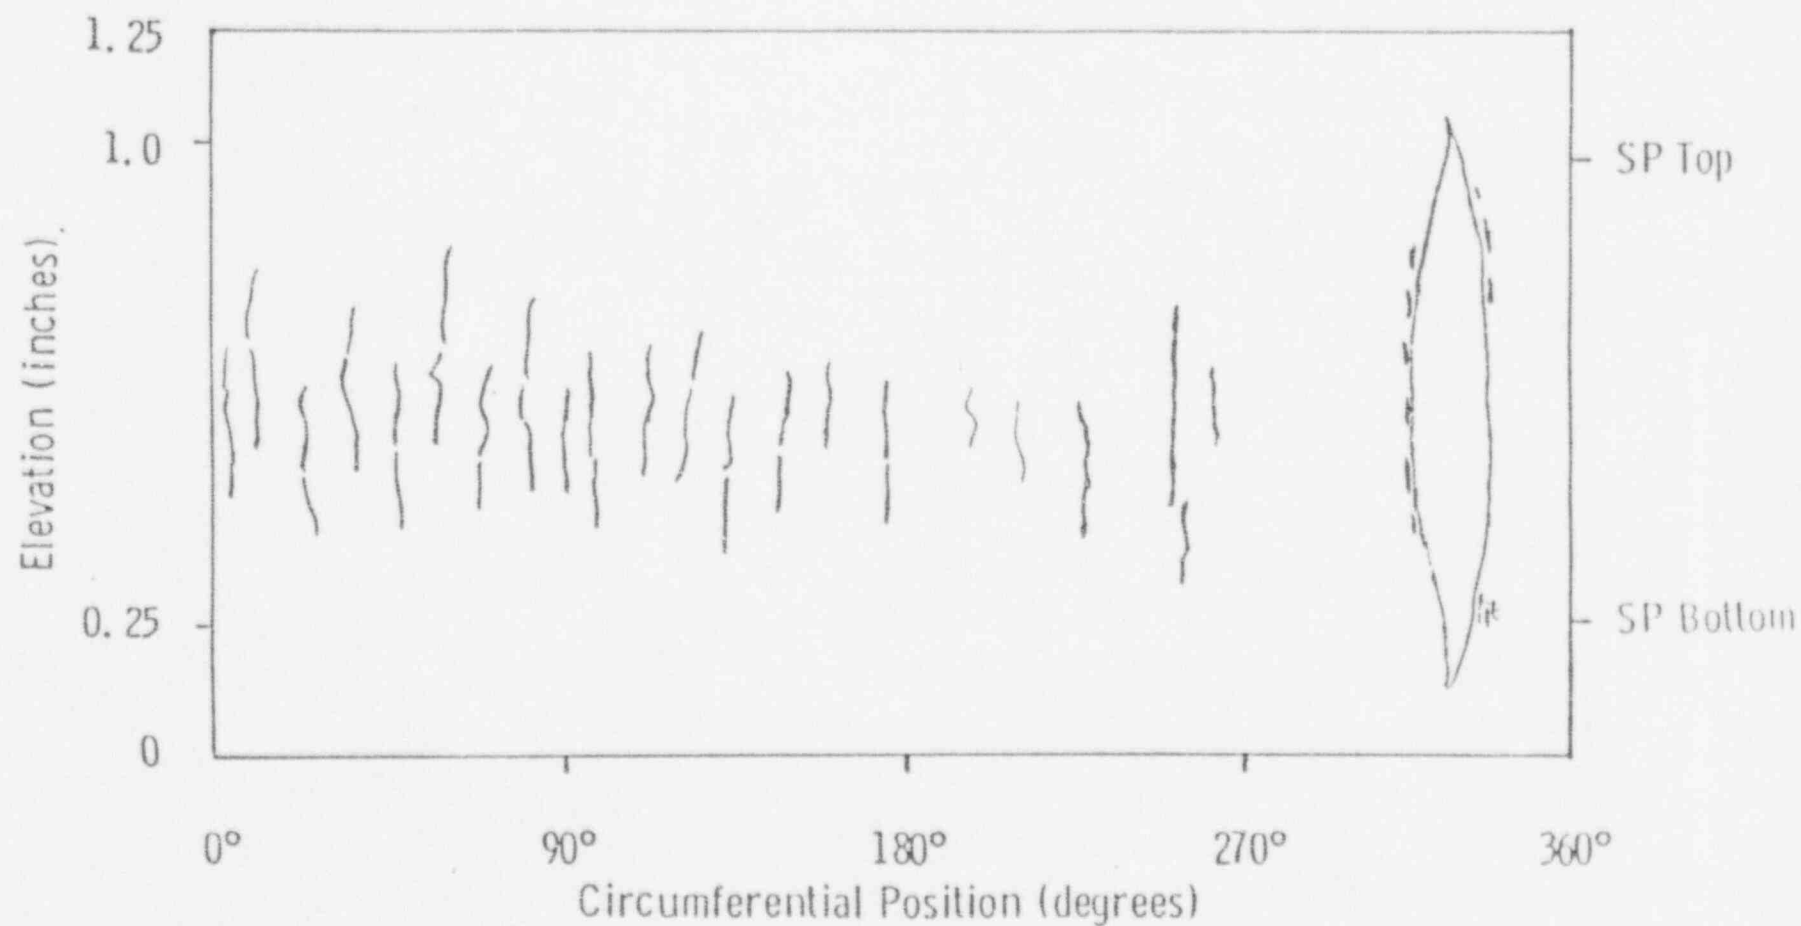
The burst fracture faces of the crevice region specimens were opened for SEM fractographic examinations. Table 3 presents a summary of the fractographic data. The burst openings occurred in axial macrocracks that were composed of numerous axially oriented intergranular microcracks of OD origin. In the case of the SP2 region of Tube R14-C80, the burst fracture microcracks

were confined to a narrow axial band. In the case of the SP1 region of Tube R19-C41, the burst fracture microcracks occurred in a large patch of microcracks within the crevice region.

The axial intergranular corrosion observed in both crevice regions was similar in crack densities and in crack morphologies, as measured by D/W ratios (the ratio of crack depth divided by the width of the crack at a mid-crack depth). The density of axial IGSCC ranged from 27 cracks in 320° for the SP2 region of Tube R14-C80 (which extrapolates to 30 cracks in 360°) to 37 cracks in 240° for the SP1 region of Tube R19-C41 (which would extrapolate to 55 cracks in 360° if the extrapolation ignored the presence of ICC). These are considered moderate crack densities. However, the crack densities are much higher in the regions where ICC patches were observed. (Nineteen cracks in 42° were counted in the main ICC patch in SP1 of Tube R19-C41, which would extrapolate to 163 cracks in 360° if the ICC were present throughout the crevice region.) The measured D/W ratios ranged from 14 to 60 in the SP2 region of Tube R14-C80 to 24 to 60 in the SP1 region of Tube R19-C41. The individual microcracks within the ICC appeared indistinguishable from the individual microcracks within the axial IGSCC with respect to crack morphology. No surface intergranular attack (IGA) was observed at any location in either specimen.

Figure 1 Sketch of the crack distribution found at the second support plate crevice region of Tube R14-C80. Included is the location of the burst test fracture face opening. The OD origin intergranular corrosion was confined to the crevice region, including that found on the burst fracture face.

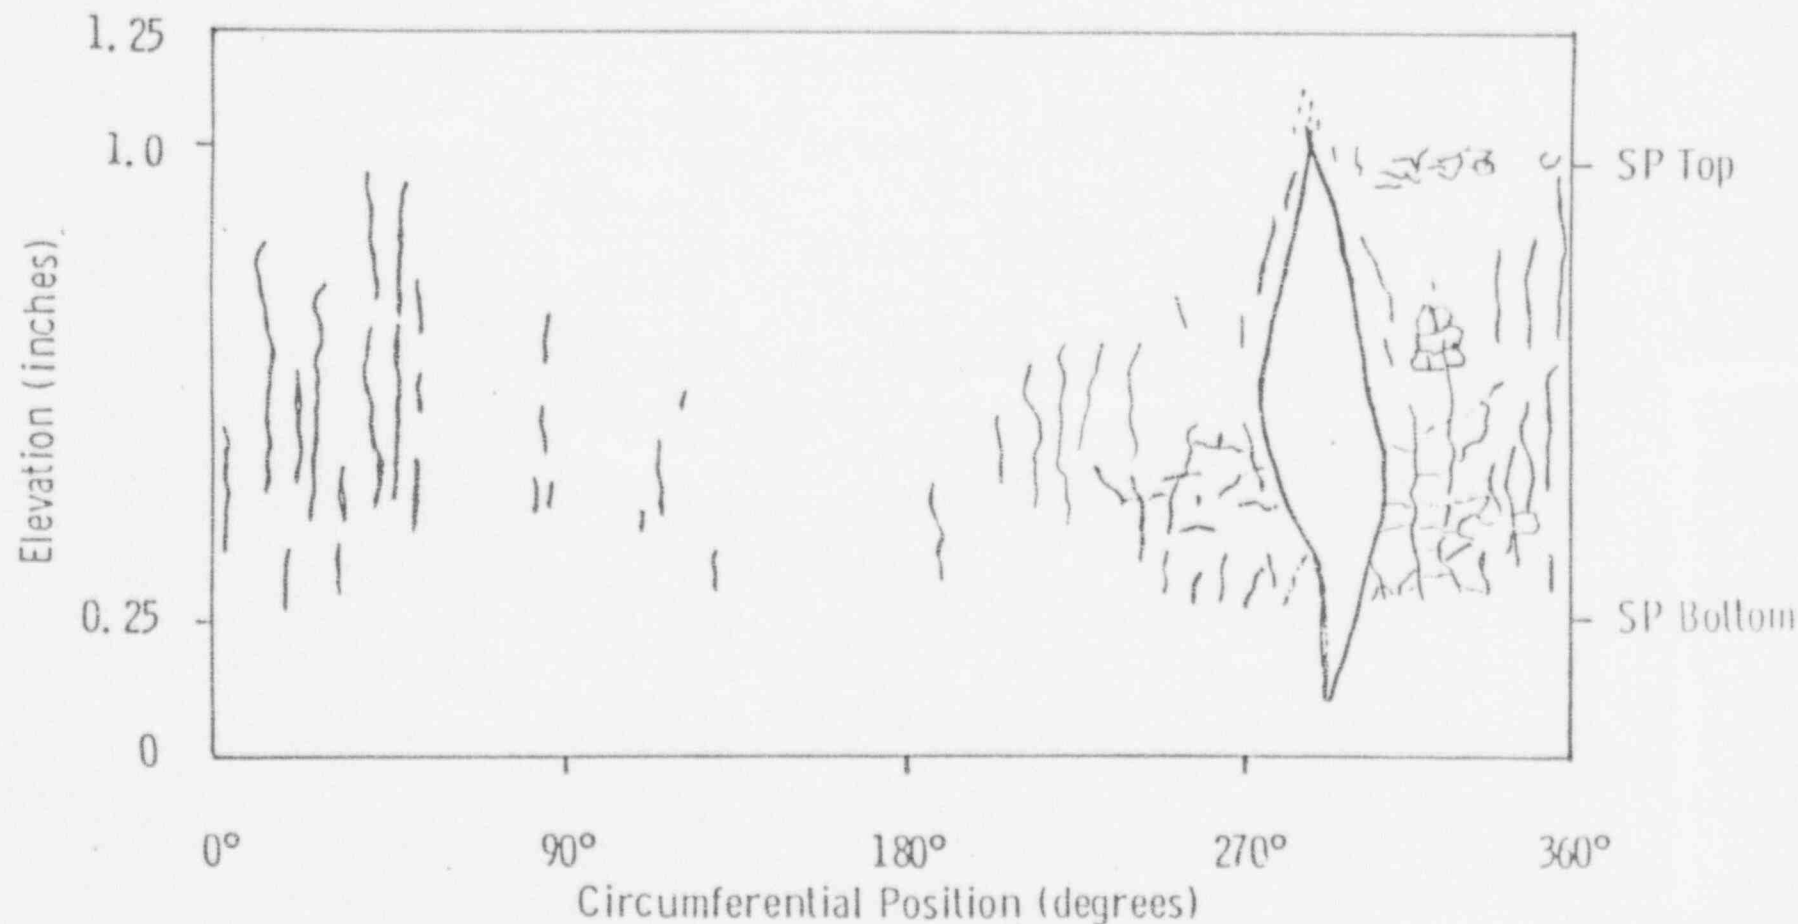
Figure 2

From the metallographic examinations, it was concluded that the dominant corrosion morphology was axial intergranular stress corrosion cracking (IGSCC). In the case of the SP1 region of Tube R19-C41, there was significant intergranular cellular corrosion (ICC) found in association with the axial IGSCC. With an ICC morphology, a complex mixture of short axial, circumferential and oblique angled cracks interact to form cell-like structures. Only a very minor amount of ICC was found in association with the axial IGSCC in the case of the SP2 region of Tube R14-C80. The ICC in SP1 of Tube R19-C41 occurred in one large patch (approximately 0.6 inch wide by 0.4 inch high) with two much smaller patches just above this large patch. Figure 3 presents a photographic montage of a portion of a radial metallographic section at a depth of approximately 10% that shows some of the ICC found in the SP1 region of Tube R19-C41. With progressive radial grinding, it was shown that the axial IGSCC was deeper than the associated ICC. The ICC disappeared at a

depth of 30 to 50% throughwall. The remaining crevice region of SP1 of Tube R19-C41, i.e., that without ICC, had axial IGSCC similar to that found in the SP2 region of Tube R14-C80.

Sketch of the crack distribution found at the first support plate crevice region of Tube R19-C41. Included is the location of the burst test fracture face opening. All deep OD origin intergranular corrosion was confined to the crevice region, including that found on the burst fracture face. Some minor intergranular corrosion was observed up to 0.2 inch above the crevice top.

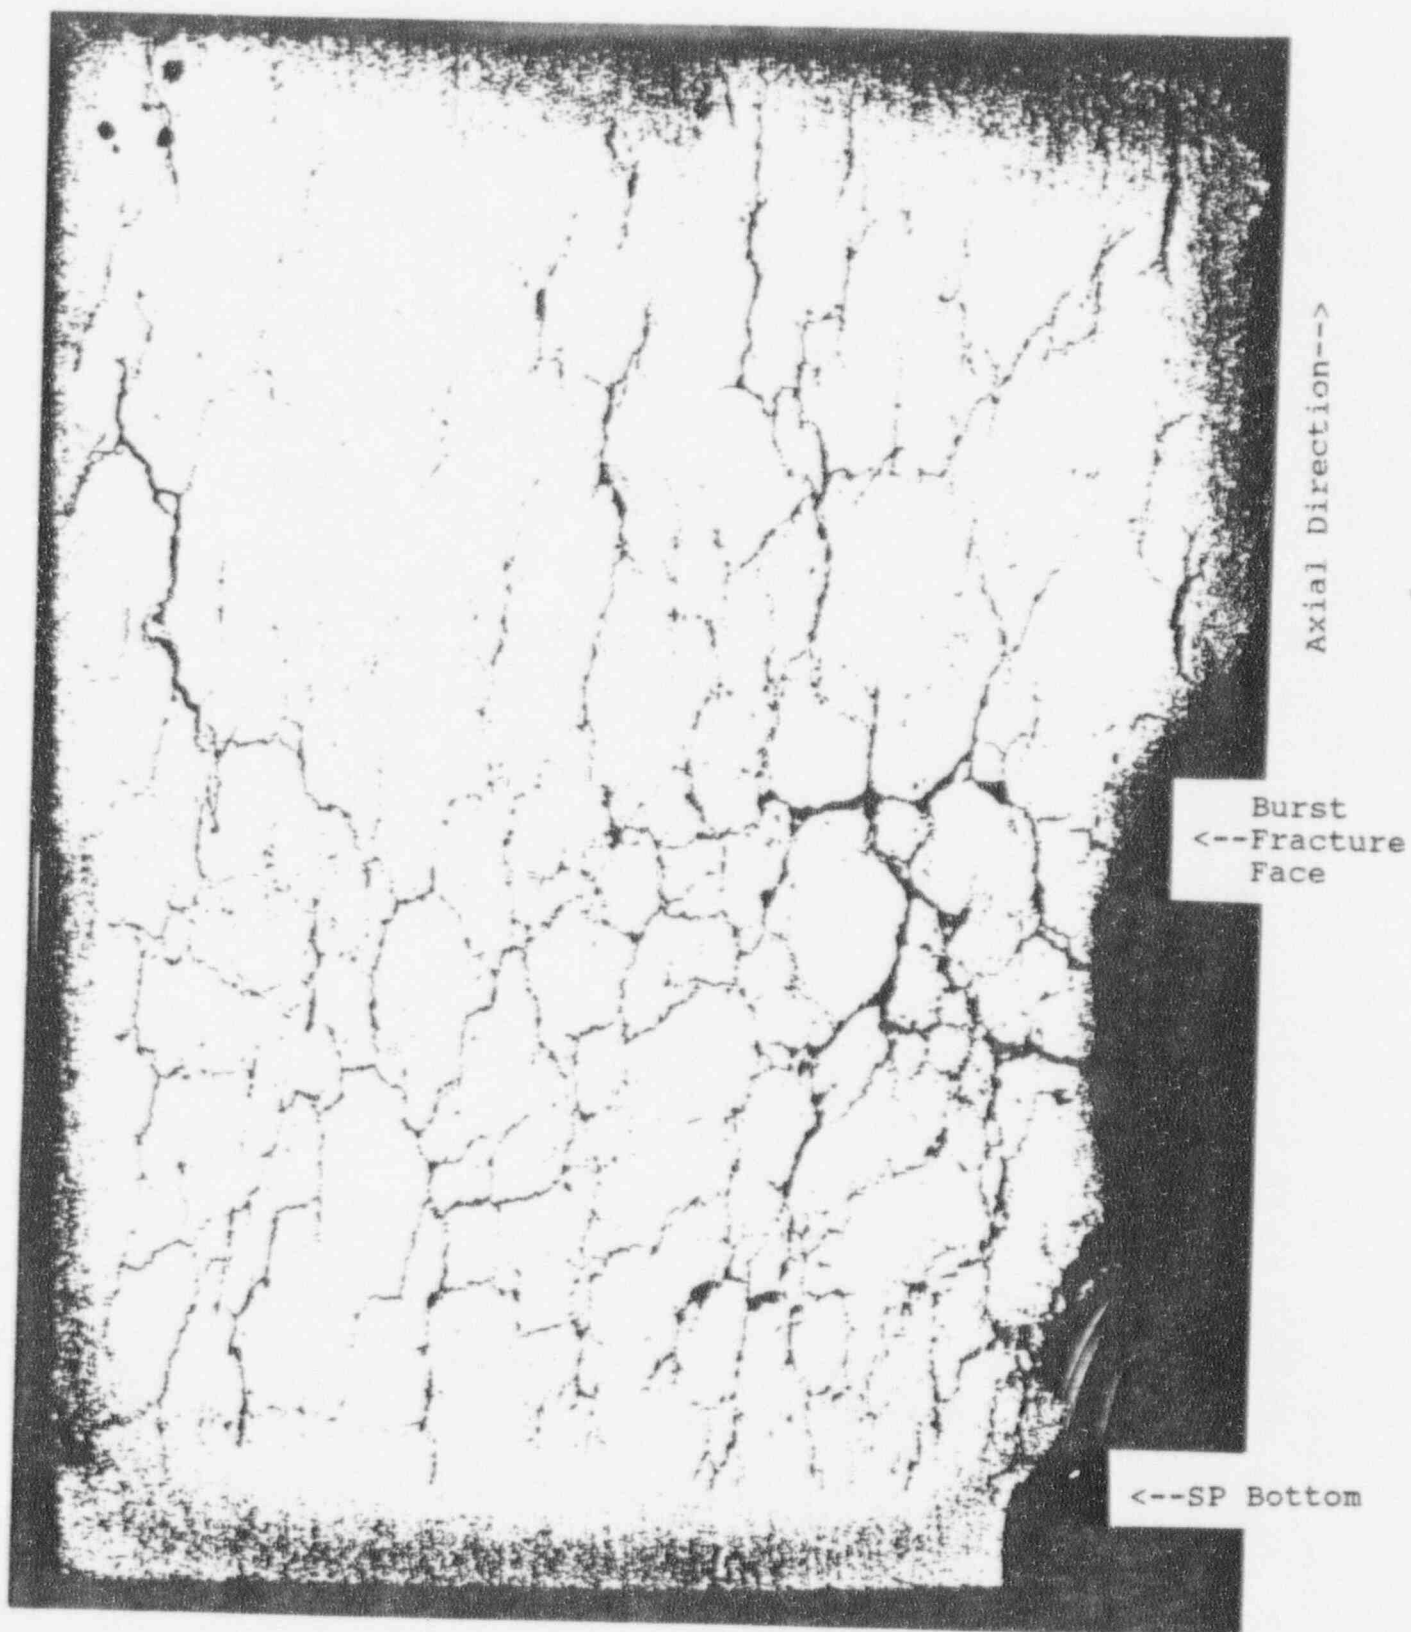
Figure 3 Radial metallography of the SP1 region of Tube R19-C41 showing intergranular cellular corrosion (ICC).
