# NORTHEAST UTILITIES

February 25, 1993  
MP-93-179

Reference: Facility Operating License No. NPF-49  
Docket No. 50-423  
Licensee Event Report 93-001-00

FACILITY NAME (1)										Millstone Nuclear Power Station Unit 3										DOCKET NUMBER (2)										PAGE (3)																													
																				05000423										1 OF 4																													
TITLE (4)																																																											
Failure to Verify Testing of NIS Inputs Into Westinghouse 7300 Process Control System Due to Procedural Deficiency																																																											
EVENT DATE (5)										LER NUMBER (6)										REPORT DATE (7)										OTHER FACILITIES INVOLVED (8)																													
MONTH			DAY			YEAR				YEAR			SEQUENTIAL NUMBER			REVISION NUMBER			MONTH			DAY			YEAR				FACILITY NAMES																														
01			26			93				93			001			00			02			25			93				05000423																														
OPERATING MODE (9)										THIS REPORT IS BEING SUBMITTED PURSUANT TO THE REQUIREMENTS OF 10 CFR § (Check one or more of the following) (11)

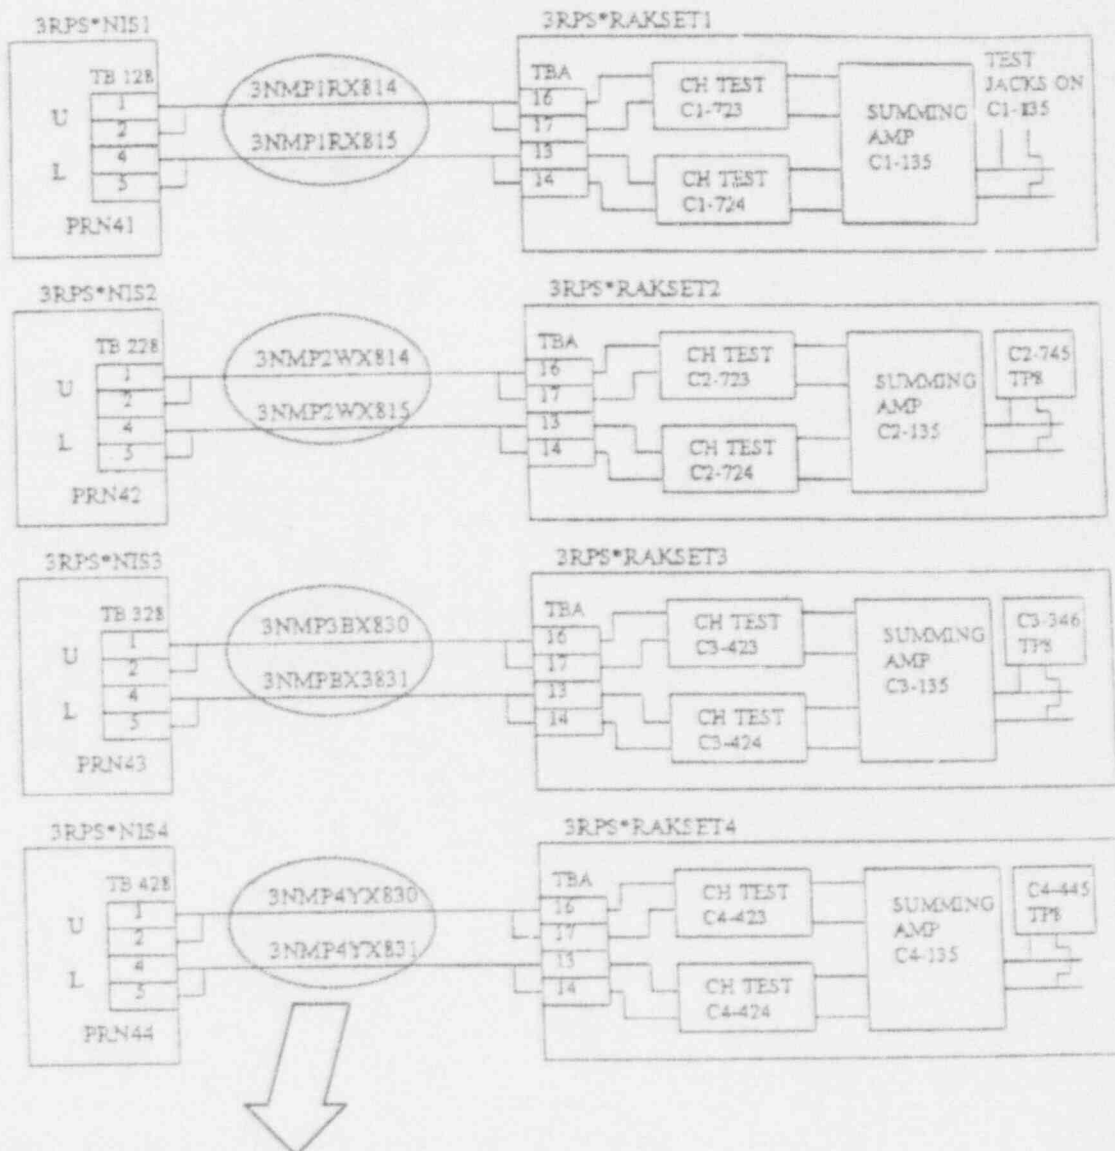
## SIGNAL PATH FROM NIS TO 7300

The untested NIS inputs to 7300 provide a Flux Deviation signal to develop Overtemperature/Delta-T (OT/ $\Delta$ T) and setpoints. This signal is generated in the NIS Axial Flux circuit and processed through the 7300 Process Control Delta-T instrument loop.

NOTE: Signal Path wiring not tested between the four NIS channel inputs to the 7300 Process Control Cabinets.
