Millstone Nuclear Power Station, Unit No. 2
Modification to Pipe
Relief Request From ASME Code Section XI Requirements

Modification to Pipe
Request for Relief From ASME Code Section XI

UNIT: Millstone Unit 2 NCR # 293-026 DATE: 1/25/93
TIME: 09:50

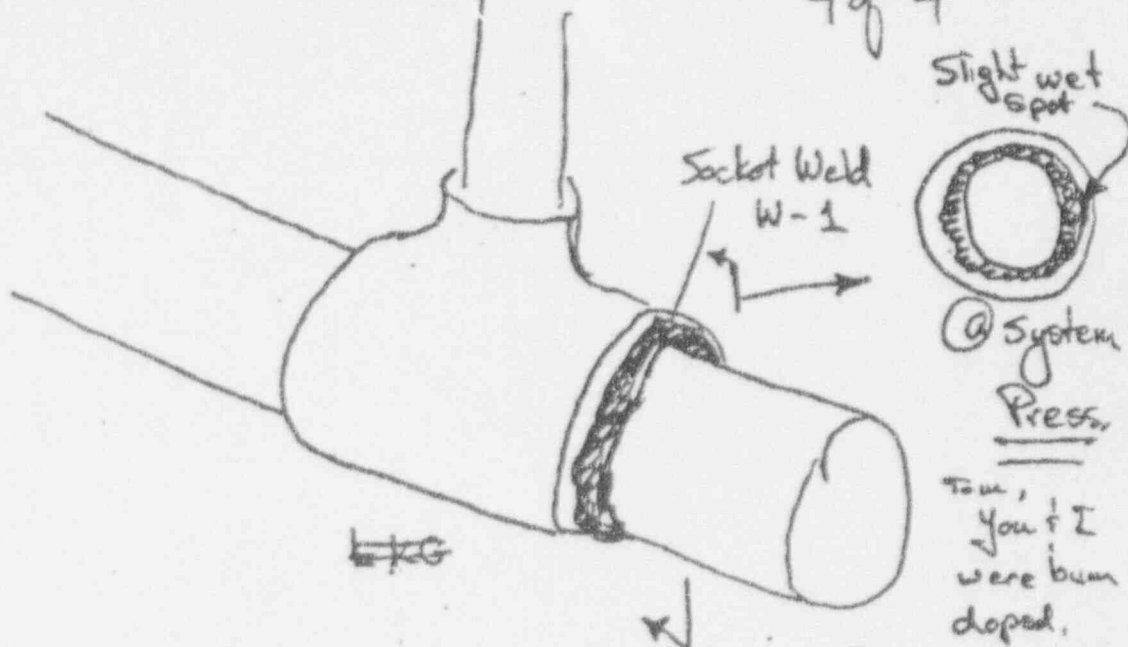
Awo m2-92-17685
weid map

Flaw Location: The small weeping leak is located at 3:00 looking north at weld W-1 of AWO M2-92-17685.

Flaw Type: Pinhole due to lack of weld fusion.

The supply piping (2"-HUD-130) to cooling coil X-181B (lower coil) developed a small weeping leak when the system hydrostatic pressure test was performed. All other joints meet the requirements of the hydrostatic pressure test. The small weeping leak is located at 3:00, looking north at weld W-1 of AWO M2-92-17685 (see attached weld map).

AWO M2-93-01582 has been written to rework the leak at the next available opportunity (i.e. plant non-operational). The joint will be repaired in accordance with ASME Section XI and the following steps;

- The weld in the area of the leak will be excavated and if necessary the entire weld will be removed.
- The excavated area will be LP inspected, to ensure solid base metal is present.
- The weld will be repaired in accordance with the NUSCo weld manual.
- The weld will be visually inspected per GWS-004.
- Once the weld is reworked the pipe will be hydrostatic pressure tested in accordance with SP-21219.
