# NORTHEAST UTILITIES

Millstone Nuclear Power Station, Unit No. 2  
RI-91-A-0036

MILLSTONE NUCLEAR POWER STATION, UNIT NO. 2  
RI-91-A-0036  
RM-8123A/B - SKETCH #1

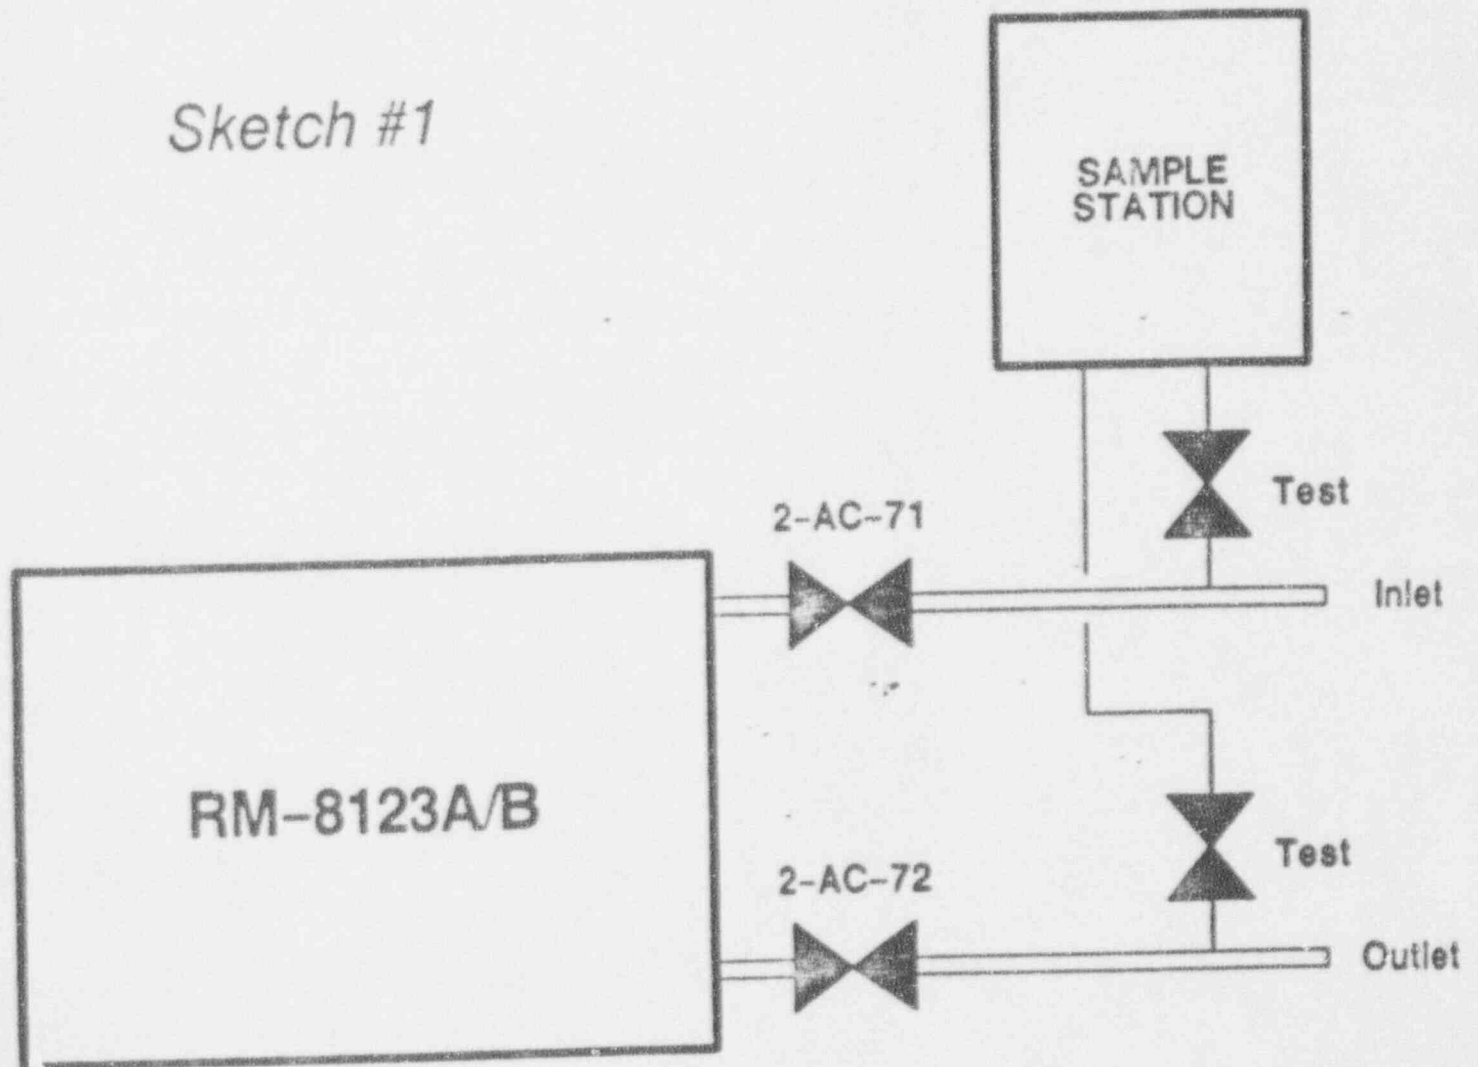
Sketch #1

The sample station located next to RM-8123A/B takes a sample by tapping off of the lines that supply the RM-8123A/B skid. The sample is taken in parallel with the RM-8123A/B skid (see Attachment 1, Sketch #1).

The discrepancy between the samples is most likely due to the sample station being partially or totally isolated when the sample in question was taken. A review of the RM-8123A/B strip chart for the February 6, 1991 date in question indicates that RM-8123A/B was not isolated. The gaseous and particulate count rates on the strip chart were representative of the expected values and did not show any deviation that would have been experienced if RM-8123A/B had been isolated. RM-8123A/B was functioning properly during this period. There is no relationship between this issue and the event addressed by PIR 91-16.

The results of the sample taken on February 6, 1991 is typical for the enclosure building atmosphere. The sample pump used for sampling is a positive displacement pump that has an automatic bypass feature. If isolated, it would draw from the surrounding atmosphere. The sample station may have been isolated partially when the sample was taken. No conclusive reason for the low sample value has been identified.

The relationship between remote and local sample results has received significant management attention. Current Health Physics requirements for sampling require local samples to be taken to eliminate any question of remote sampling accuracy. NNECO recognizes the need to evaluate improvements in sampling processes and will enhance procedures addressing sampling techniques by August 30, 1991.
