## LICENSEE EVENT REPORT (LER)

FACILITY NAME (1) James A. FitzPatrick Nuclear Power Plant										DOCKET NUMBER (2) 05000333										PAGE (3) 1 OF 2																													
TITLE (4) Normal and Emergency Service Water Corrosion, Silting and Check Valve Problems																																																	
EVENT DATE (5)			LER NUMBER (6)				REPORT DATE (7)			OTHER FACILITIES INVOLVED (8)																																							
MONTH	DAY	YEAR	YEAR	SEQUENTIAL NUMBER	REVISION NUMBER	MONTH	DAY	YEAR	FACILITY NAMES					DOCKET NUMBER(S)																																			
														05000333																																			
														05000333																																			
OPERATING MODE (9)		THIS REPORT IS SUBMITTED PURSUANT TO THE REQUIREMENTS OF 10 CFR 5. (Check one or more of the following) (11)																																															
N																																																	
POWER LEVEL (10)		20.402(b)												20.405(c)												50.73(a)(2)(iv)												73.71(b)

UPDATED REPORT - PREVIOUS REPORT DATE 8/29/90  
EIIIS Codes are in []

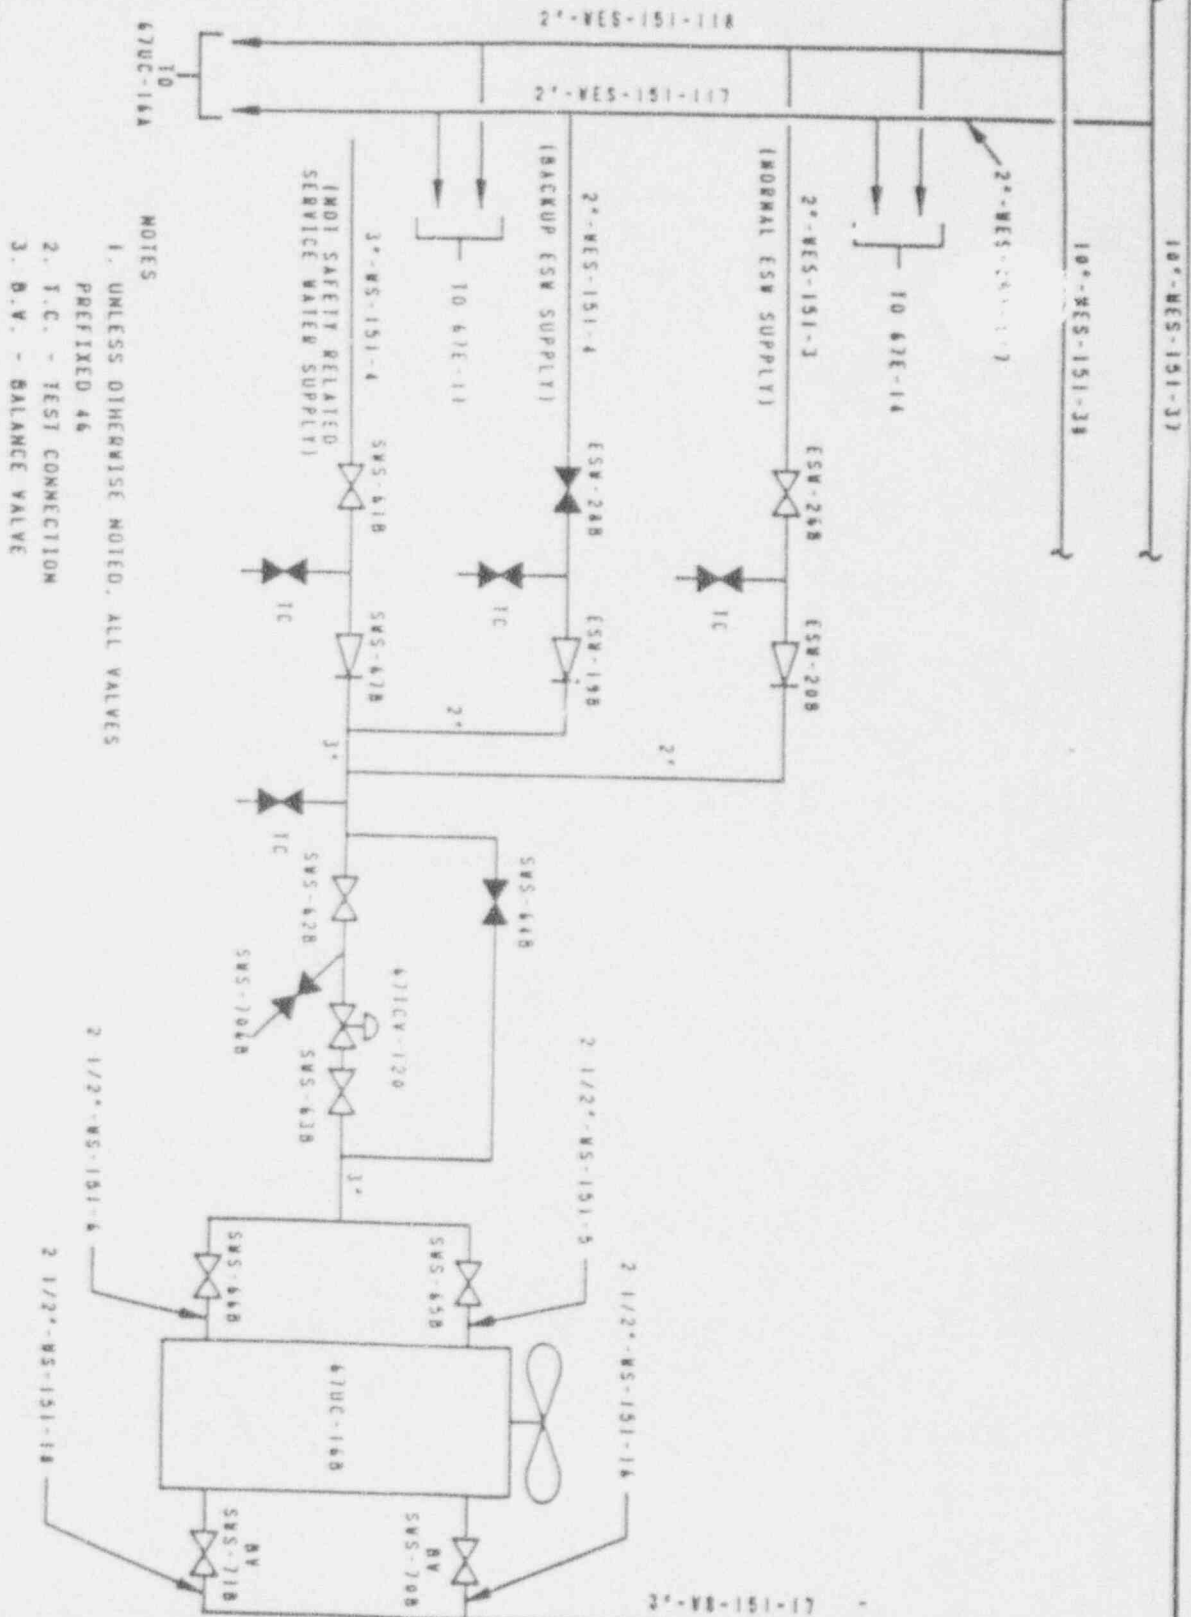
Figure 2

As part of the follow-on check valve disassembly program, check valves 46ESW-19A, 19B, 20A, and 20B (2 inch ESW piston check valves) were disassembled and found sticking shut due to silt and corrosion product build-up in the valve bore. Prior to being reworked, the valve bonnets were replaced, and the valves were successfully flow tested with ESW using an existing surveillance test. This surveillance test had been used quarterly during normal operations to verify operability of the valves. Following the test, the valves again disassembled and found not to be sticking shut. Also, as part of the follow-on IST check valve disassembly program, swing check valves 46SWS-67A and 67B (3 inch NSW check valves) were found sticking open.

Visual inspection of the 2 inch ESW supply line upstream of the piston check valves revealed no significant corrosion or silt build-up. The 2 inch pipe downstream of the piston check valves up to the tee-in to the 3 inch NSW pipe (3 feet in length) was found to have 30 percent reduction in cross-sectional flow area due to corrosion build-up. Approximately 5 feet of the 3 inch NSW supply to the cooler was inspected and revealed general corrosion with less than 10 percent reduction in cross-sectional flow area. Inspection of the cooler 2-1/2 inch ESW/NSW supply and return lines revealed areas of general to heavy corrosion with a 10 to 30 percent reduction in cross-sectional flow area. The length of each of these areas of general to heavy corrosion as estimated to be 8 feet in length.

The coolers were disassembled and found to have very minor tube plugging due to silt/sand.

As discussed above, the 2 inch piston check valves (46ESW-19A, 19B, 20A, and 20B) in the ESW supply lines to the electric bay coolers were initially found sticking shut. The valve bonnet was replaced and satisfactory flow tested with ESW, reopened, and found to be operable as defined by the visual inspection criteria. This indicated that the normally aligned safety-related valves (46ESW-19A and 20B) would have been capable of performing the open safety function and no safety concern existed. During post-work testing the east electric bay normal ESW supply check valve (46ESW-20B) was found to stick open on the first attempt to backflow test.

1. All unsatisfactory valves were cleaned and restored to service.
2. The electric bay coolers were cleaned and restored to service.
3. Degraded piping was cleaned or replaced and restored to service.
4. Test connections were added adjacent to 46SWS-67A and 67B, 46ESW-19A, 19B, 20A, and 20B to facilitate in-situ operability testing of these check valves.
5. Y-strainer meshes were sized up to prevent clogging.
6. The electric bay coolers were satisfactorily performance tested with ESW as part of a coordinated ESW system test. The test results were compared to thermal hydraulic model projections.

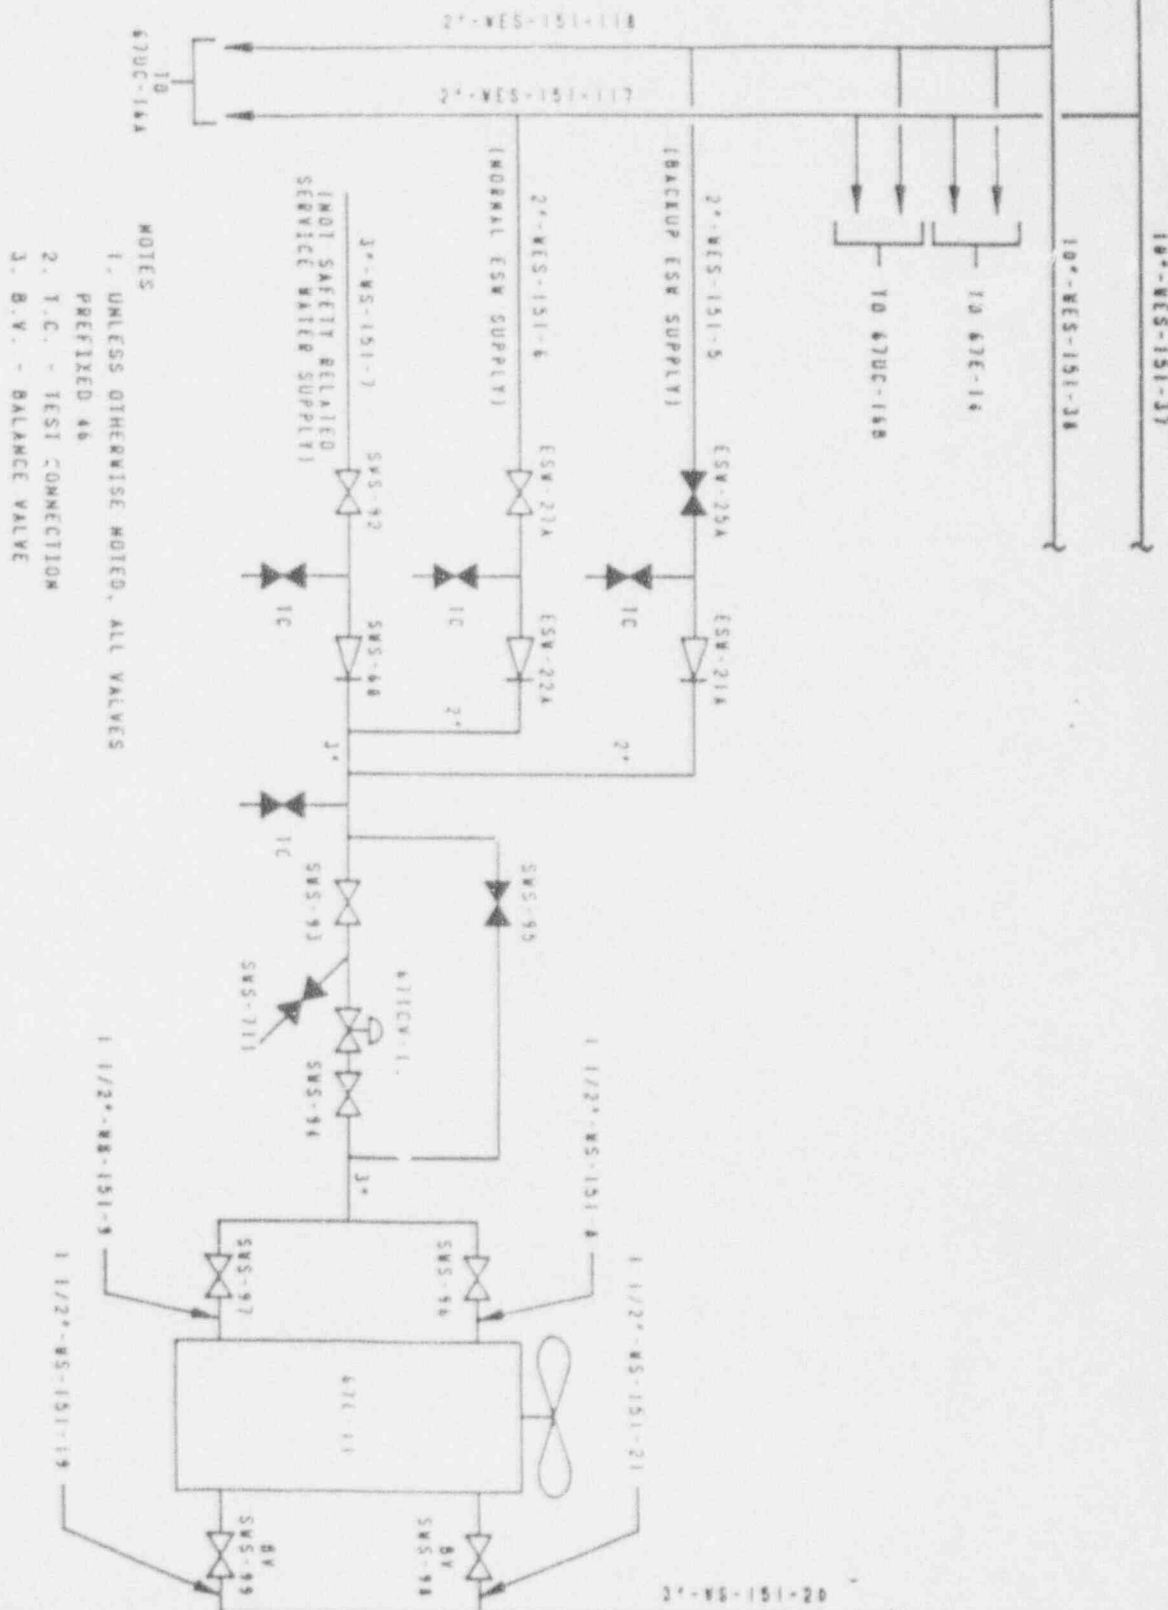
Figure 3

As part of the initial IST check valve disassembly program scope, check valves 46ESW-21A, 21B, 22A, and 22B (2 inch ESW piston check valves) were disassembled and found sticking shut due to silt and corrosion product build-up in the valve bore. The valves were initially declared inoperable due to failing the visual inspection criteria. Also as part of the initial IST check valve disassembly program scope, swing check valves 46SWS-68 and 69 (3 inch NSW check valves) were found sticking open.

Visual inspection of the 2 inch ESW supply line upstream of the piston check valves revealed no significant corrosion or silt build-up. The 2 inch pipe downstream of the piston check valves up to the tee-in to the 3 inch NSW pipe was found to have 30 percent reduction in cross-sectional flow area due to corrosion build-up. Approximately 7 feet of the 3 inch NSW supply to the cooler was inspected and revealed general corrosion with less than a 10 percent reduction in cross-sectional flow area. Inspection of the cooler 1-1/2 inch ESW/NSW supply and return lines revealed areas of general to heavy corrosion with a 30 percent reduction in cross-sectional flow area. The length of each of these areas of general to heavy corrosion is no more than 8 feet in length.

The coolers were disassembled and found to have very minor tube plugging due to silt/sand.

As discussed above, the 2 inch piston check valves (46ESW-21A, 21B, 22A, and 22B) in the ESW supply lines for the cable tunnel coolers were initially found sticking shut. However, based on the similarity of the as-found condition of these 2 inch piston checks to the electric bay cooler 2 inch piston checks and the satisfactory response of the electric bay piston checks, it is considered that the cable tunnel piston checks would have responded similarly. These cable tunnel piston check valves were also subjected to quarterly surveillance tests where ESW was flushed through the valves to demonstrate operability. As a result, it is concluded that the valves were capable of performing their safety function.

1. All unsatisfactory valves were cleaned and restored to service.
2. The cable tunnel coolers were cleaned and restored to service.
3. All the piping inspected was cleaned or replaced and restored to service.
4. Test connections were added adjacent to 46SWS-68 and 69, 46ESW-21A, 21B, 22A, and 22B to facilitate in-situ operability testing of these check valves.
5. Y-strainer meshes were sized up to prevent clogging.
6. The cable tunnel coolers were satisfactorily performance tested with ESW as part of a coordinated ESW system test. The test results were compared to thermal hydraulic model projections.

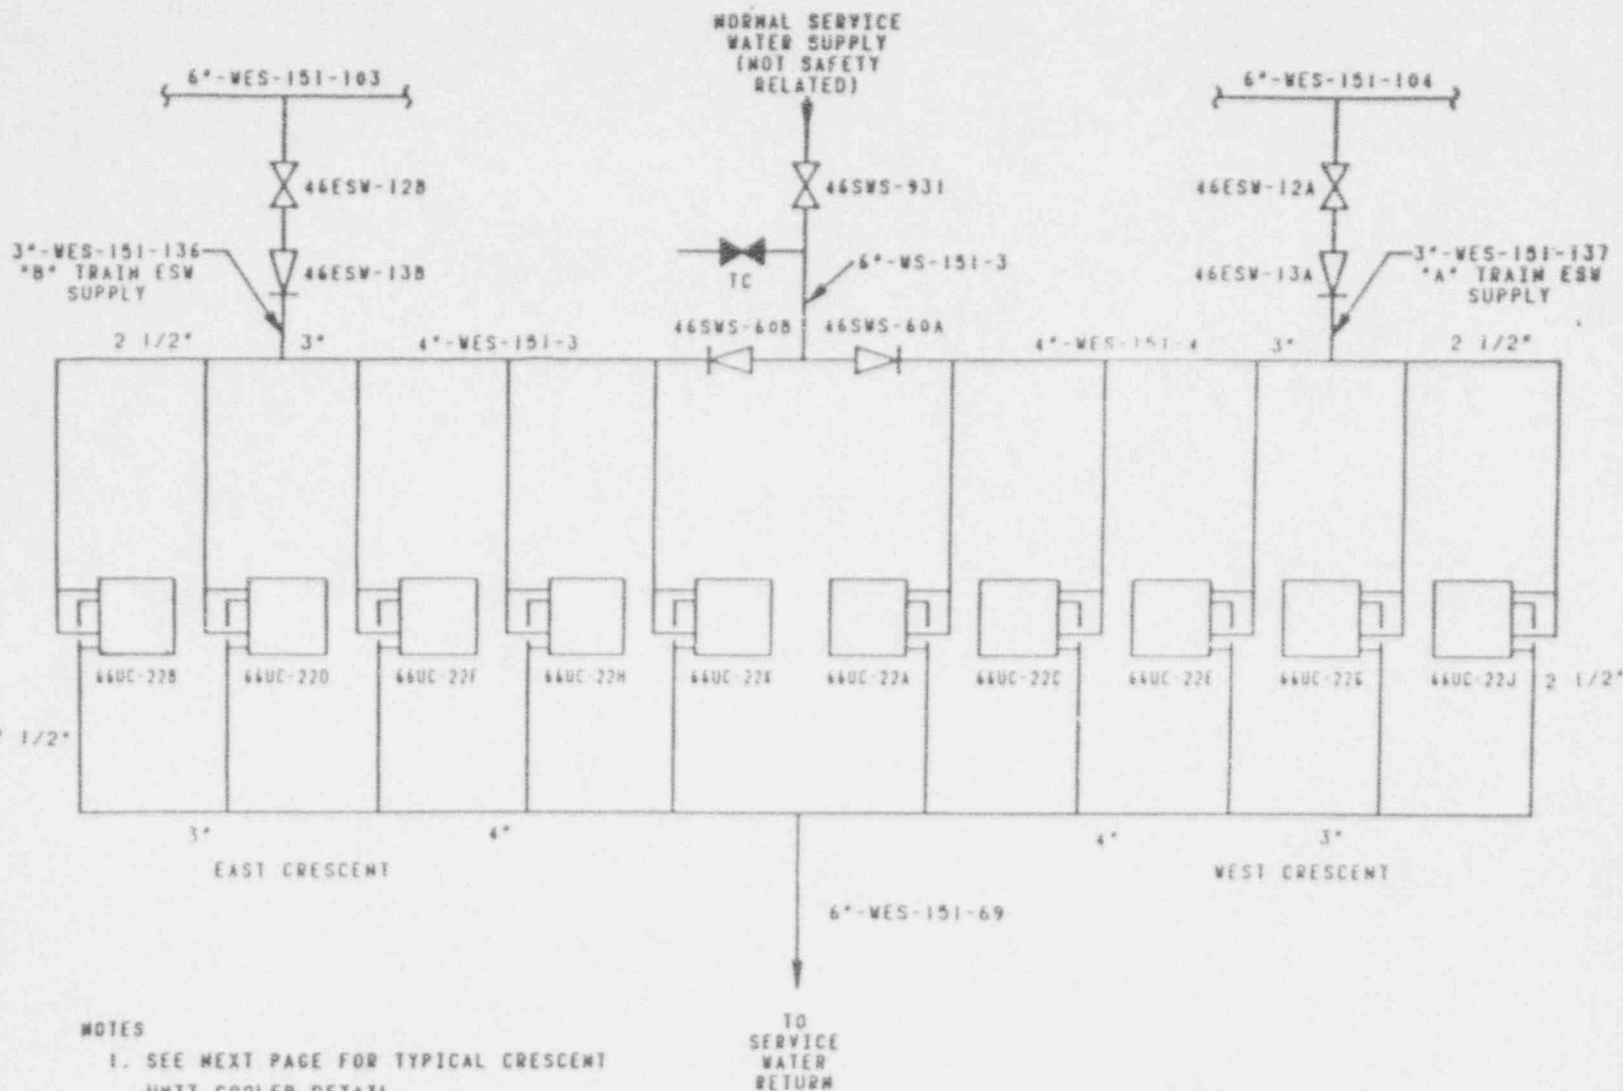
Figure 7

The crescent unit coolers were flushed to minimize silt build-up and since December 1988, the coolers have been periodically tested to demonstrate satisfactorily performance and the test data is trended. They are only disassembled and inspected when satisfactory performance testing is not achieved. Boroscopic inspection of the 3 inch and 4 inch lines revealed no concerns. Piping was found to be clean and in good condition.

As part of the initial IST check valve disassembly scope, 4 inch NSW supply check valves 46SWS-60A and B were opened and found sticking through full travel, but able to seat. The valves were initially declared inoperable due to failing the visual inspection criteria. ESW supply 3 inch swing check valves 46ESW-13A and 13B were opened, passed the visual inspection criteria, and declared operable.
