CALVERT CLIFFS NUCLEAR POWER PLANT
1650 CALVERT CLIFFS PARKWAY • LUSBY, MARYLAND 20657-4702

SUBJECT: Calvert Cliffs Nuclear Power Plant
Unit Nos. 1 and 2; Docket Nos. 50-317 and 50-318;
License Nos. DPR 53 and DPR 69
Licensee Event Report 93-001
Technical Specification 3.0.3 Entry; Loss of Control Room
Air Conditioning

LICENSEE EVENT REPORT (LER)

TITLE (4)
Technical Specification 3.0.3 Entry; Loss of Control Room Air Conditioning

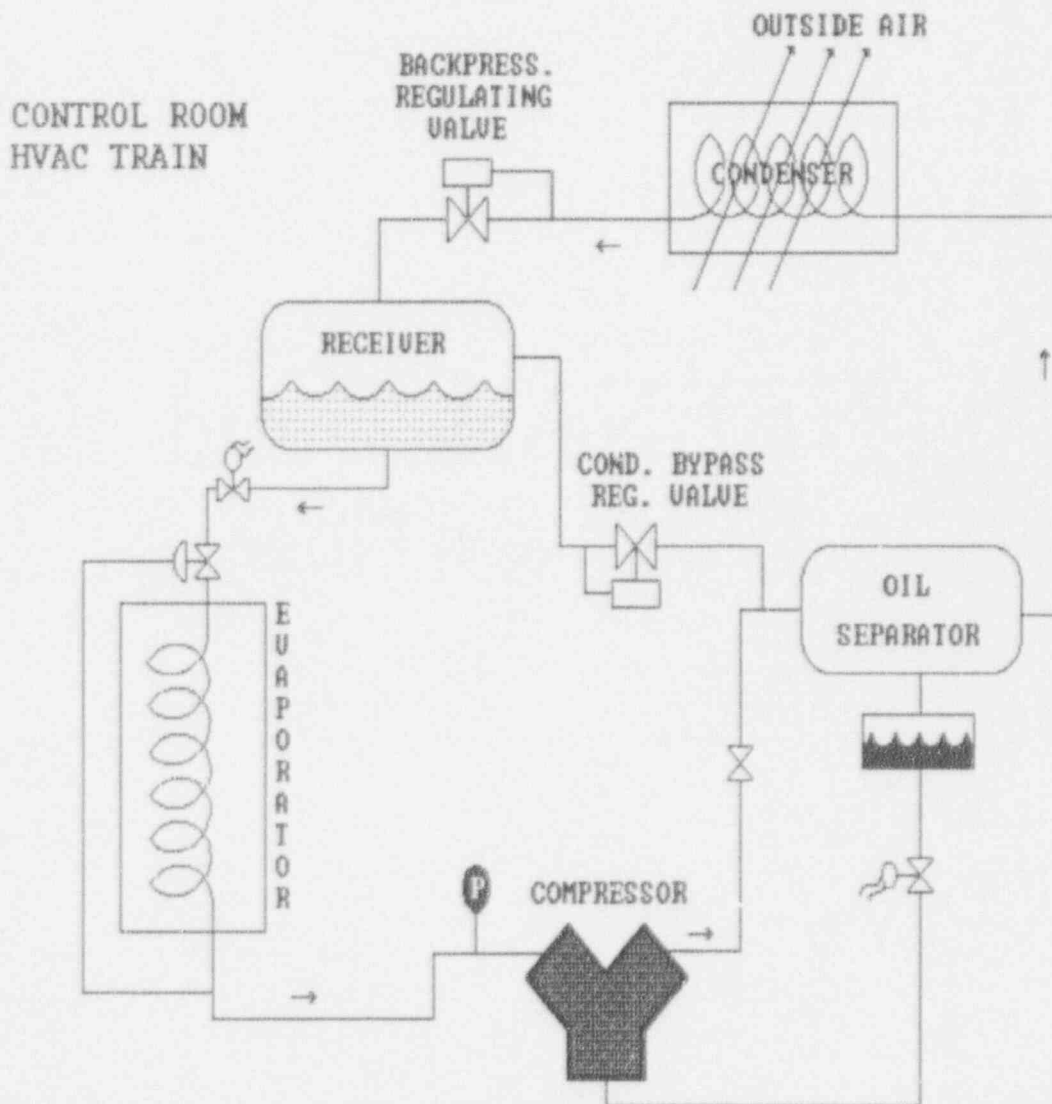
FIGURE 1

Each CR HVAC train has an air handling unit, evaporator, liquid receiver, air-cooled condenser, compressor, and a head pressure control system that permits operation during low outdoor air temperatures (Figure 1). Low ambient temperature operation prevents excessive heat rejection capacity in the air-cooled condenser and the condenser backpressure regulating valve closes allowing liquid refrigerant to backup or "stack" in the condenser coils. To maintain adequate compressor suction pressure, a condenser bypass regulating valve opens bypassing hot refrigerant gas directly to the receiver.

The immediate cause of No. 12 compressor becoming inoperable was insufficient refrigerant level to support a compressor start at extremely low outside temperatures. During cold outdoor temperature conditions, sufficient refrigerant inventory must be maintained in the air conditioning unit to compensate for density changes and stacking of liquid refrigerant in the condenser while maintaining adequate refrigerant inventory in the receiver. Insufficient refrigerant in the receiver can induce a low compressor suction pressure resulting in a compressor trip during starting. At the time of the event, outside air temperature was approximately 16 degrees Fahrenheit. This caused a significant amount of refrigerant to migrate to the condenser resulting in a low suction pressure at the compressor.
