CALVERT CLIFFS NUCLEAR POWER PLANT
1650 CALVERT CLIFFS PARKWAY • LUSBY, MARYLAND 20657-4702

SUBJECT: Calvert Cliffs Nuclear Power Plant
Unit Nos. 1 and 2; Docket Nos. 50-317 and 50-318;
License Nos. DPR 53 and DPR 69
Licensee Event Report 93-001
Technical Specification 3.0.3 Entry; Loss of Control Room
Air Conditioning

LICENSEE EVENT REPORT (LER)

TITLE (4)
Technical Specification 3.0.3 Entry; Loss of Control Room Air Conditioning

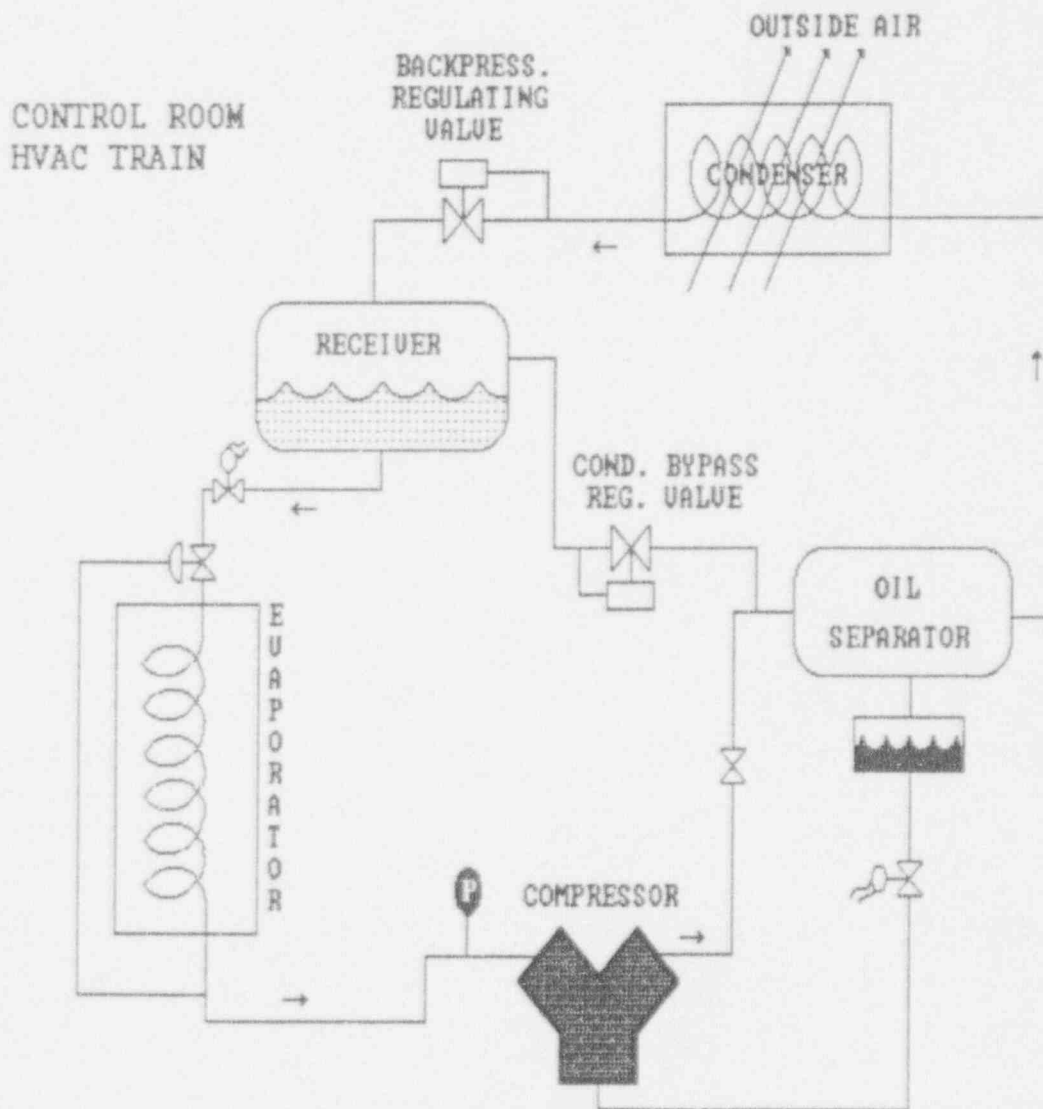
FIGURE 1

Each CR HVAC train has an air handling unit, evaporator, liquid receiver, air-cooled condenser, compressor, and a head pressure control system that permits operation during low outdoor air temperatures (Figure 1). Low ambient temperature operation prevents excessive heat rejection capacity in the air-cooled condenser and the condenser backpressure regulating valve closes allowing liquid refrigerant to backup or "stack" in the condenser coils. To maintain adequate compressor suction pressure, a condenser bypass regulating valve opens bypassing hot refrigerant gas directly to the receiver.

The immediate cause of No. 12 compressor becoming inoperable was insufficient refrigerant level to support a compressor start at extremely low outside temperatures. During cold outdoor temperature conditions, sufficient refrigerant inventory must be maintained in the air conditioning unit to compensate for density changes and stacking of liquid refrigerant in the condenser while maintaining adequate refrigerant inventory in the receiver. Insufficient refrigerant in the receiver can induce a low compressor suction pressure resulting in a compressor trip during starting. At the time of the event, outside air temperature was approximately 16 degrees Fahrenheit. This caused a significant amount of refrigerant to migrate to the condenser resulting in a low suction pressure at the compressor.

CONTROL ROOM HVAC TRAIN

- C. A detailed troubleshooting procedure was initiated for No. 12 CR HVAC. The system was charged with 100 pounds of additional refrigerant. At 8:45 p.m. on February 2, 1993, No. 12 CR HVAC train was started and successfully operated during a 1 hour test. The train was then shutdown and allowed to cooldown in preparation for a planned cold start.

- A. Design Engineering is performing a detailed review of the relationship between required refrigerant inventory and outside air temperature. This relationship is needed to define guidelines between recommended refrigerant inventory and outside air temperature for our CR HVAC system. This information will be utilized in subsequent maintenance activities to ensure the system meets full system design requirements.
- B. Procedures for maintenance of the CR HVAC systems will be revised to ensure they specify an appropriate weight of refrigerant.
- C. Based upon the guidelines from Design Engineering, we will evaluate methods to ensure that adequate refrigerant inventory is maintained for CR HVAC system operation.
- D. Operating practices are being modified to additionally record, at appropriate intervals, the receiver liquid level of the standby CR HVAC train.
