LIMERICK GENERATING STATION

SUBJECT: Licensee Event Report
Limerick Generating Station - Unit 2

Reference:	Docket No. 50-353
Report Number:	2-93-003
Revision Number:	00
Event Date:	February 13, 1993
Report Date:	March 11, 1993
Facility:	Limerick Generating Station P.O. Box 2300, Sanatoga, PA 19464-2300

FACILITY NAME (1) Limerick Generating Station, Unit 2										DOCKET NUMBER (2) 0 5 0 0 0 3 5 3 1 OF 0 6										PAGE (3) 1 OF 0 6									
TITLE (4) Engineered Safety Feature Actuations Resulting From a Spurious Division 2 Loss of Coolant Accident Signal due to Personnel Error.																													
EVENT DATE (5)			LER NUMBER (6)				REPORT DATE (7)			OTHER FACILITIES INVOLVED (8)																			
MONTH	DAY	YEAR	YEAR	SEQUENTIAL NUMBER	REVISION NUMBER	MONTH	DAY	YEAR	FACILITY NAMES					DOCKET NUMBER(S)															
0 2	1 3	9 3	9 3	0 0 3	0 0	0 3	1 1	9 3						0 5 0 0 0															
OPERATING MODE (9)			THIS REPORT IS SUBMITTED PURSUANT TO THE REQUIREMENTS OF 10 CFR § (Check one or more of the following) (11)																										
1			20.402(b)				20.405(c)				<input checked="" type="checkbox"/> 50.73(a)(2)(iv)				73.71(b)														
POWER LEVEL (10)			20.405(a)(

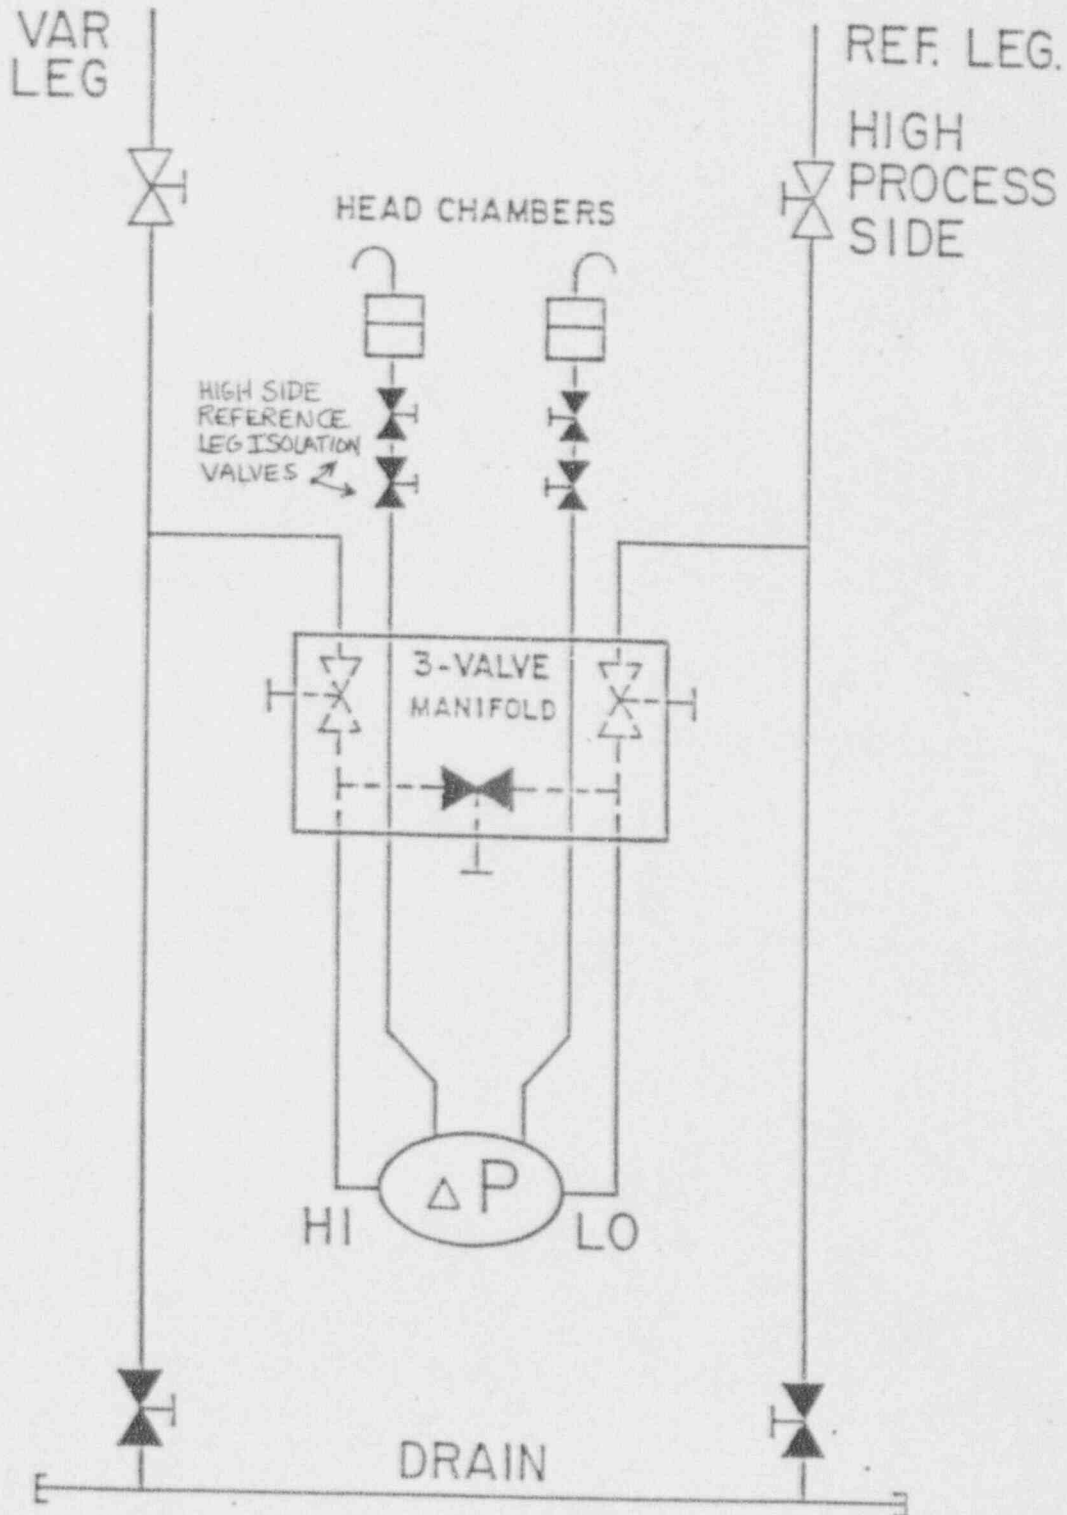
FIGURE 1

On February 13, 1993, at 0318 hours, while the unit was in shutdown for refueling, an inadvertent Division 2 Loss of Coolant Accident (LOCA) signal was initiated. The LOCA signal was generated during the performance of the Surveillance Test (ST) procedure ST-2-042-402-2, "Feedwater Main Turbine Trip System Actuation - Reactor Vessel Water Level - High; Level 8, Channel B Calibration/Functional Test." The calibration/functional sections of the ST procedure were successfully completed. An Instrumentation and Controls (I&C) technician was self-verifying instrument valve positions for an RPV water level differential pressure (dP) transmitter prior to allowing another I&C Technician to perform the Independent Verification of Restoration (IVOR) section of the ST procedure. While the dP transmitter was in service, the I&C technician inadvertently opened, then immediately re-closed, two isolation valves to the high pressure side reference leg head chamber (see Figure 1). The two isolation valves are used for calibration purposes only, and their normal positions are correctly indicated in the ST procedure. The I&C technician believed he had incorrectly left the two valves in the closed position following the performance of the ST procedure. Instead of rechecking the normal positions of the valves, the I&C technician mistakenly re-opened the two isolation valves. The resultant surge in reference leg pressure caused by quickly reclosing the isolation valves caused an inadvertent RPV low water level signal below Level 1 (+32 inches above the top of active fuel).

The cause of this event was cognitive personnel error. The normal positions of the two high pressure side reference leg head chamber isolation valves (see Figure 1) are correctly indicated in the ST procedure. The I&C technician had successfully completed the calibration/functional sections of the ST procedure and was performing a self-verification of his 'as left' valve positions. The I&C technician believed that he had incorrectly left the two isolation valves in the closed positions following the performance of the ST procedure. Instead of rechecking the normal positions of the isolation valves (i.e., closed), the I&C technician mistakenly re-opened, then quickly reclosed, the isolation valves causing the spurious Division 2 LOCA signal to initiate.
