MONTICELLO NUCLEAR GENERATING PLANT		3004	
TITLE:	SRI REVIEW AND APPROVAL FORM	Revision 12	06/02/92
		Page 1 of 2

SRI No. 93-006 Rev. No. 0 Add. No. \_\_\_\_\_  
 FOI No. \_\_\_\_\_ Page 1 of \_\_\_\_\_  
 TITLE: BASIS FOR CONTINUED OPERATION WITH CRACK  
IN CORE SPRAY HEADER

Basis for Continued Operation  
with Crack in Core Spray Header  
Page 9 of 9.

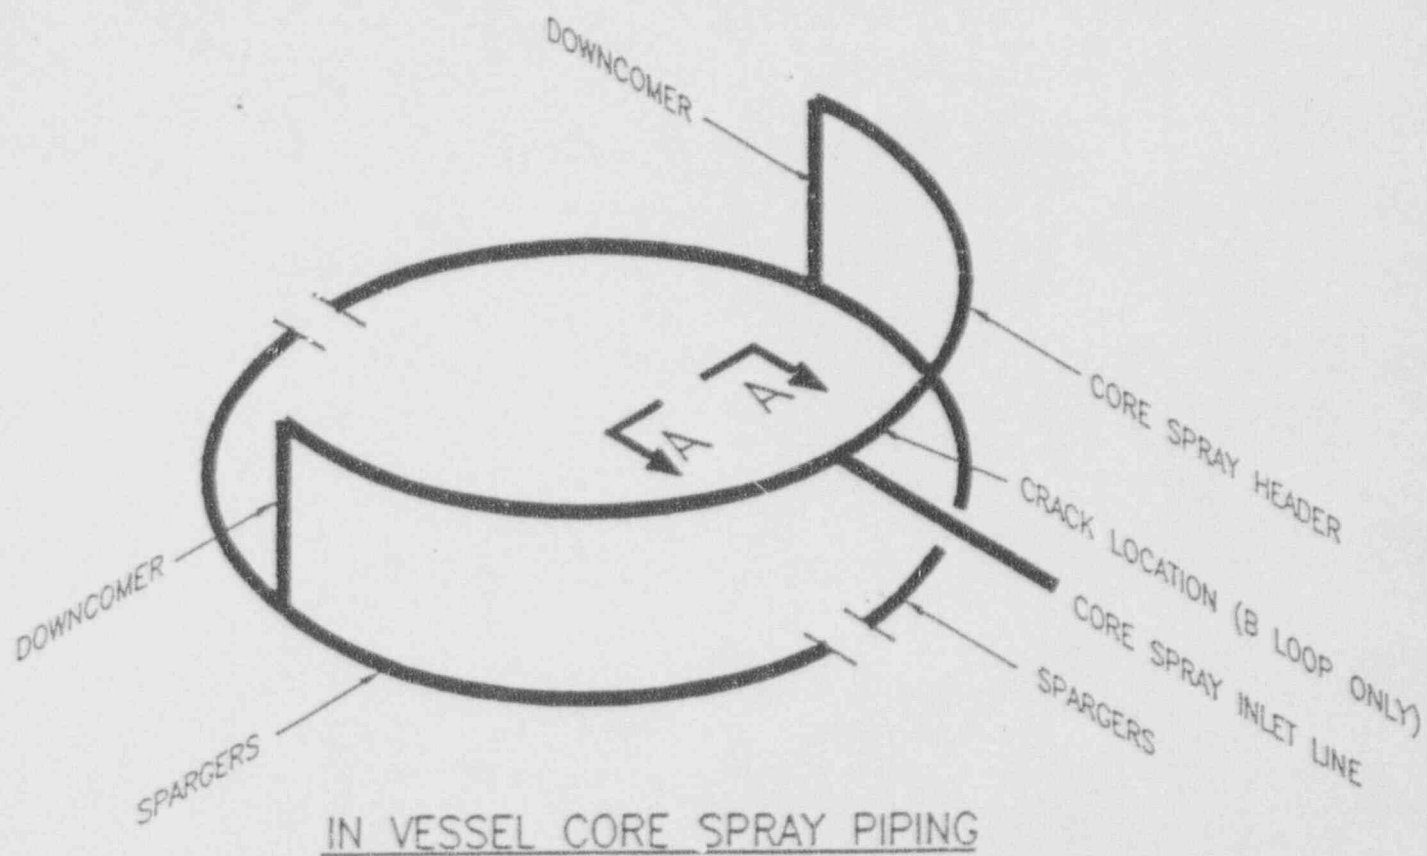
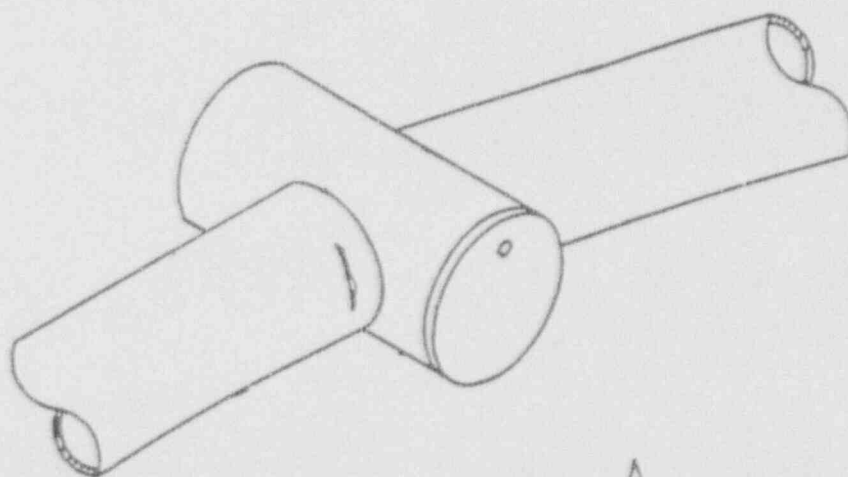
FIGURE #1  
E# 93Q170

The in-vessel visual inspection performed during the 1993 refueling outage identified a small crack indication on the 'B' core spray header where the piping and the tee box meet as shown in figure 1. The function of the junction box and the attached distribution pipes is to direct core spray flow from the vessel inlet nozzle through the annulus area to the spargers inside the shroud. The integrity of this safety related piping system must be maintained to ensure that core spray flow can be delivered to the core to achieve its design function. The purpose for this SRI is to evaluate the acceptability of operating with this crack through one fuel cycle with no operational changes or restrictions.

The crack is located on the left arm of the 'B' core spray distribution pipe adjacent to the junction box weld. It is concluded that the crack is most likely caused by intergranular stress corrosion cracking (IGSCC) for the following reasons:

The crack is located at the 3:00 position (viewing the pipe axially towards the tee box) about 1/4" from the weld. Initial estimates of crack length based on video camera surveys was about 3". A later measurement with a reference scale placed at the crack location indicated the circumferential crack length was actually closer to 2 1/4". In addition, an underwater UT examination of the crack area using NSP's approved method for IGSCC detection revealed that the crack was through wall, did not appear to have major ID origin and no ID or OD cracking was evident at the 12:00 and 6:00 positions.

SECTION A-A  
DETAIL OF CRACK IN  
CORE SPRAY PIPING

NOTE:  
CRACK ON B LOOP  
ONLY AT 90° (N-5A)
