SUBJECT: Arkansas Nuclear One - Unit 1  
Docket No. 50-313  
License No. DPR-51  
Licensee Event Report 50-313/91-003-01

In accordance with 10CFR50.73(a)(2)(iv), enclosed is a supplement to the subject report concerning an automatic actuation of the Emergency Feedwater System.

This supplement is being submitted to provide updated information regarding the root cause of this event.

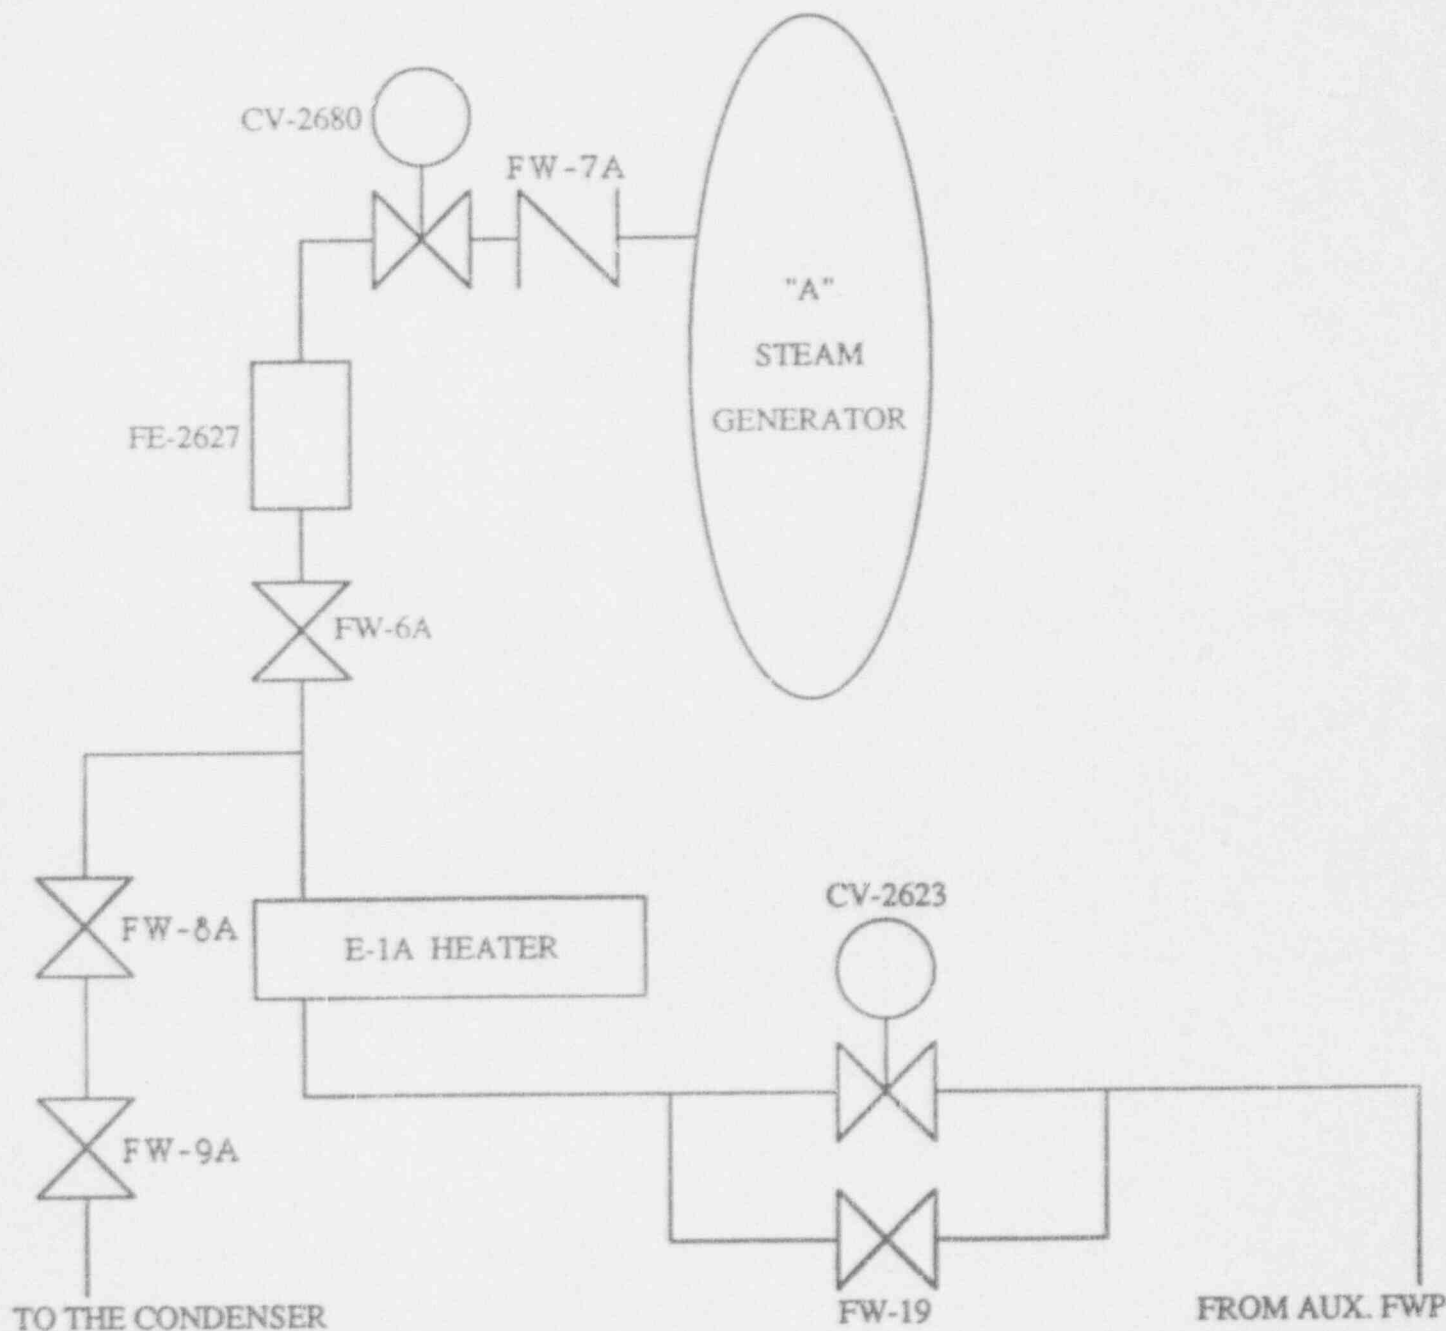
ATTACHMENT

The cause of this event was originally determined to be leakage past the seat of FW-3A (feedwater recirculation line) which was closed at the time of this event, and through FW-9A, which was open, to the condenser (see attachment). This leakage, over a period of time when OTSG feedwater was not required, resulted in the feedwater line between CV-2623 and FW-7A becoming voided. When the 'A' OTSG reached its lower limit, CV-2623 began to open as designed. However, since flow was entering a partially voided line, the OTSG level continued to drop and CV-2623 continued to ramp open in response to the decreasing level. As CV-2623 continued to open, P-75 discharge pressure dropped below OTSG pressure and 'B' OTSG level began to decrease, resulting in the 'B' startup valve (CV-2673) beginning to open farther. It was believed that P-75 pumping into the voided feedwater line had resulted in the pump reaching a 'runout' condition which rendered it incapable of supplying feedwater to the OTSGs. However, subsequent evaluations performed during refueling outage 1R10 (February - May, 1992) determined that, although leakage past the seat of FW-8A was a contributing factor to this event, it was not the root cause. Disassembly and inspection of P-75 during 1R10 revealed that the first stage channel ring bushing was loose and had caused abnormal wear on the second stage impeller. Conversation with the pump vendor (Ingersoll-Rand) verified that the loose bushing could move into the suction of the next stage impeller and effectively reduce the inlet area of that impeller. At increased flow rates, the restriction produced by the bushing could result in significant throttling. Therefore, it was concluded that the internal pump damage was the primary cause of this event.
