Subject: McGuire Nuclear Station Unit 2  
Docket No. 50-370  
Licensee Event Report 370/93-01

# LICENSEE EVENT REPORT (LER)

FACILITY NAME(1) McGuire Nuclear Station, Unit 2							DOCKET NUMBER(2) 05000 370		PAGE(3) 1 OF 13	
TITLE(4) A Unit 2 Manual Reactor Trip was Initiated as a Result of Equipment Failure.										
EVENT DATE(5)			LER NUMBER(6)			REPORT DATE(7)			OTHER FACILITIES INVOLVED(8)	
MONTH	DAY	YEAR	YEAR	SEQUENTIAL NUMBER	REVISION NUMBER	MONTH	DAY	YEAR	FACILITY NAMES	DOCKET NUMBER(S)
02	22	93	93	01	0	03	24	93		05000 370
										05000

**Metallurgical Analysis Report**

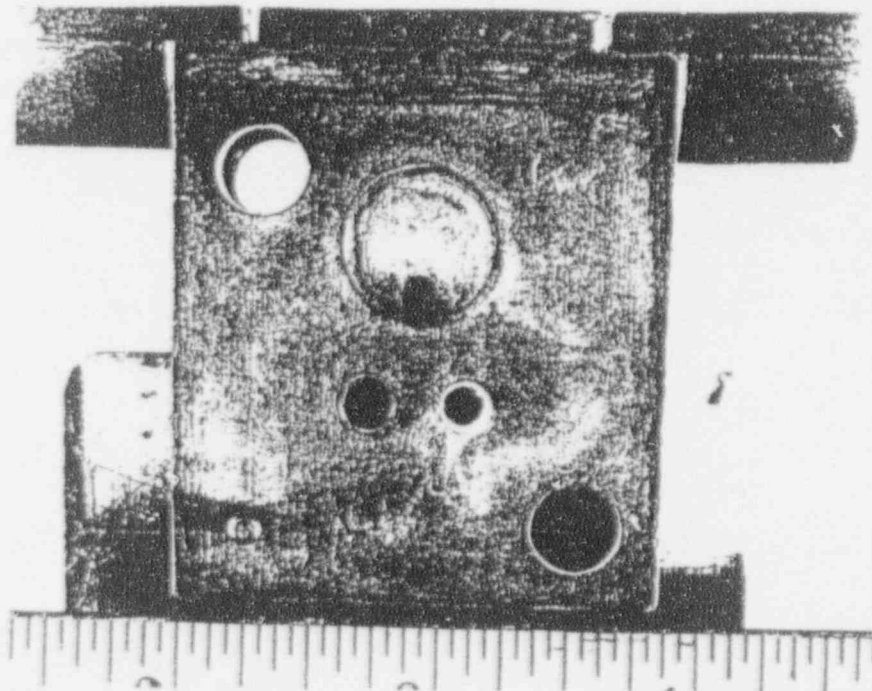
The material in the control air line only partially occluded the port, as viewed from the manifold block (Figure 1). The material was a fine yellowish-white powder and was not magnetic.

The white powder in the control air port and around the inner bellows appeared to be related to the flux used in soldering the bellows. It was believed to be flux which had not liquified during soldering; the melted flux residue was orange-brown and resinous. It was found to contain chloride.

Figure 1 View of manifold block of valve positioner, showing extent of yellowish-white material in control air port. Ma-2497.

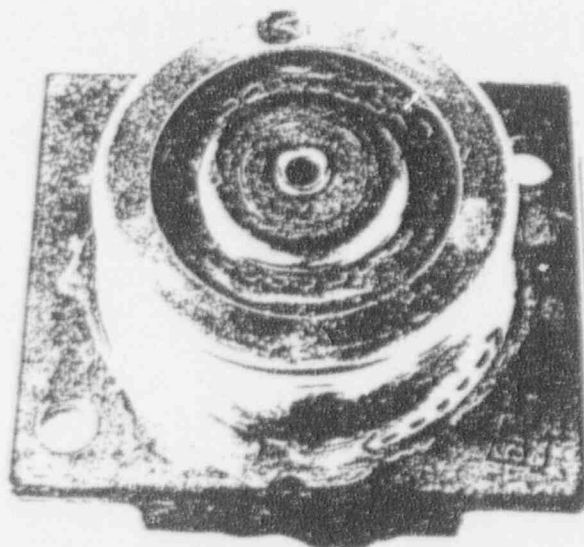
The outer shield of the relay was sectioned off through the solder joint. The outer bellows, which was generally clean, was sectioned through the base solder joint and around the cap at top (Figure 2). The inner bellows was cracked below the second convolution from the bottom (base plate) side, in the transition from the flat convolution underside to the radius (Figure 3). The crack covered ~100° of the circumference. While the metal was generally shiny, several dark blue stains appeared around the crack, one in the center of its length (Figure 4).

Figure 2 Overall view of failed valve positioner relay, as received. Shield and outer bellows were cut away as shown to reveal inner bellows. Ma-2496.

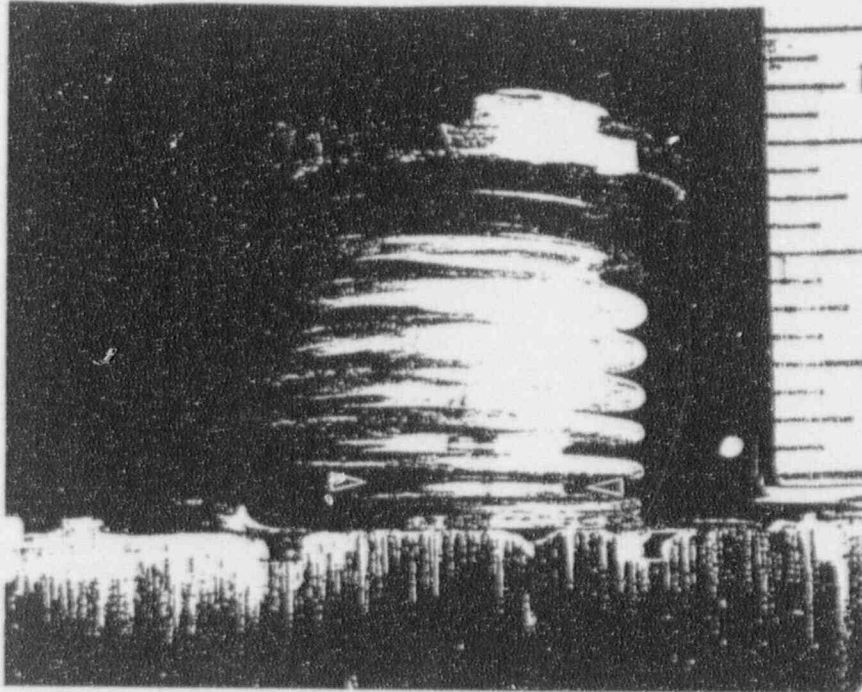
Figure 3 Inner bellows revealed by sectioning. Crack is visible under second convolution from bottom (arrows). Gauge = 1/16". Ma-2500.

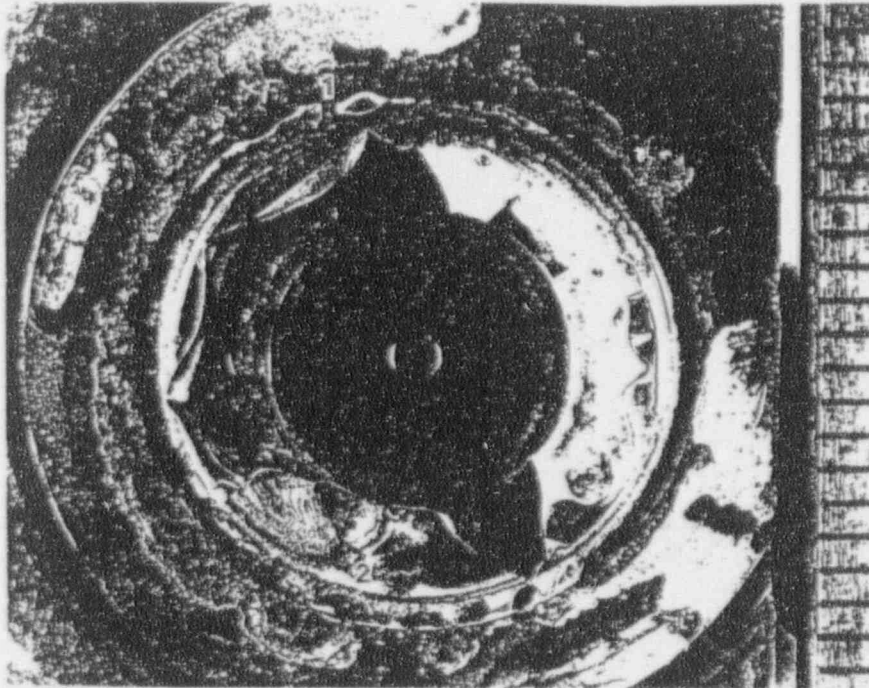
The inside of the outer bellows and the outside of the inner bellows were dusted with the same yellowish-white powder as was found in the control air port. The base plate was caked with the powder in some areas and had several patches of orange-brown resinous solder flux visible (Figure 5). It appeared that the powder was original solder flux, possibly degraded or dried, that had not melted to form the orange-brown resin.

Figure 5 Base plate with inner bellows sectioned off. Area 1 shows flux partially converted to white powder; Area 2 shows flux mixed with solder. Gauge = 1/16". Ma-2501.

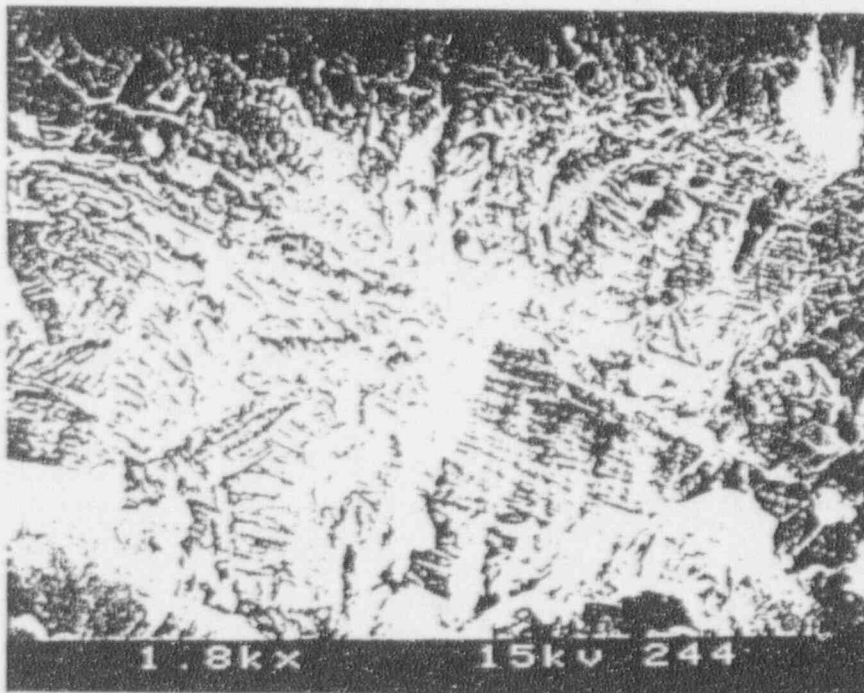
The crack was pulled apart to examine the fracture surface. Scanning electron microscope examination located many regions of distinct fatigue striations along the crack length (Figure 6).

The crack in the inner bellows of the valve positioner relay appeared to have been initiated by stress-corrosion cracking, as evidenced by the presence of branching cracks near the center of the fracture. One crack which reached critical flaw size then propagated through fatigue under vibrational stresses, as shown by the presence of fatigue striations elsewhere on the fracture surface.

Figure 6 Fatigue striations visible on fracture surface of crack in Figure 4, broken open. Crack traveled from bottom to top. (1800X) S-1888.

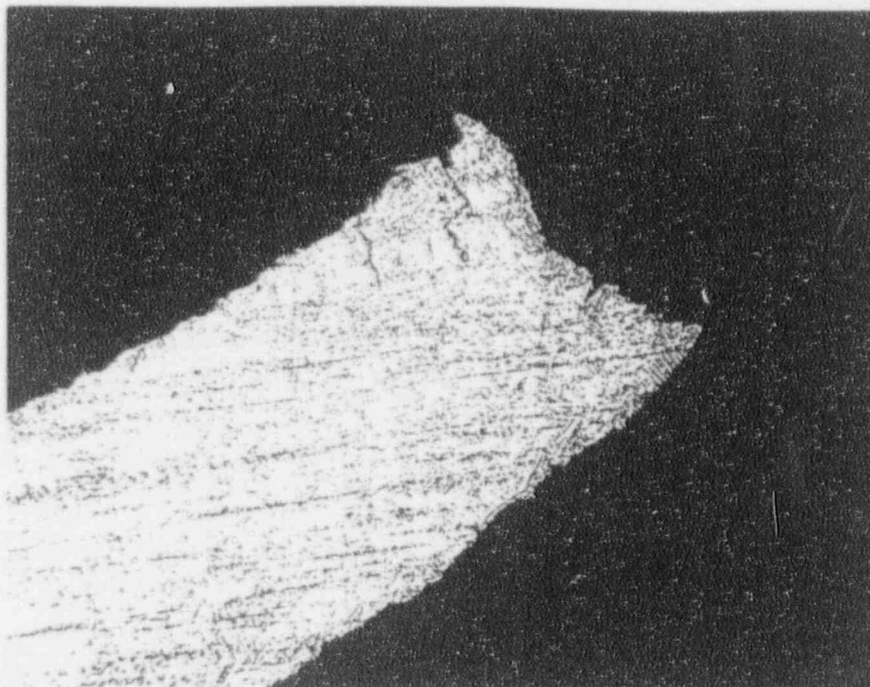
A cross-section was taken through the center of the crack near the blue stain. Two branching cracks were found extending from the exterior surface of the inner bellows, parallel to the main crack (Figure 7). The small cracks were characteristic of stress corrosion cracks; once one grew to a critical flaw size, its mode of growth changed to fatigue and propagated through-wall.

Figure 7 Cross-section through inner bellows near center of crack. Two branching cracks extend from OD, parallel to fracture surface (right). (500X) Mi-2632.

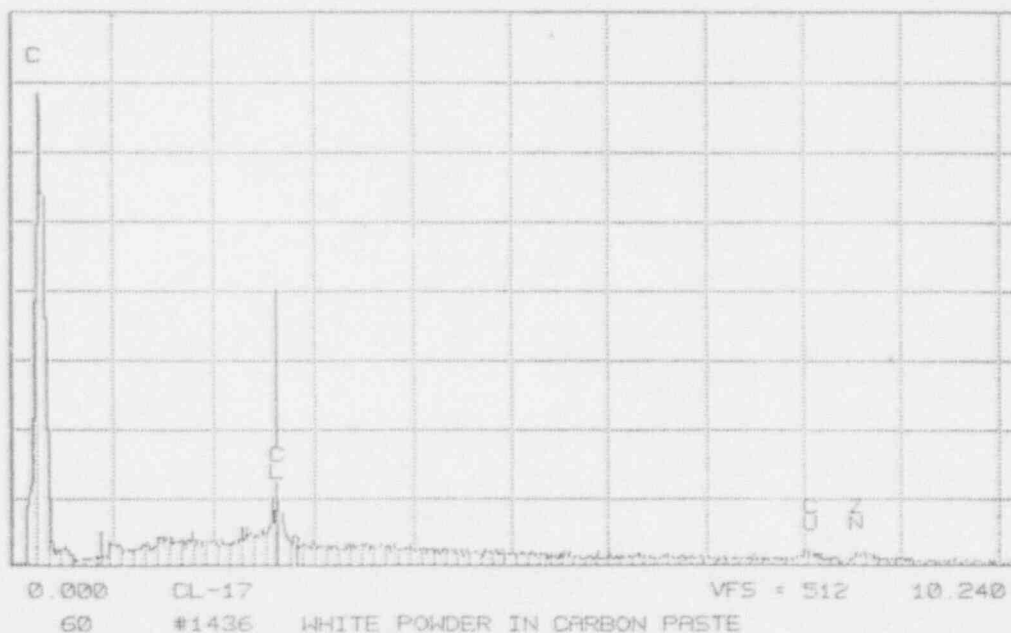
Qualitative chemical analysis using EDS was performed on the yellowish-white powder using two methods. Both indicated that the material was resinous or organic (carbon-rich) and contained some amount of chloride (Figure 8).

Chloride is not typically an actor in the stress corrosion of brass. Ammonia compounds are known to cause SCC in brass, but ammonia is undetectable by EDS. Heating and precipitation/wet chemical testing was used to qualitatively indicate whether ammonia compounds were present in the resinous flux residue. No ammonia was detected; the flux residue was determined to be fairly acidic (pH of ~1).

Figure 8 EDS spectrum produced by yellowish-white powder, mounted to stub with carbon paste. Carbon is the major signal but chloride is distinctly present.
